ENVIRONMENTAL TEST REPORT No. 6737-A Rev 1

Shock Testing

Valve Actuators KEM, WEM, WE

IEC 60068-2-27

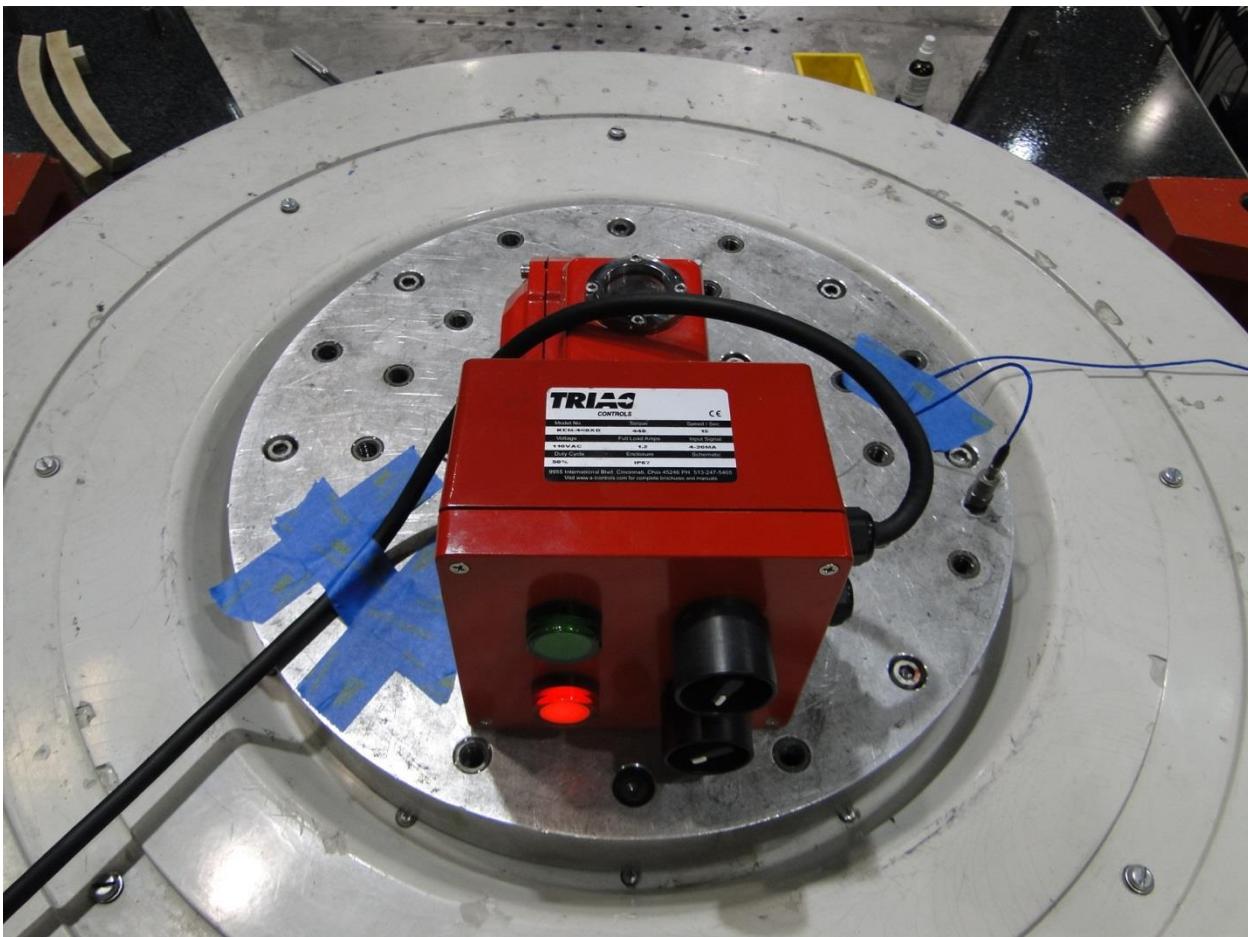
Photo 5.2.1-1: Vertical axis shock on KEM-440XD

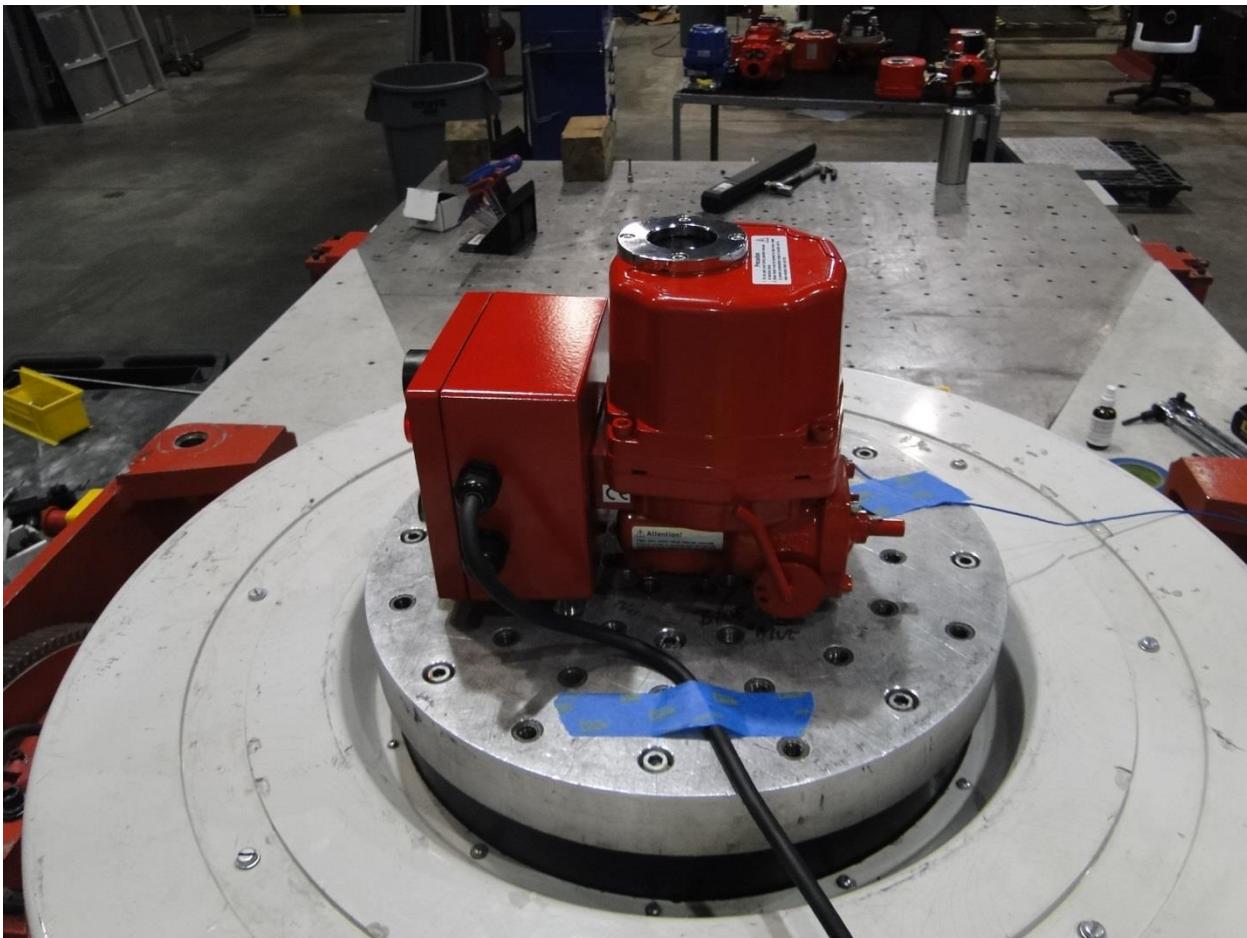
Photo 5.2.1-2: Vertical axis shock on WEM-690XD

- Step 8) Note: During the first shock pulse on WEM-690XD became loosened. The unit was tightened using shorter mounting bolts and the test resumed with no anomalies.

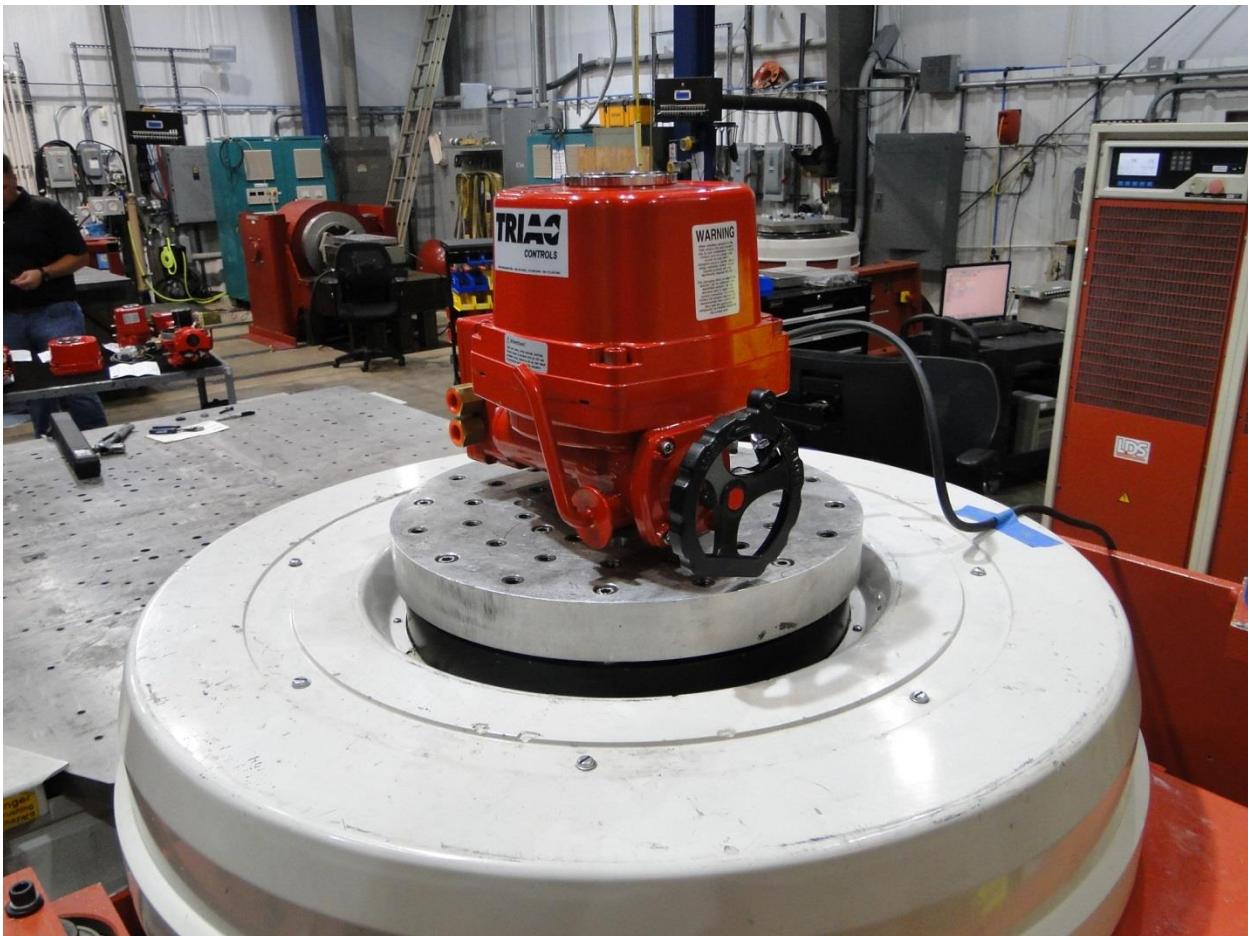
Photo 5.2.1-3: Vertical axis shock on WEM-4400

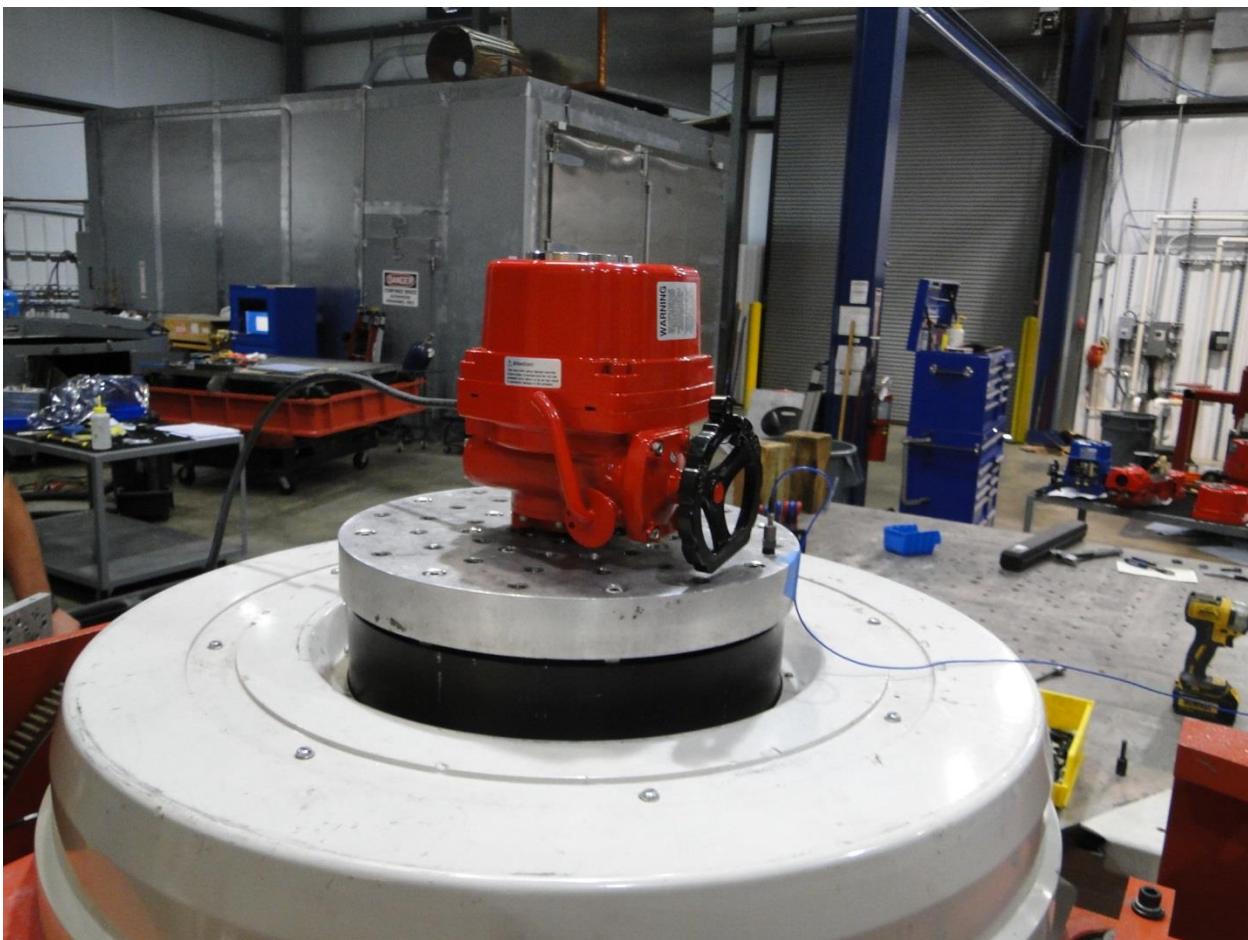
Photo 5.2.1-4: Vertical axis shock on WE-1350X-VR

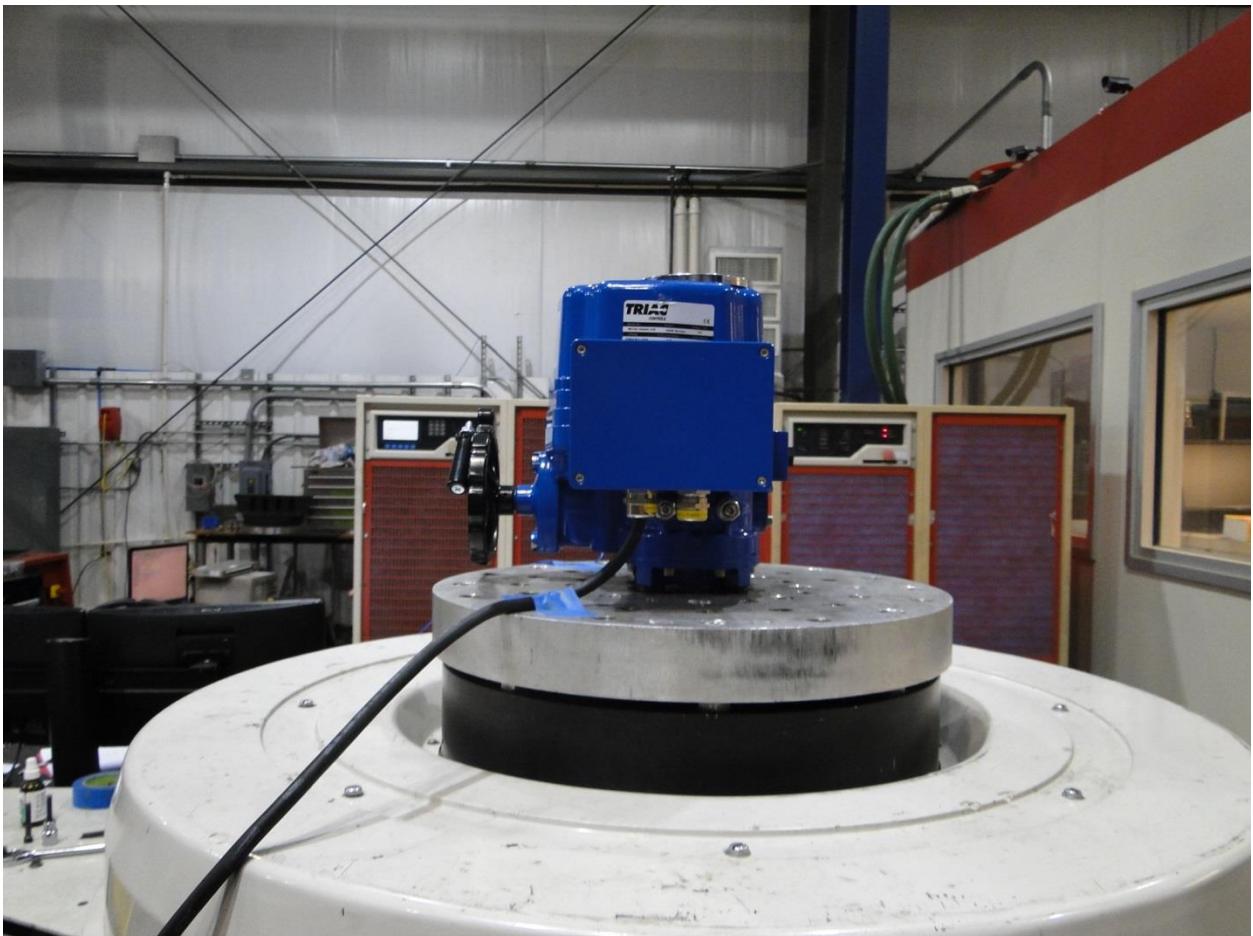
Photo 5.2.1-5: Vertical axis shock on WE-1350E-VR

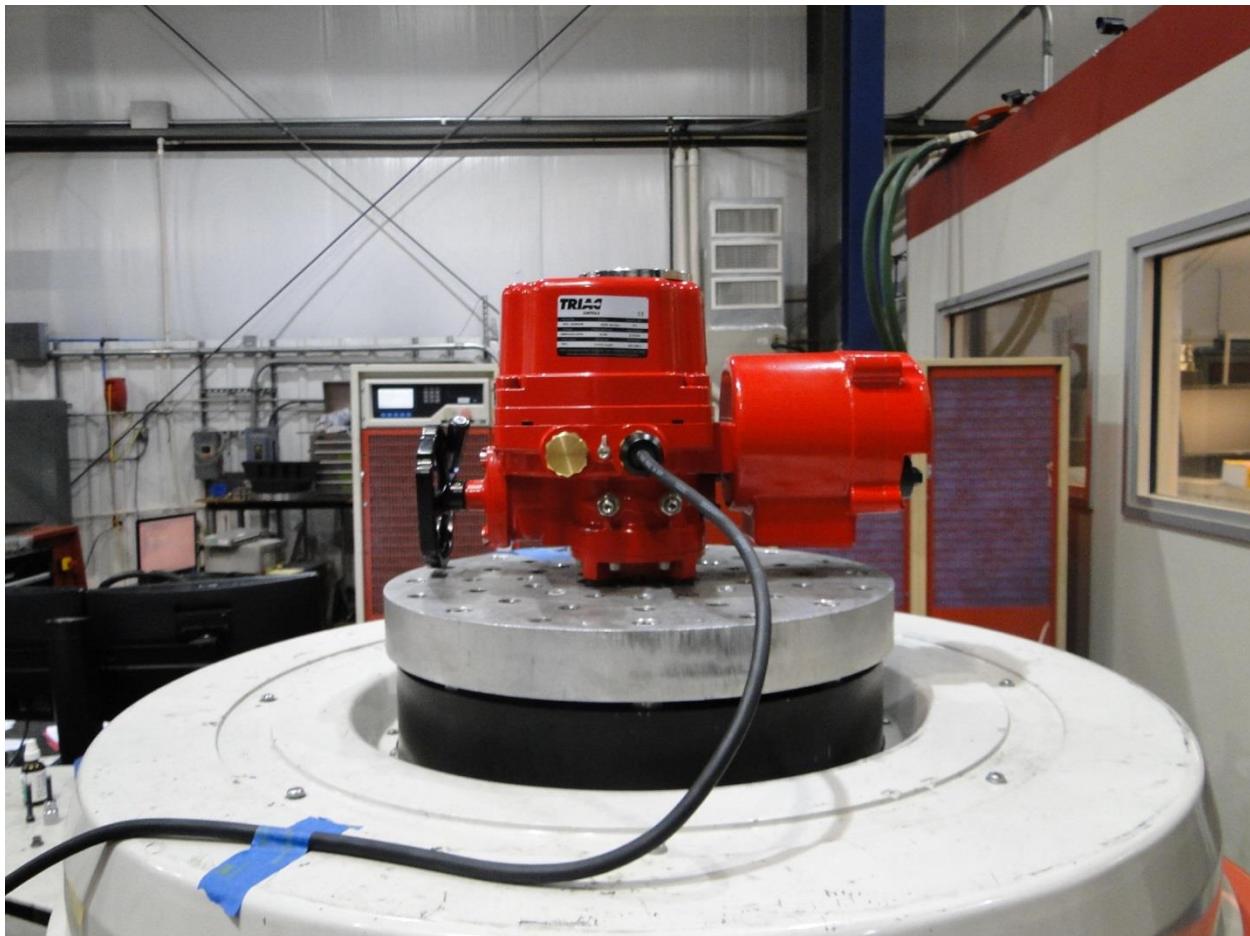
Photo 5.2.1-6: Vertical axis shock on WE-1350HB

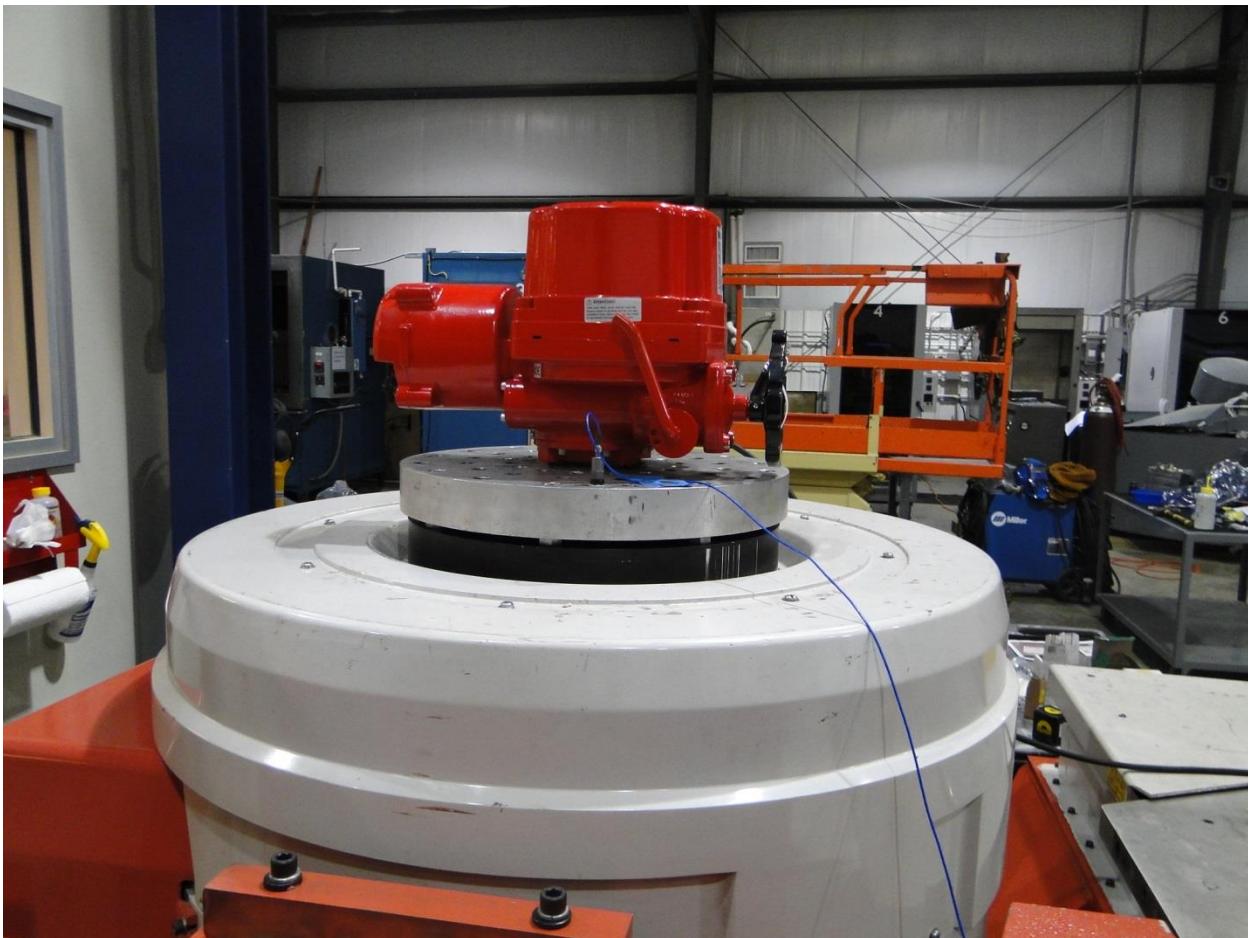
Photo 5.2.1-7: Vertical axis shock on WE-2640HB

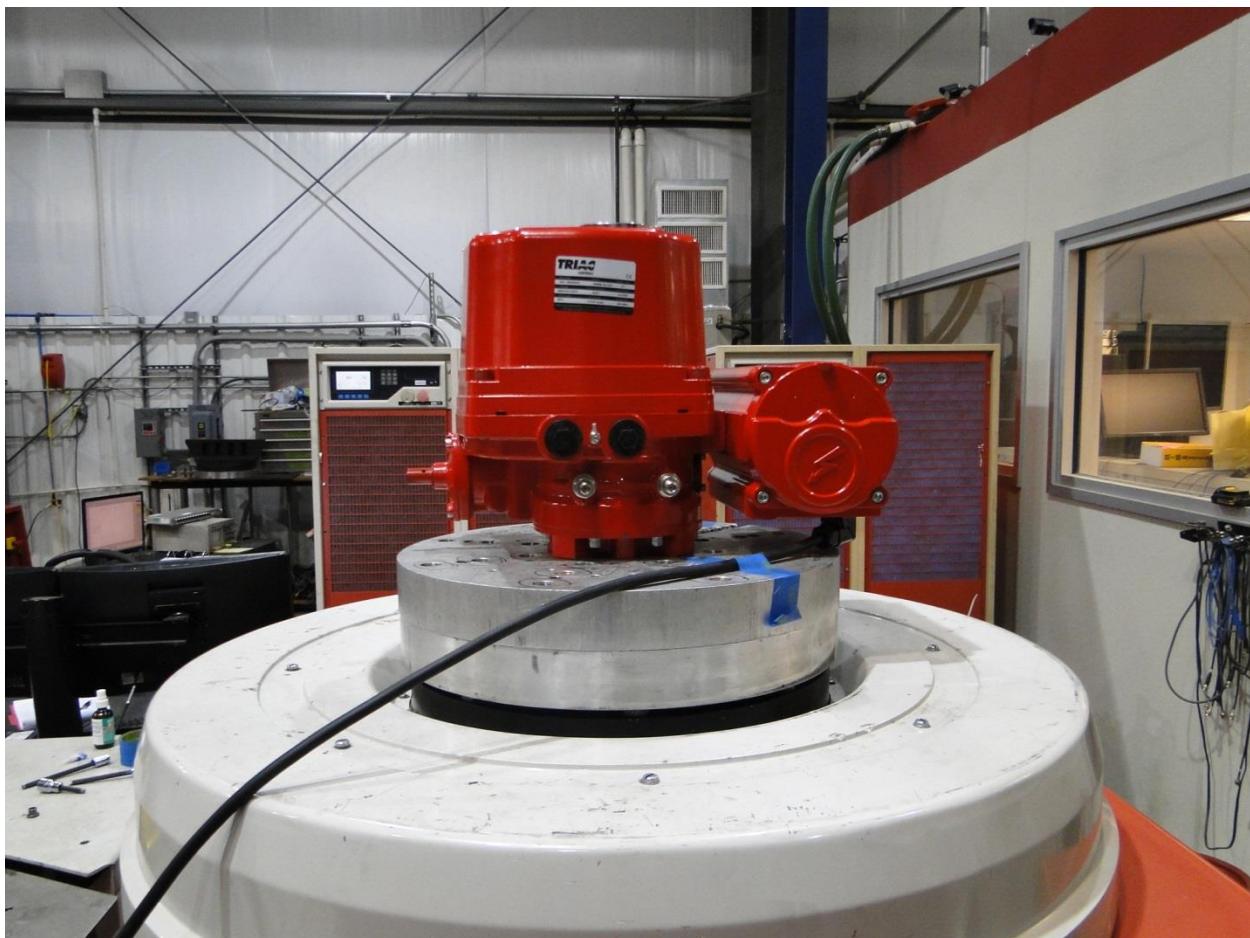
Photo 5.2.1-8: Vertical axis shock on WE-10500HB

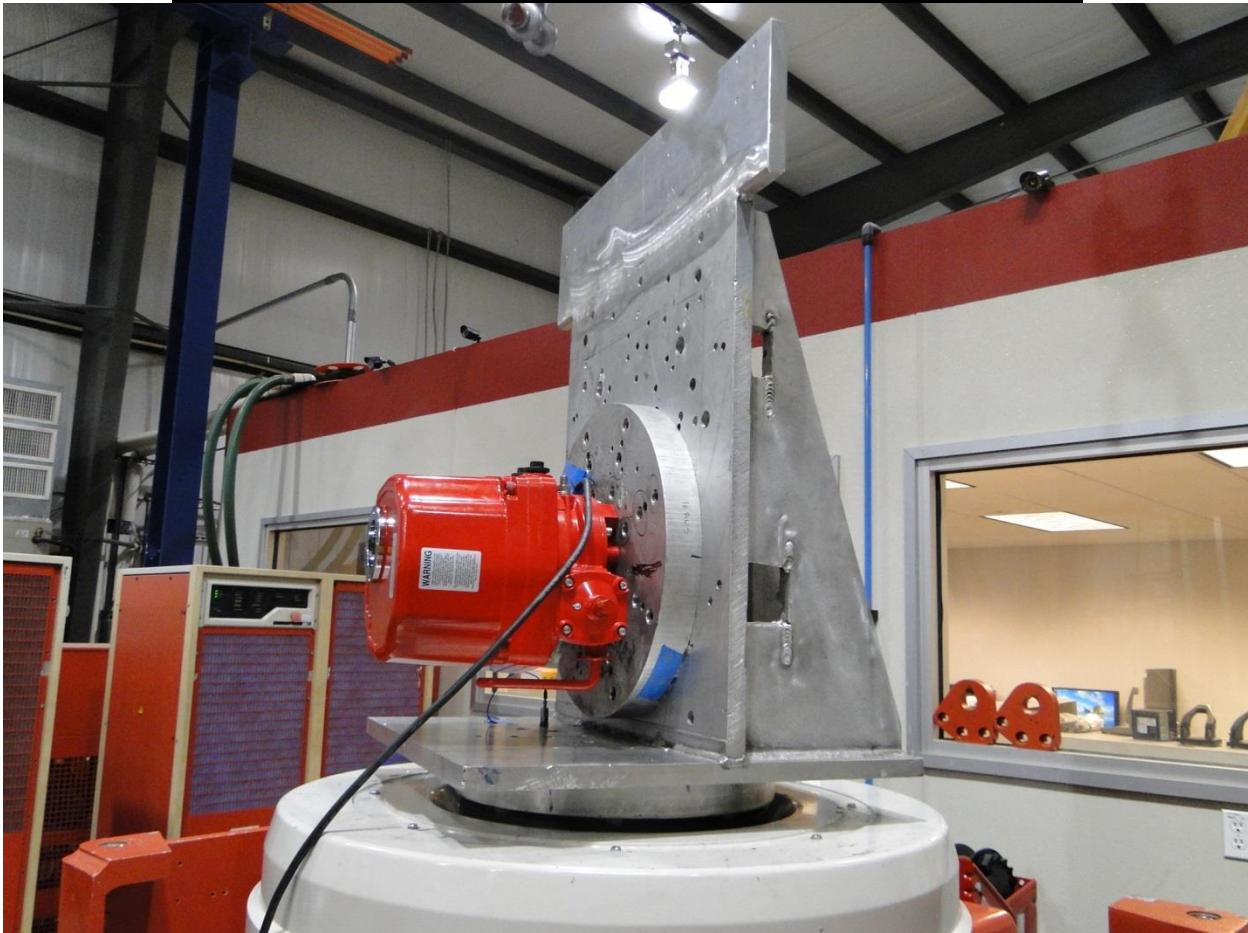
Photo 5.2.1-9 Longitudinal axis shock on WE-10500HB

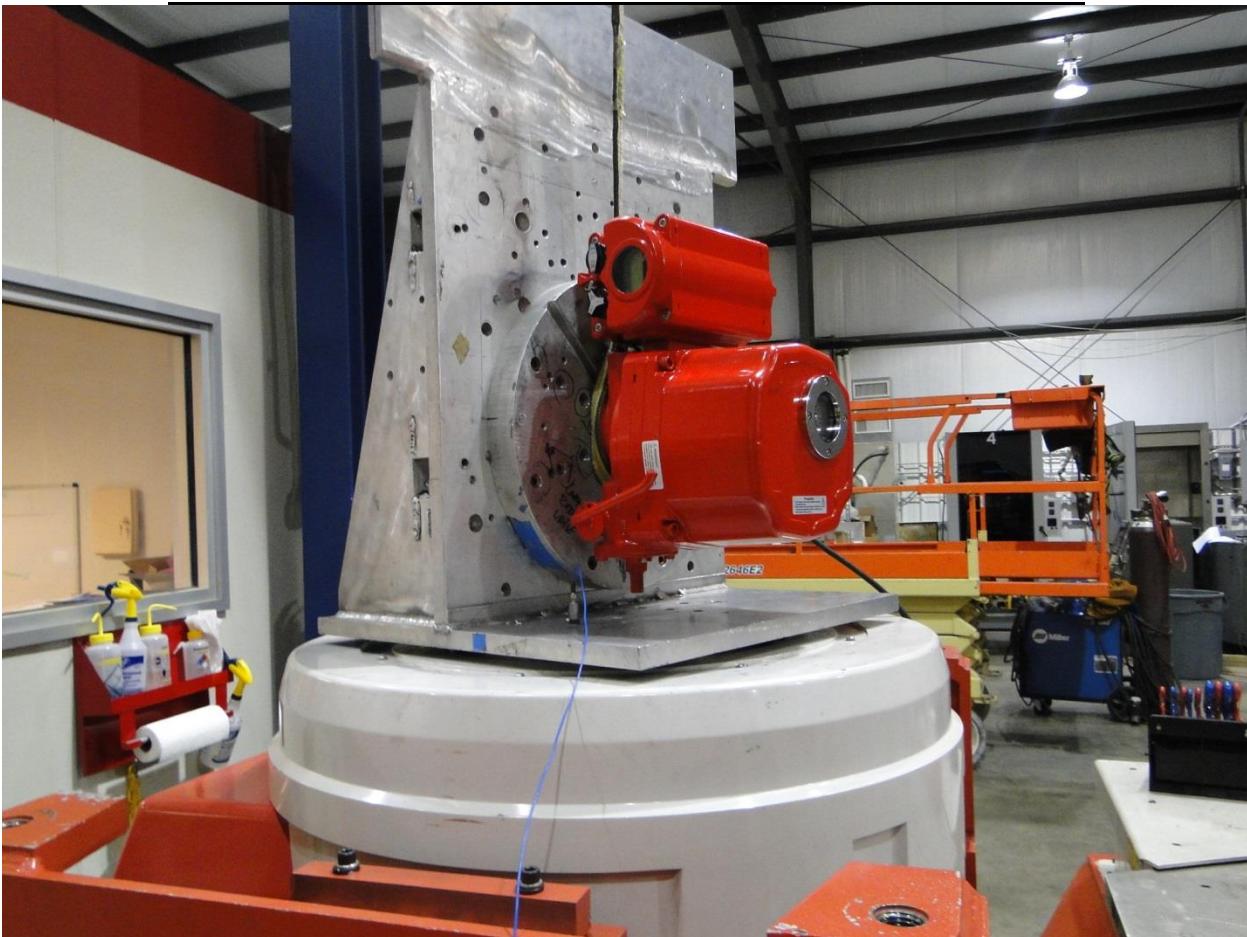
Photo 5.2.1-10 Transverse axis shock on WE-10500HB

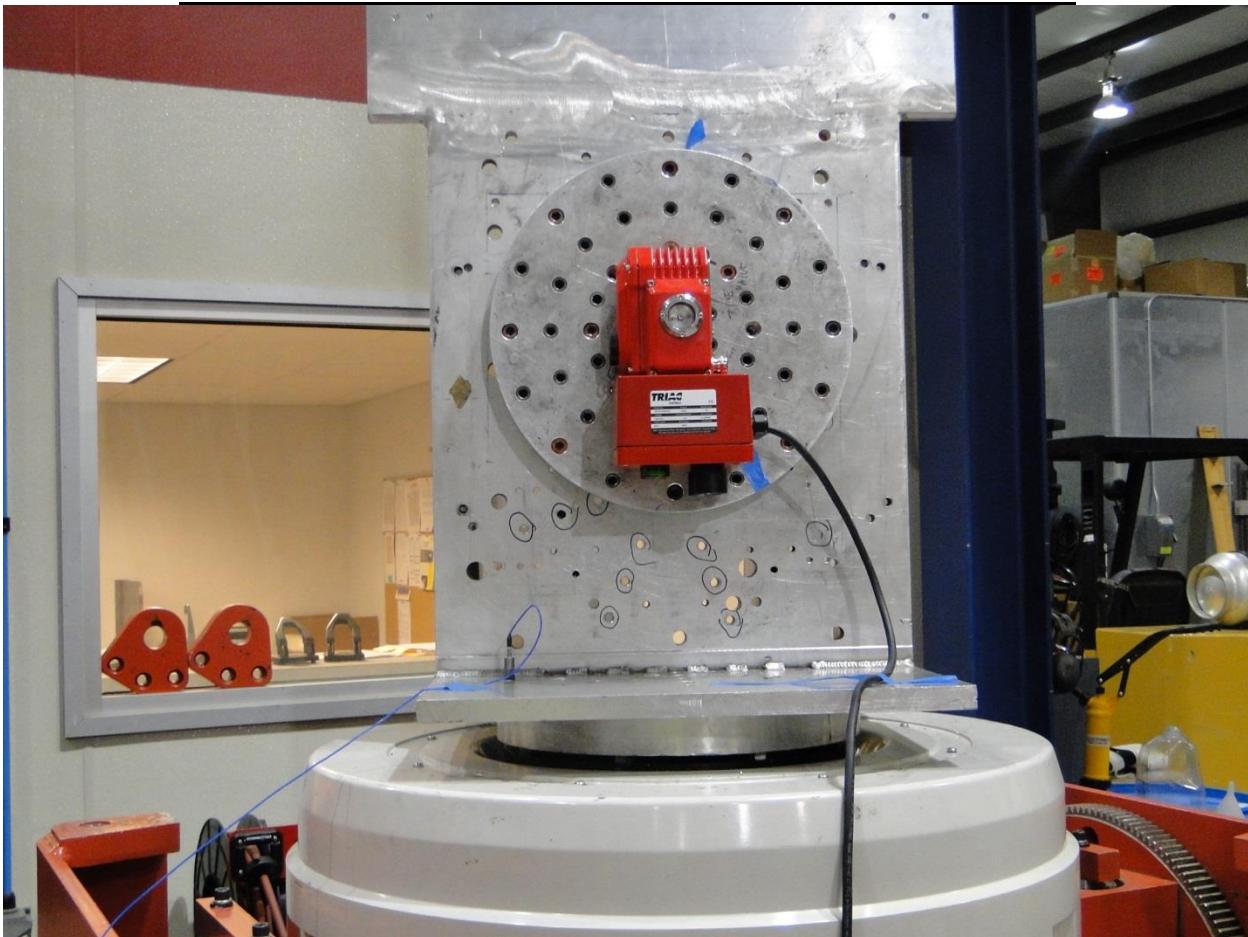
Photo 5.2.1-11 Transverse axis shock on KEM-440XD

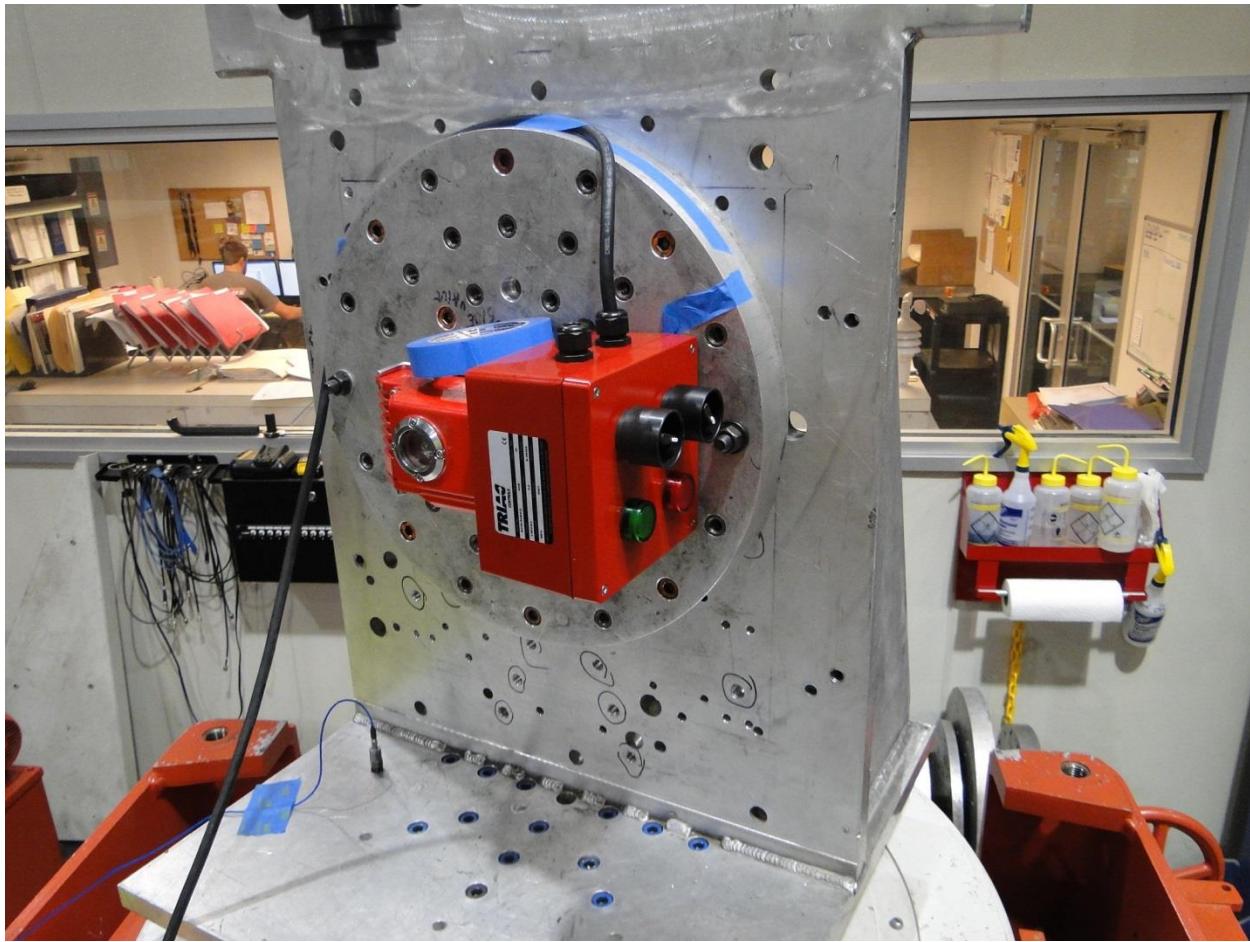
Photo 5.2.1-12 Longitudinal axis shock on KEM-440XD

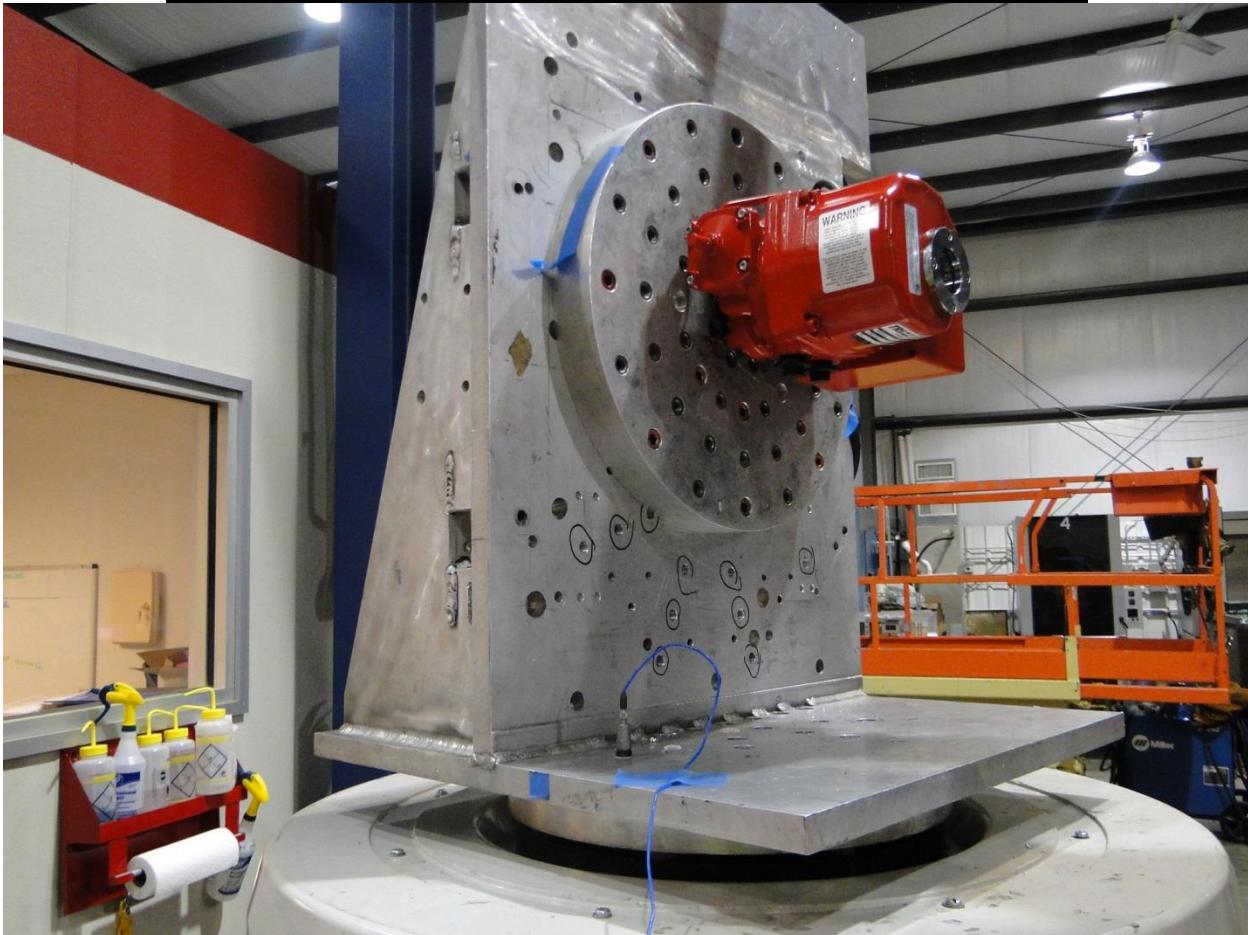
Photo 5.2.1-13 Longitudinal axis shock on WEM-690XD

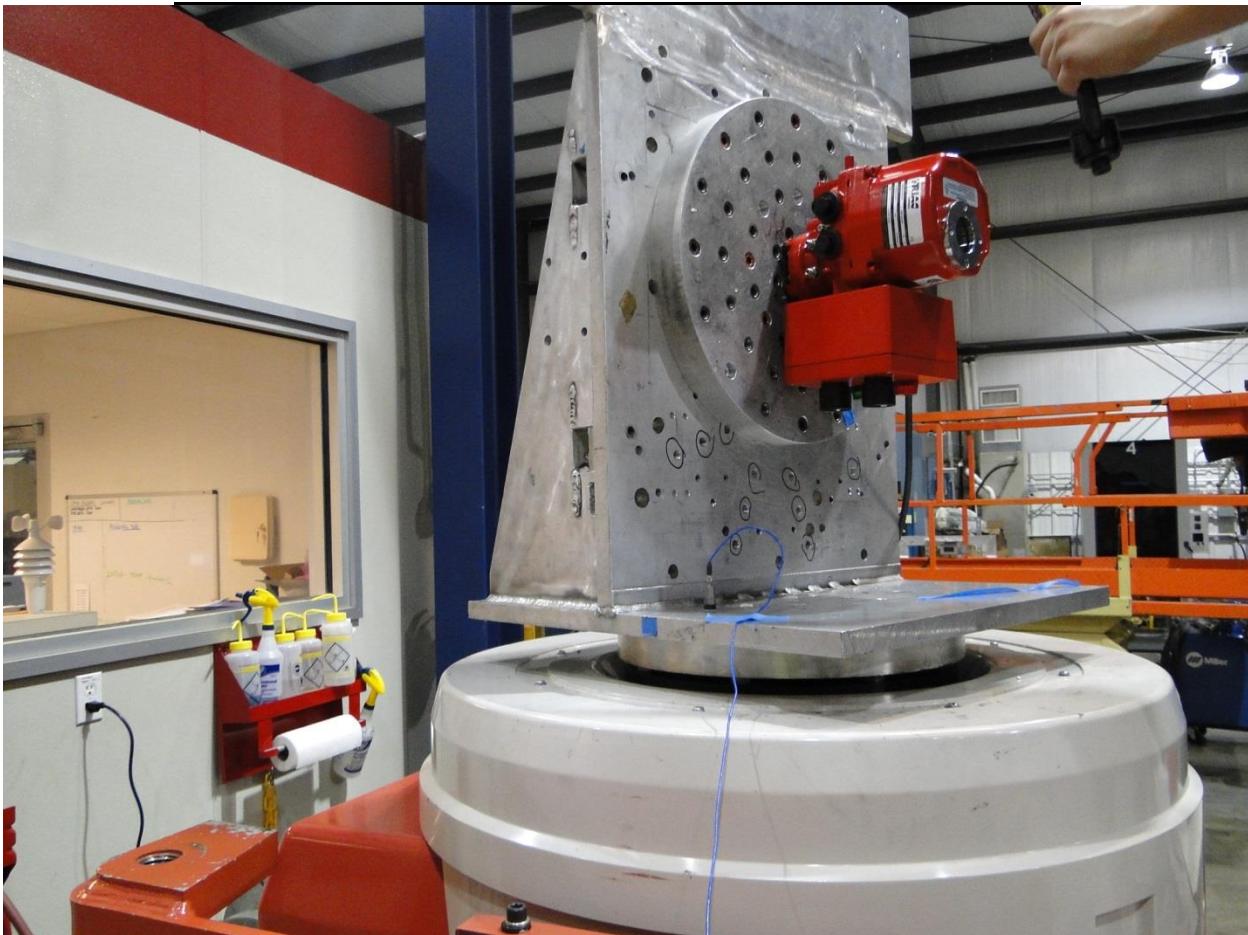
Photo 5.2.1-14 Transverse axis shock on WEM-690XD

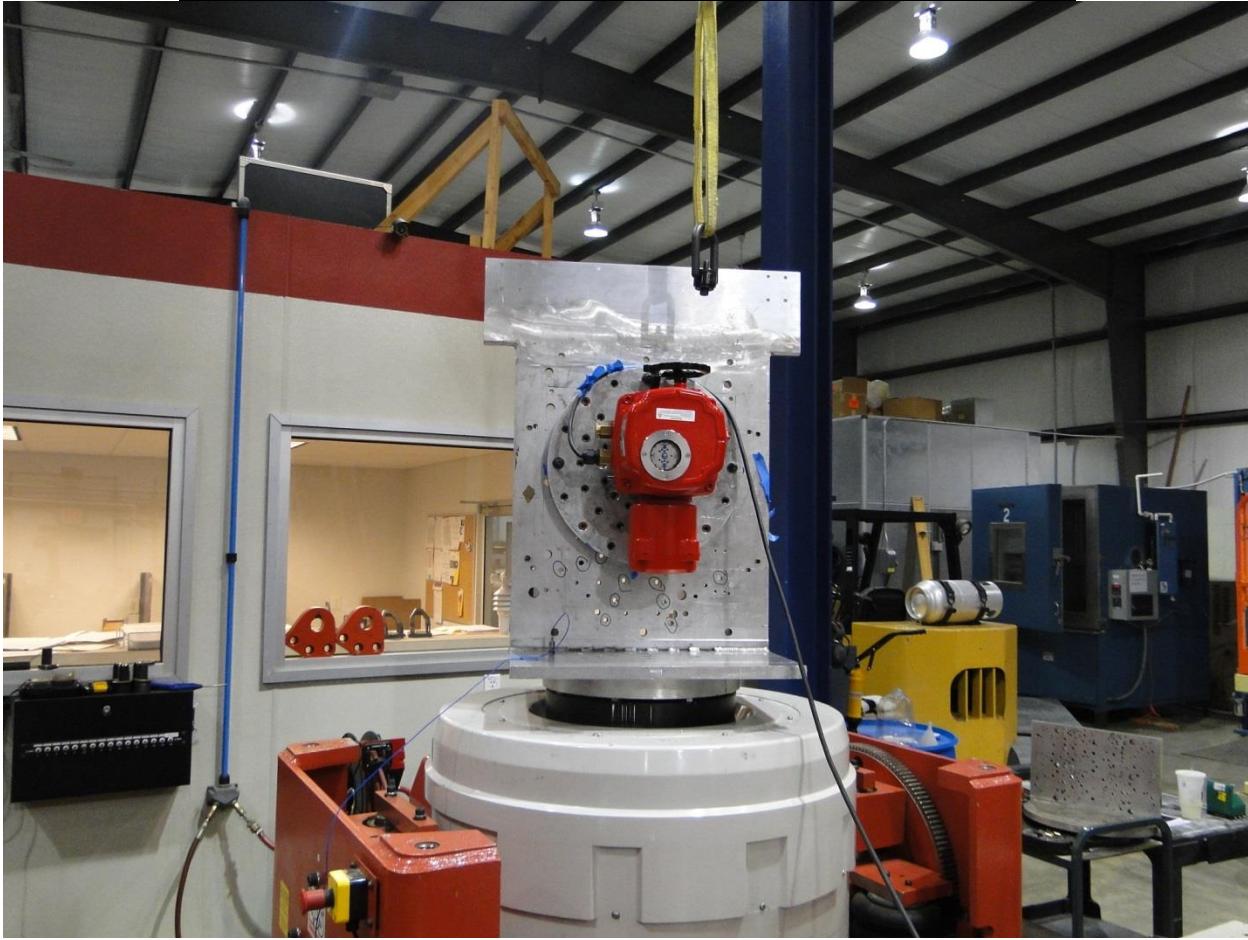
Photo 5.2.1-15 Transverse axis shock on WE-2640HB

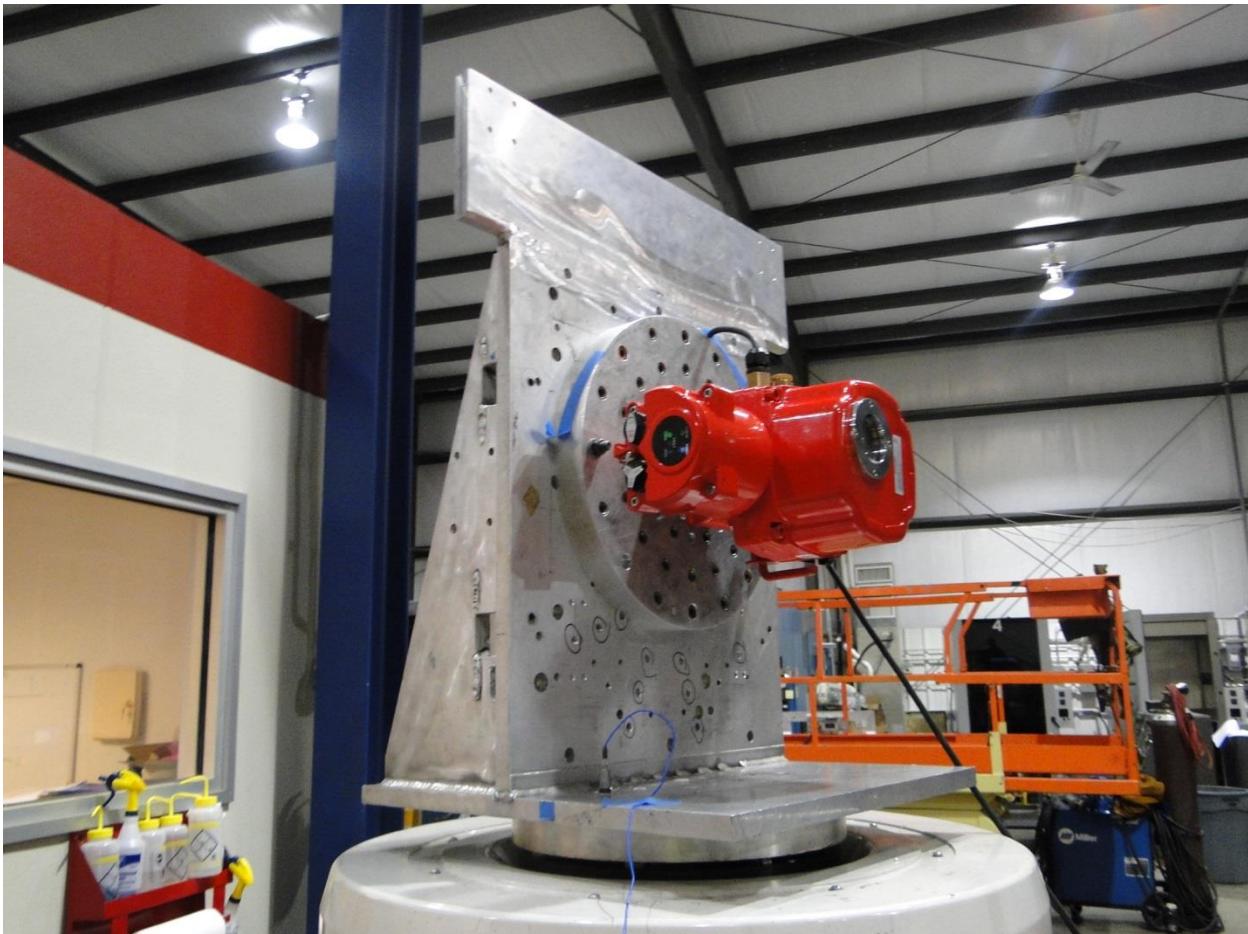
Photo 5.2.1-16 Longitudinal axis shock on WE-2640HB

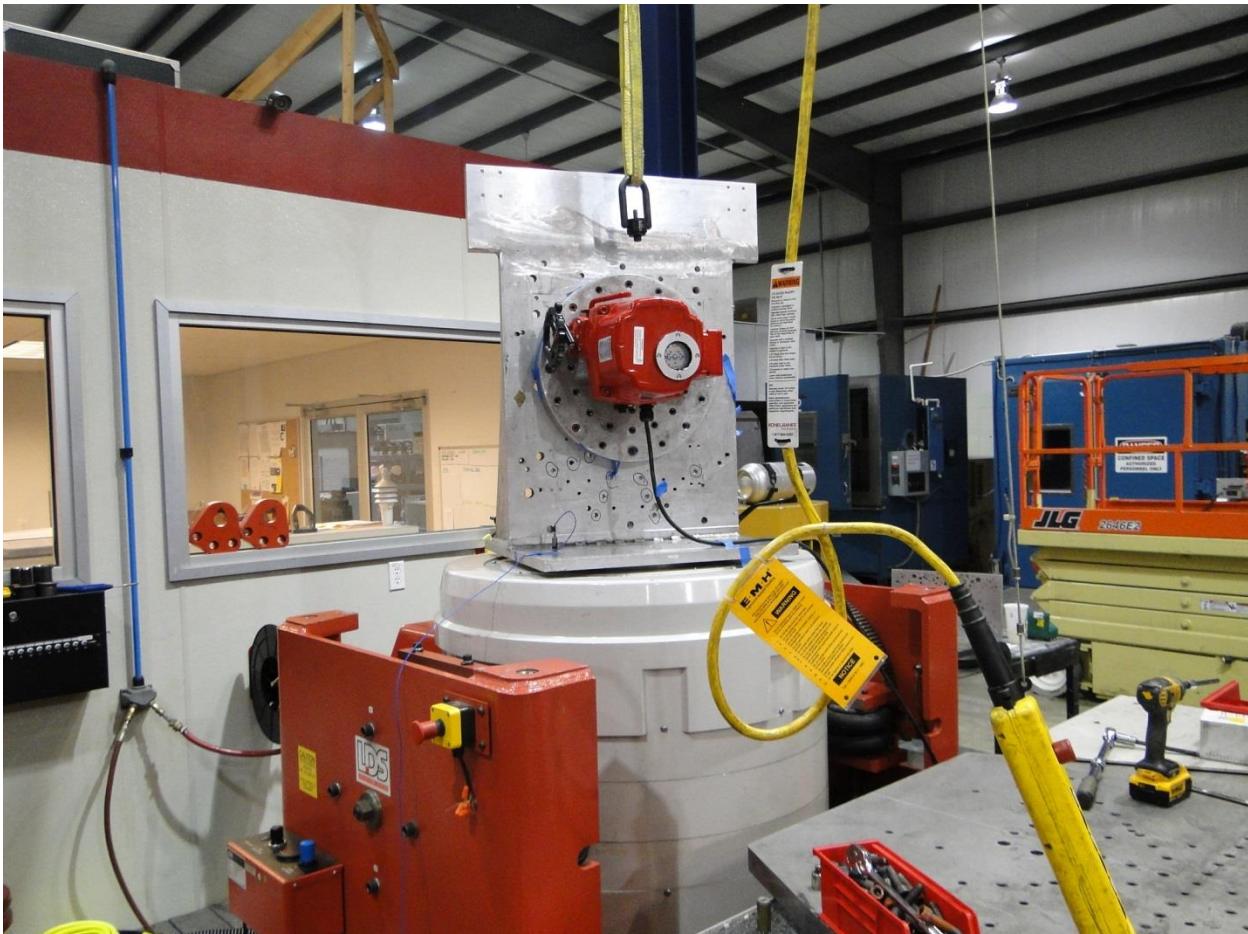
Photo 5.2.1-17 Longitudinal axis shock on WEM-4400

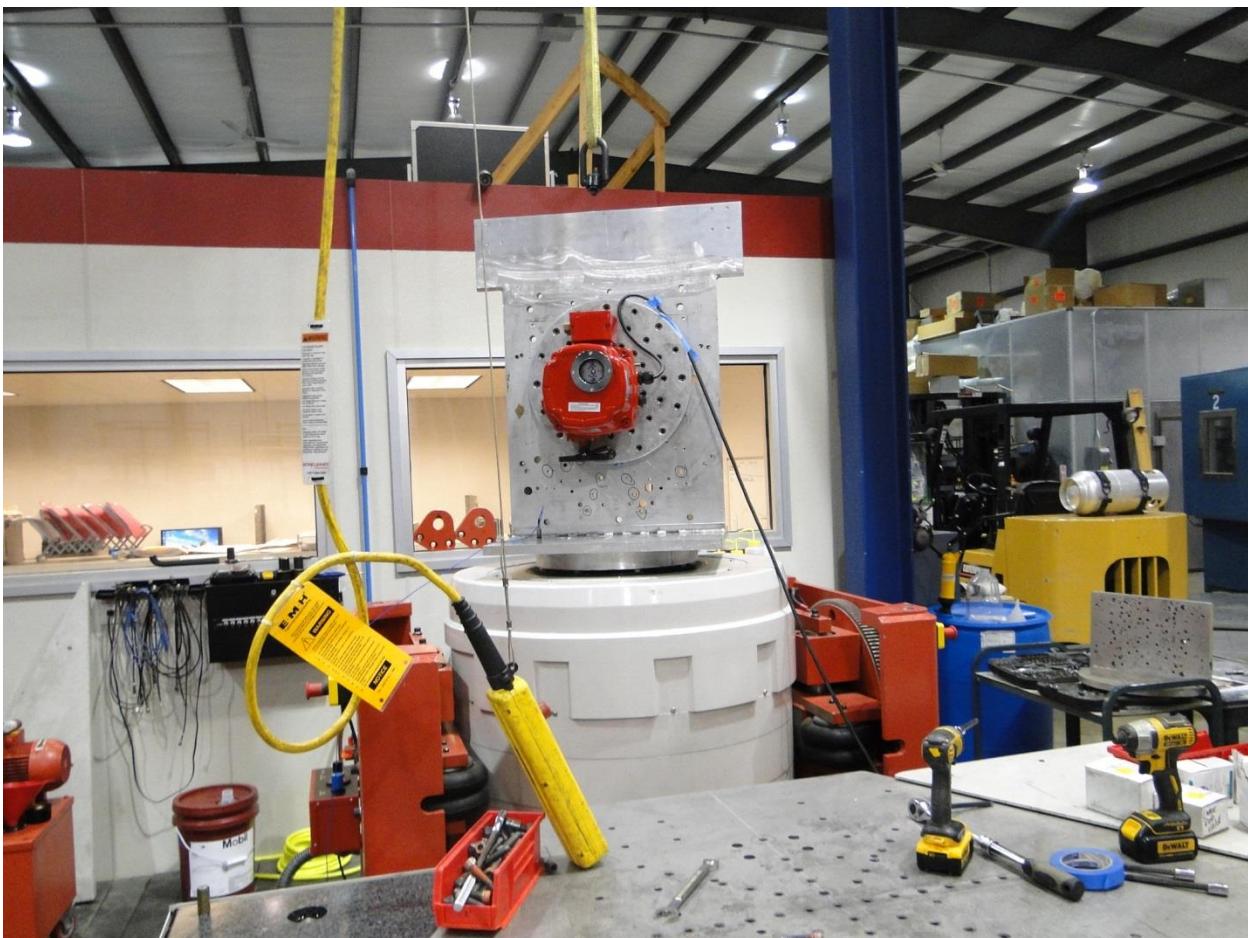
Photo 5.2.1-18 Transverse axis shock on WEM-4400

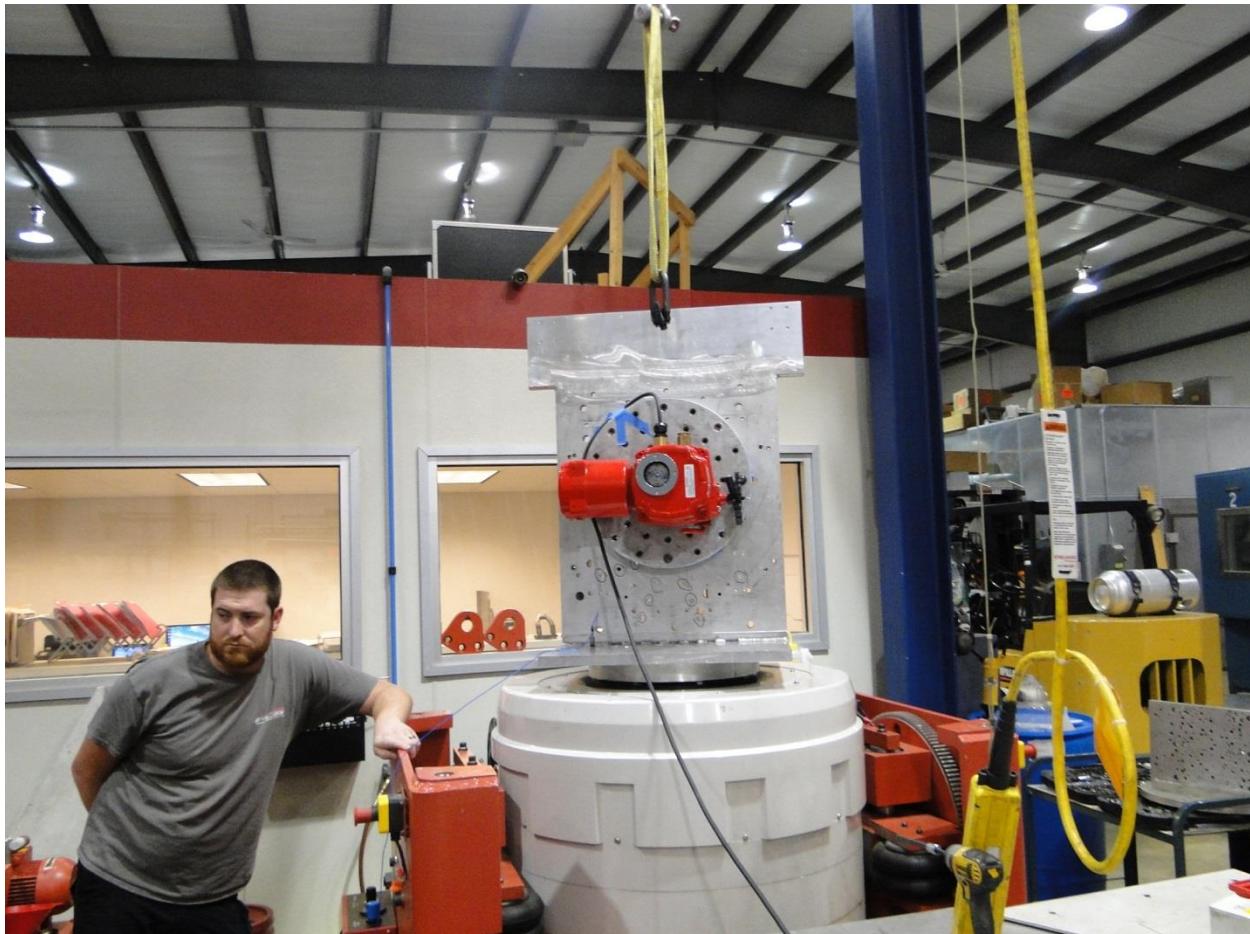
Photo 5.2.1-20 Longitudinal axis shock on WE-1350HB
