ENVIRONMENTAL TEST REPORT No. 6737-A Rev 1

Shock Testing

Valve Actuators KEM, WEM, WE

IEC 60068-2-27

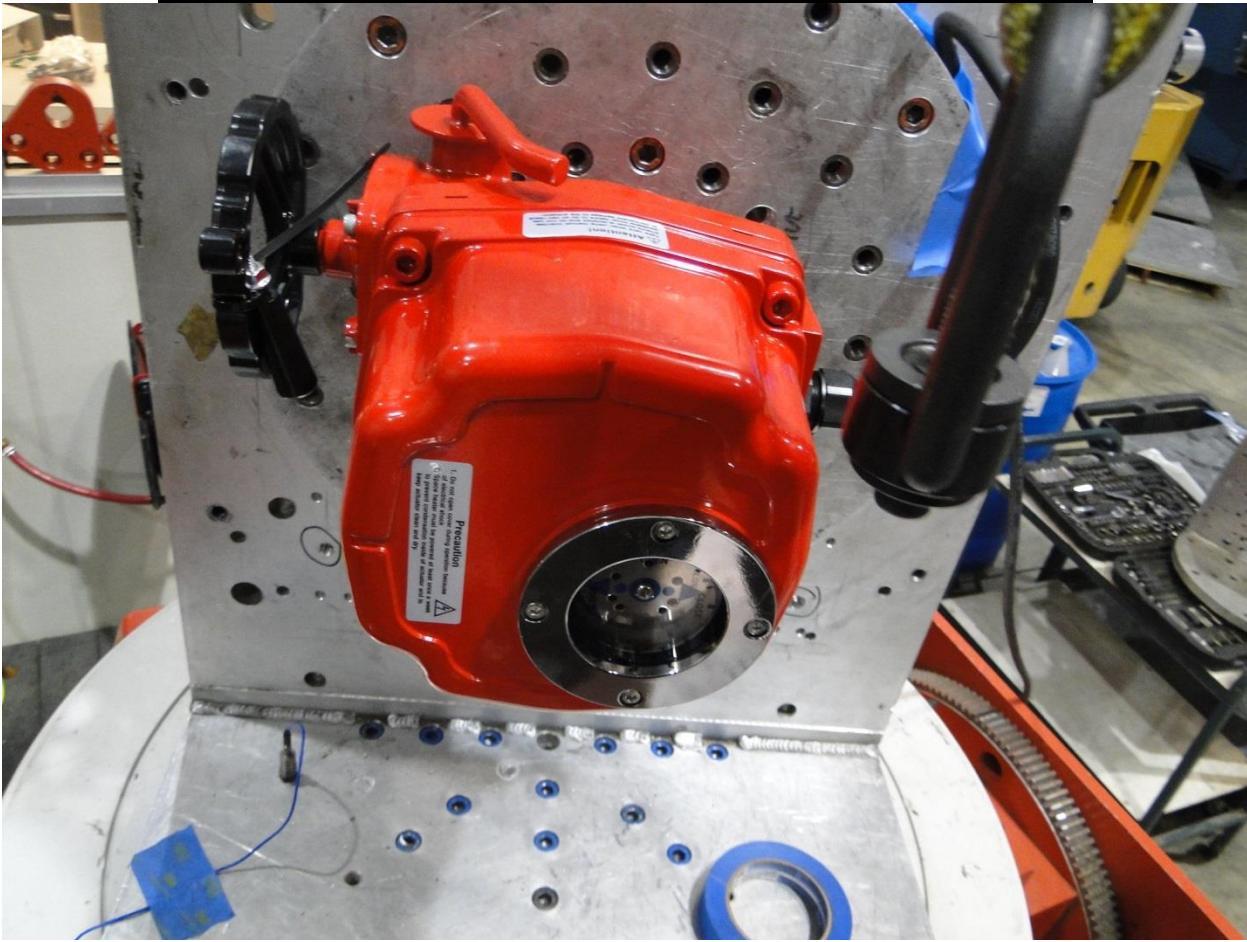
Photo 5.2.1-21 Transverse axis shock on WE-1350X-VR

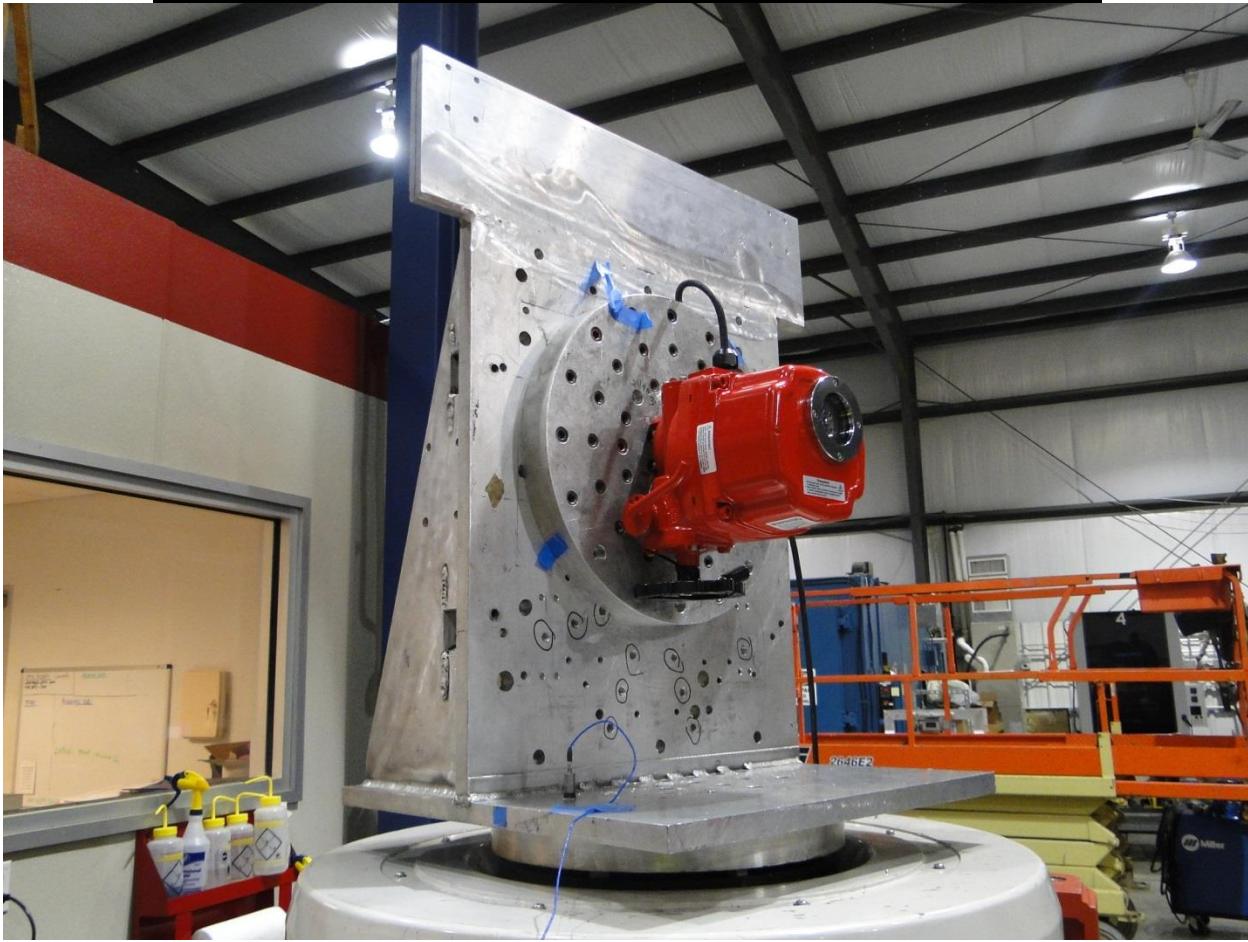
Photo 5.2.1-22 Longitudinal axis shock on WE-1350X-VR

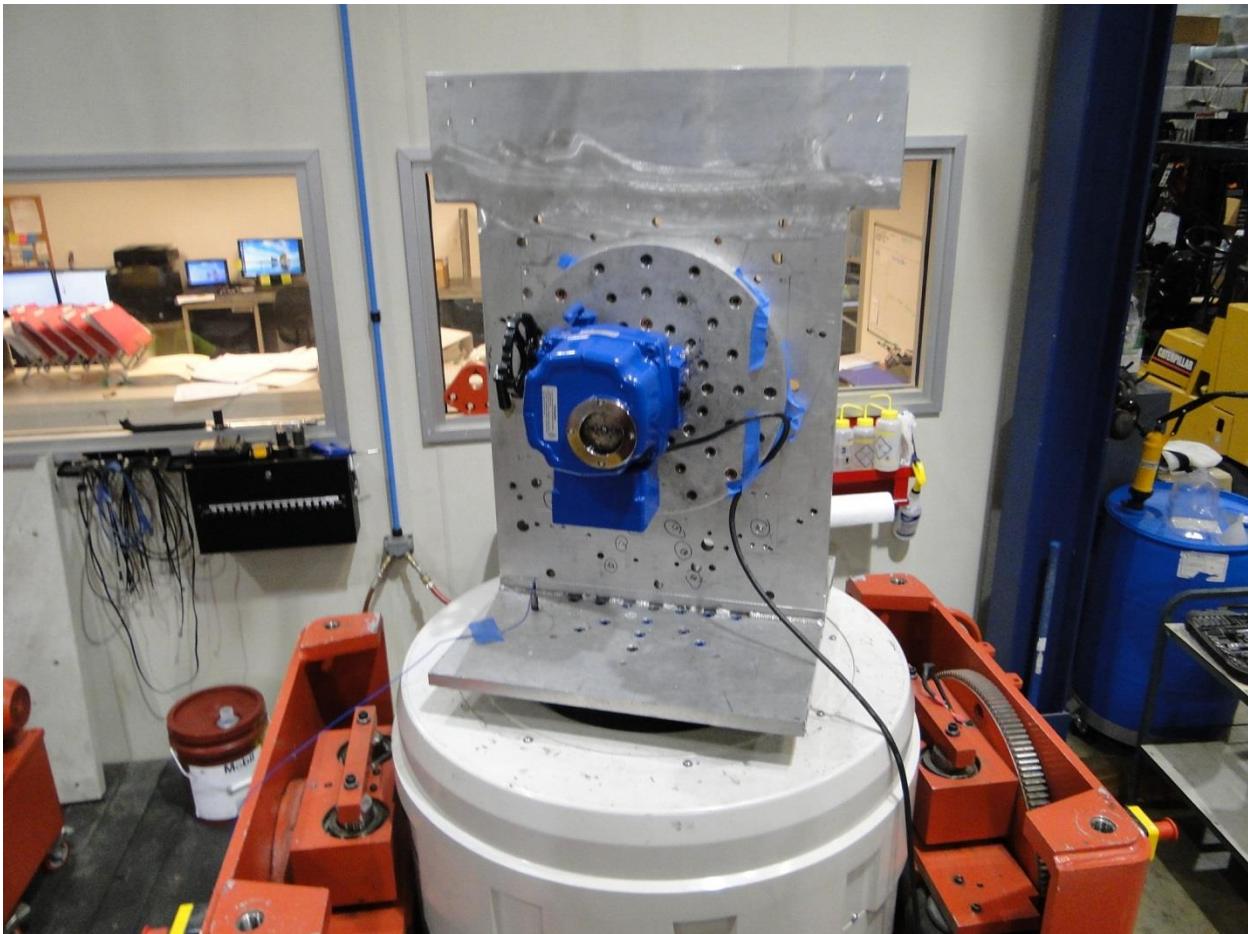
Photo 5.2.1-23 Transverse axis shock on WEM-1350E-VR

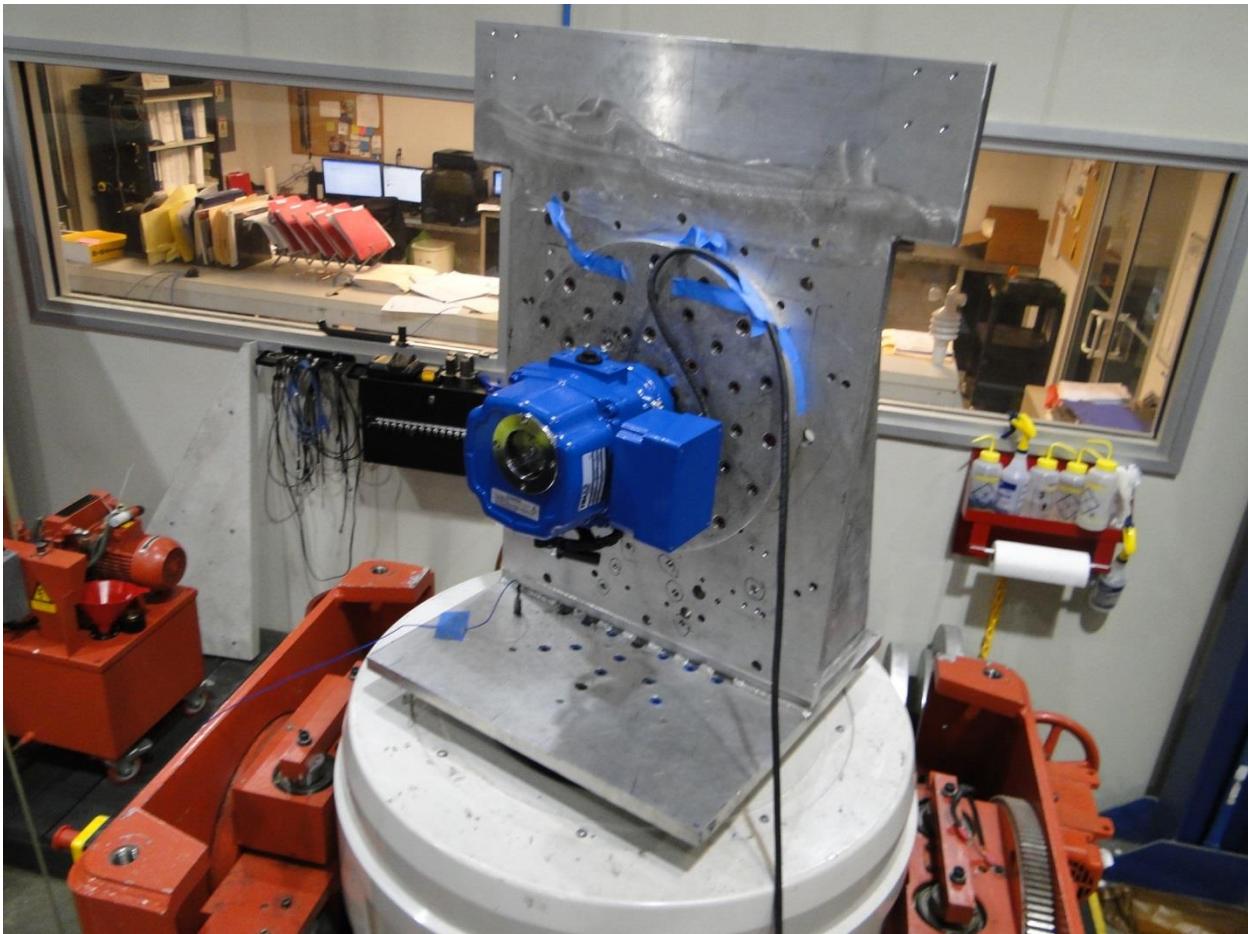
Photo 5.2.1-24 Longitudinal axis shock on WEM-1350E-VR

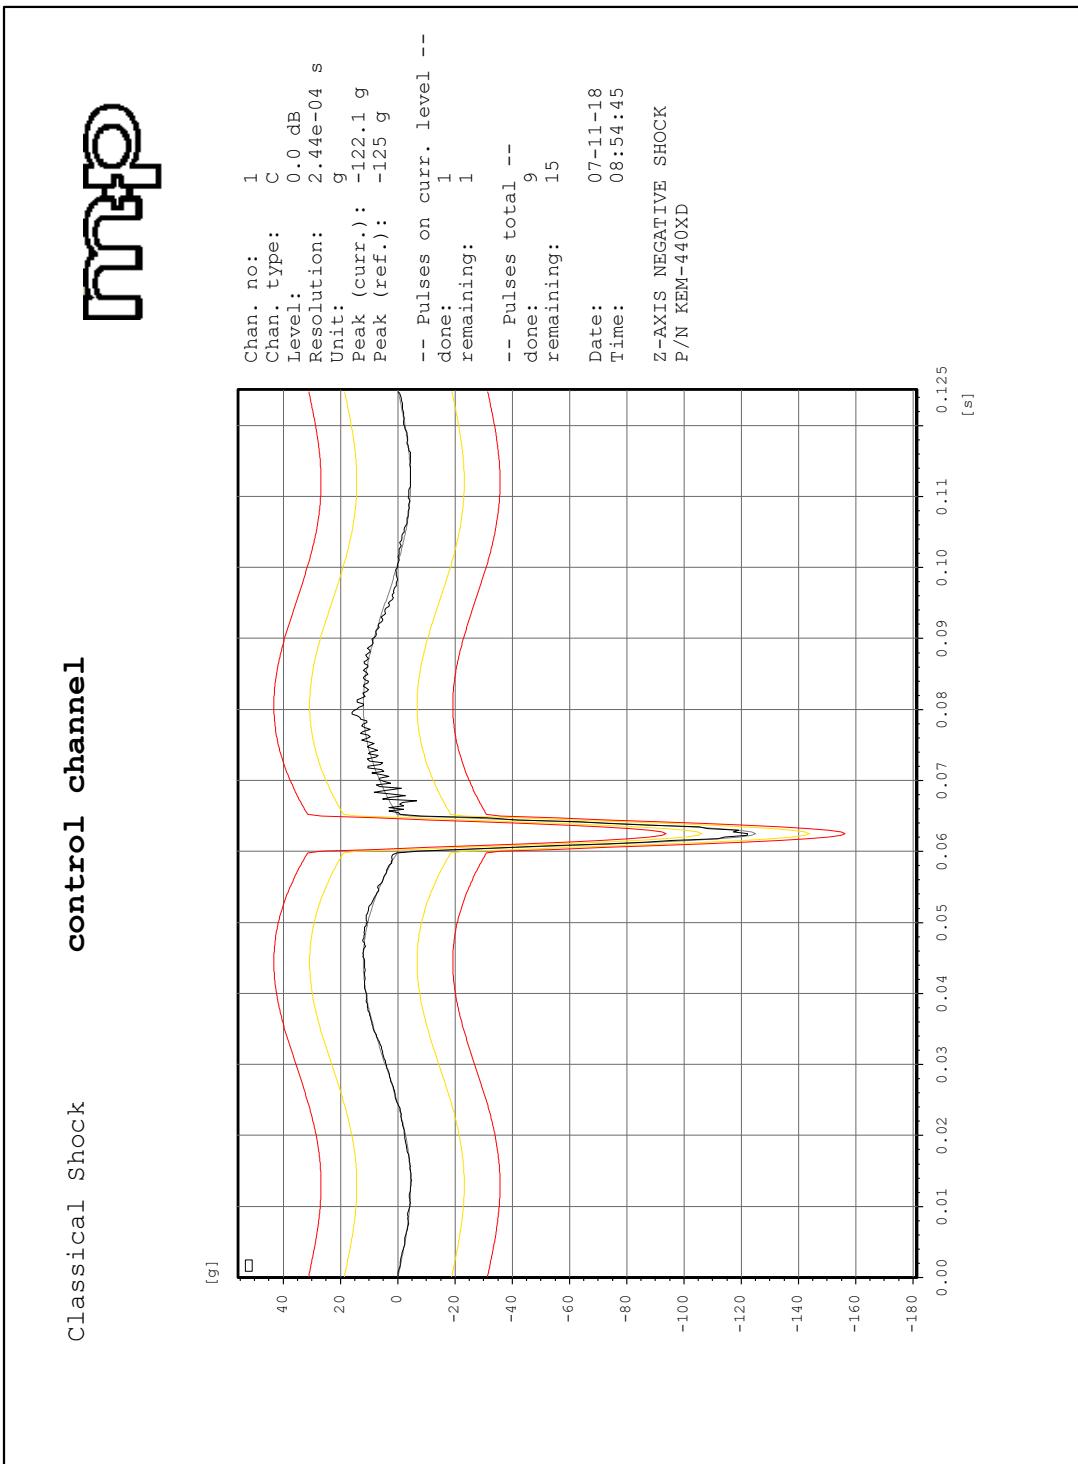
Chart 5.2.1-26: Vertical axis Shock Profile, P/N KEM-440XD, Negative 1

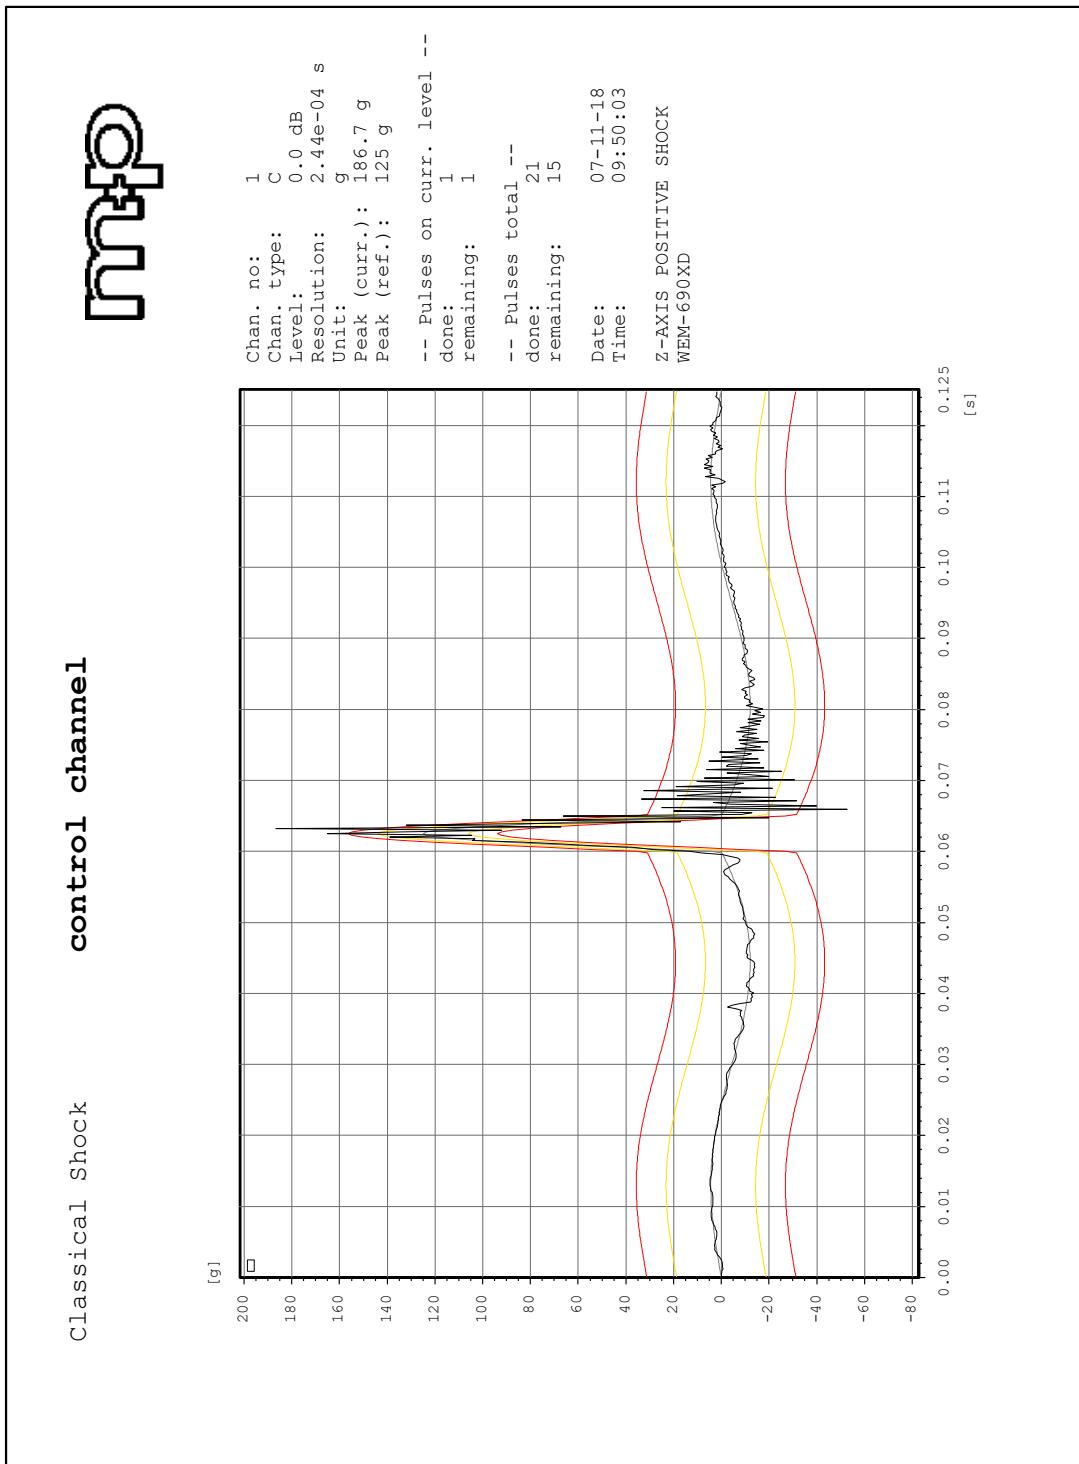
Chart 5.2.1-27: Vertical axis Shock Profile, P/N WEM-690XD, Positive 1

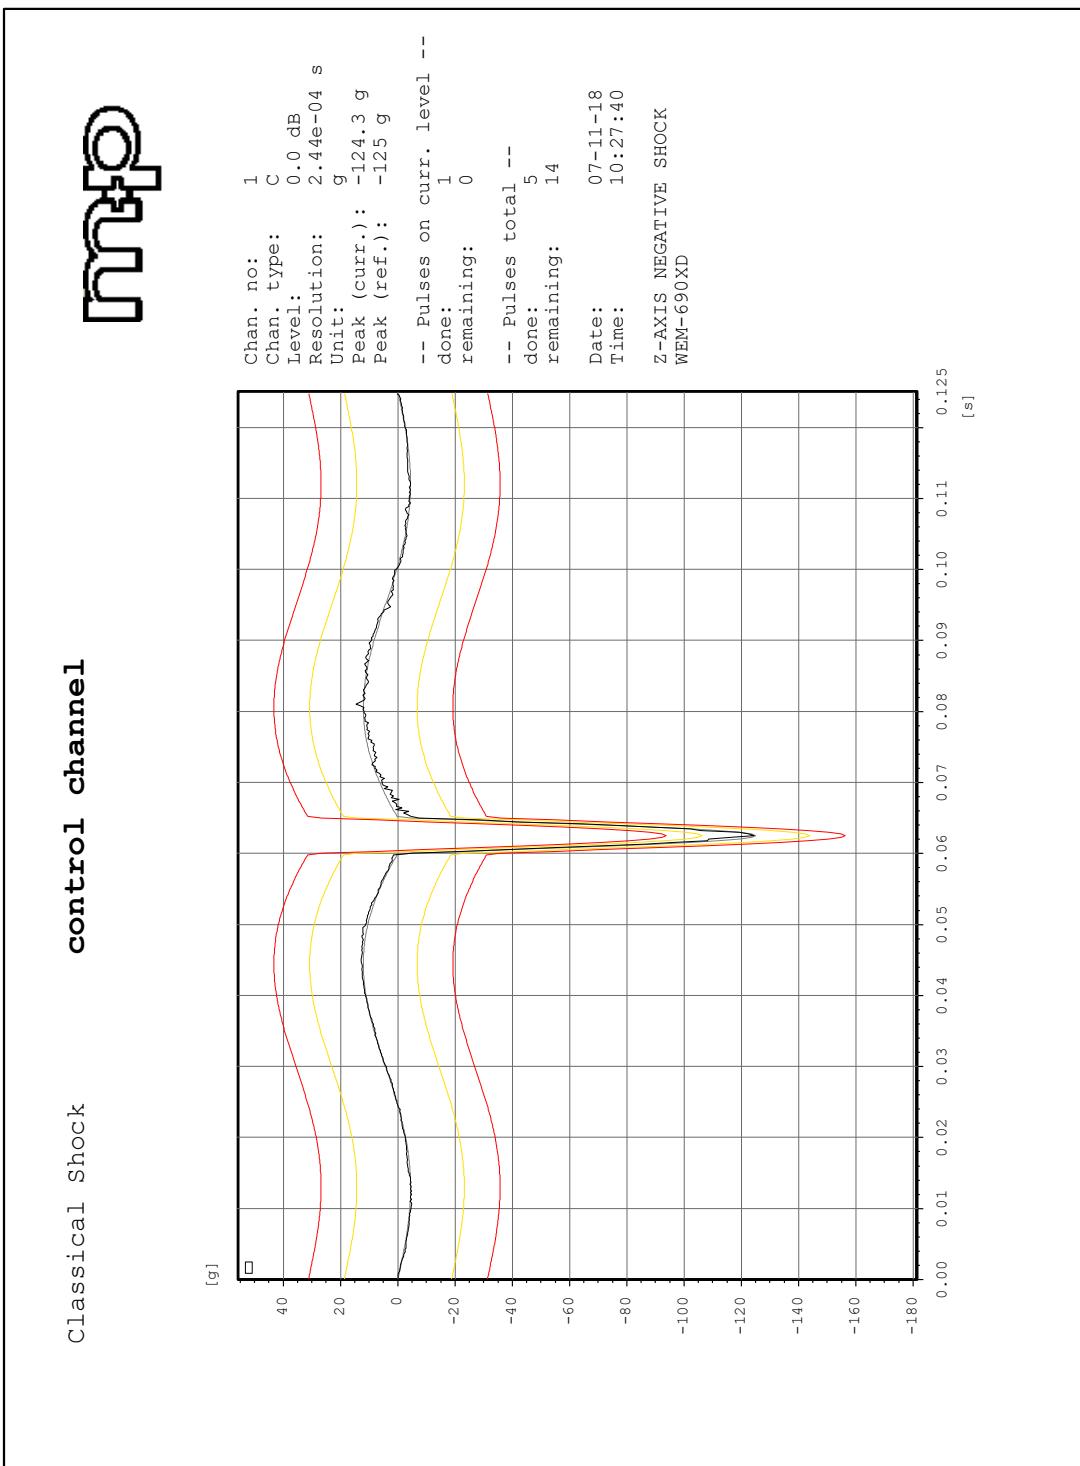
Chart 5.2.1-28: Vertical axis Shock Profile, P/N WEM-690XD, Negative 1

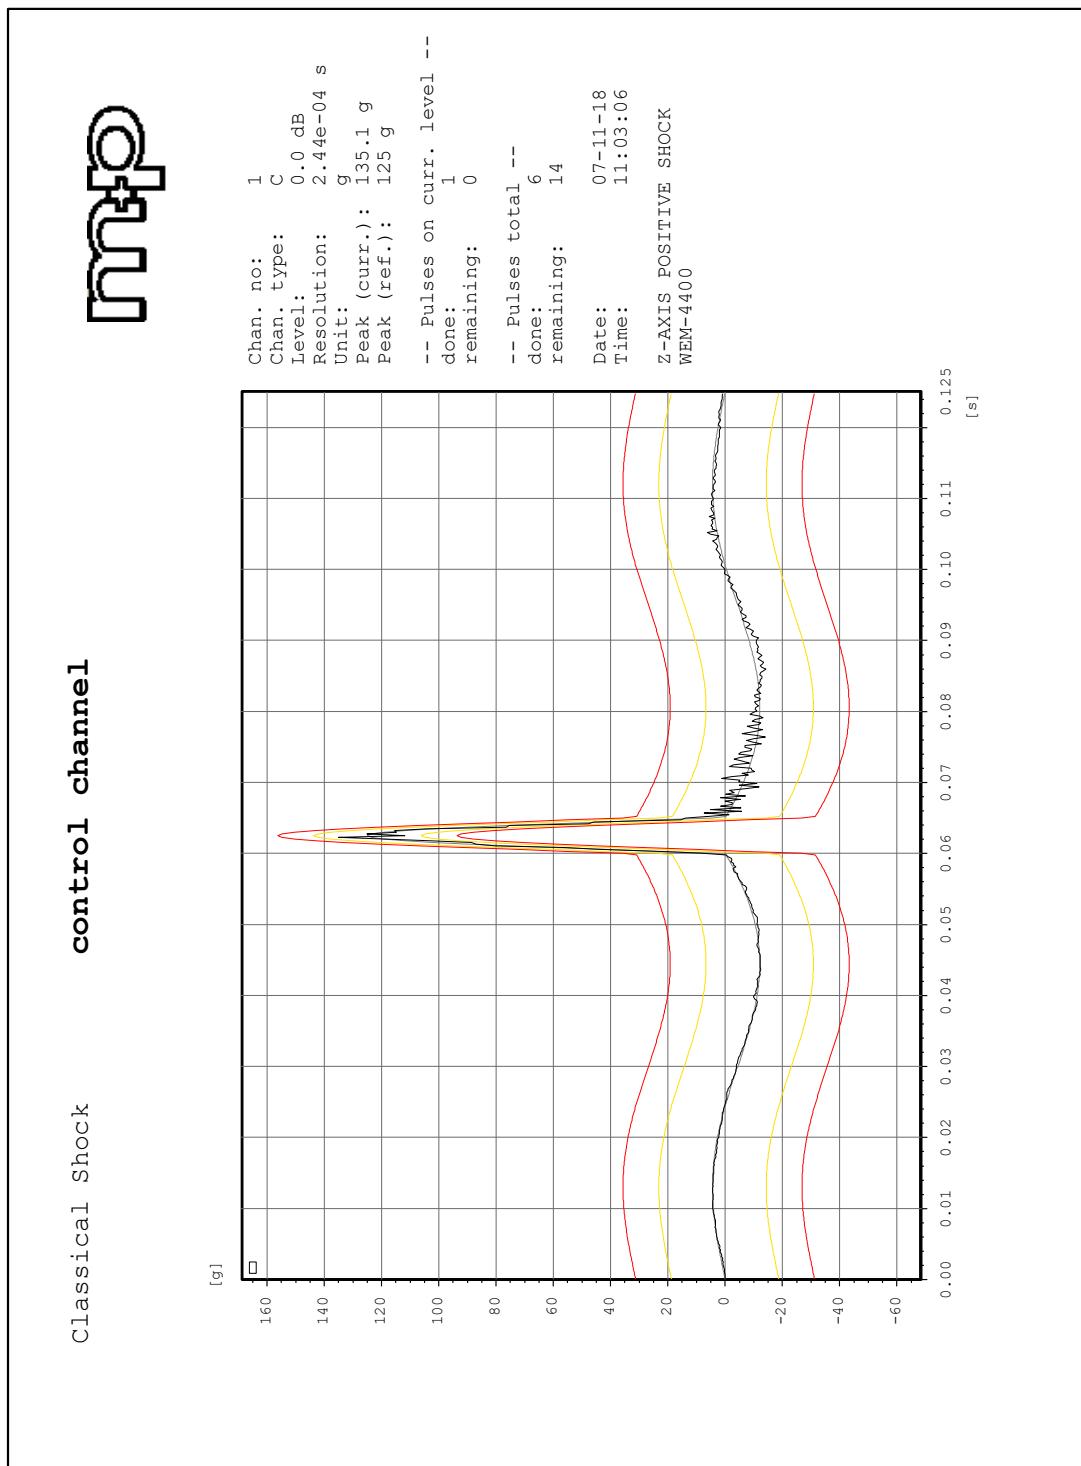
Chart 5.2.1-29: Vertical axis Shock Profile, P/N WEM-4400, Positive 1

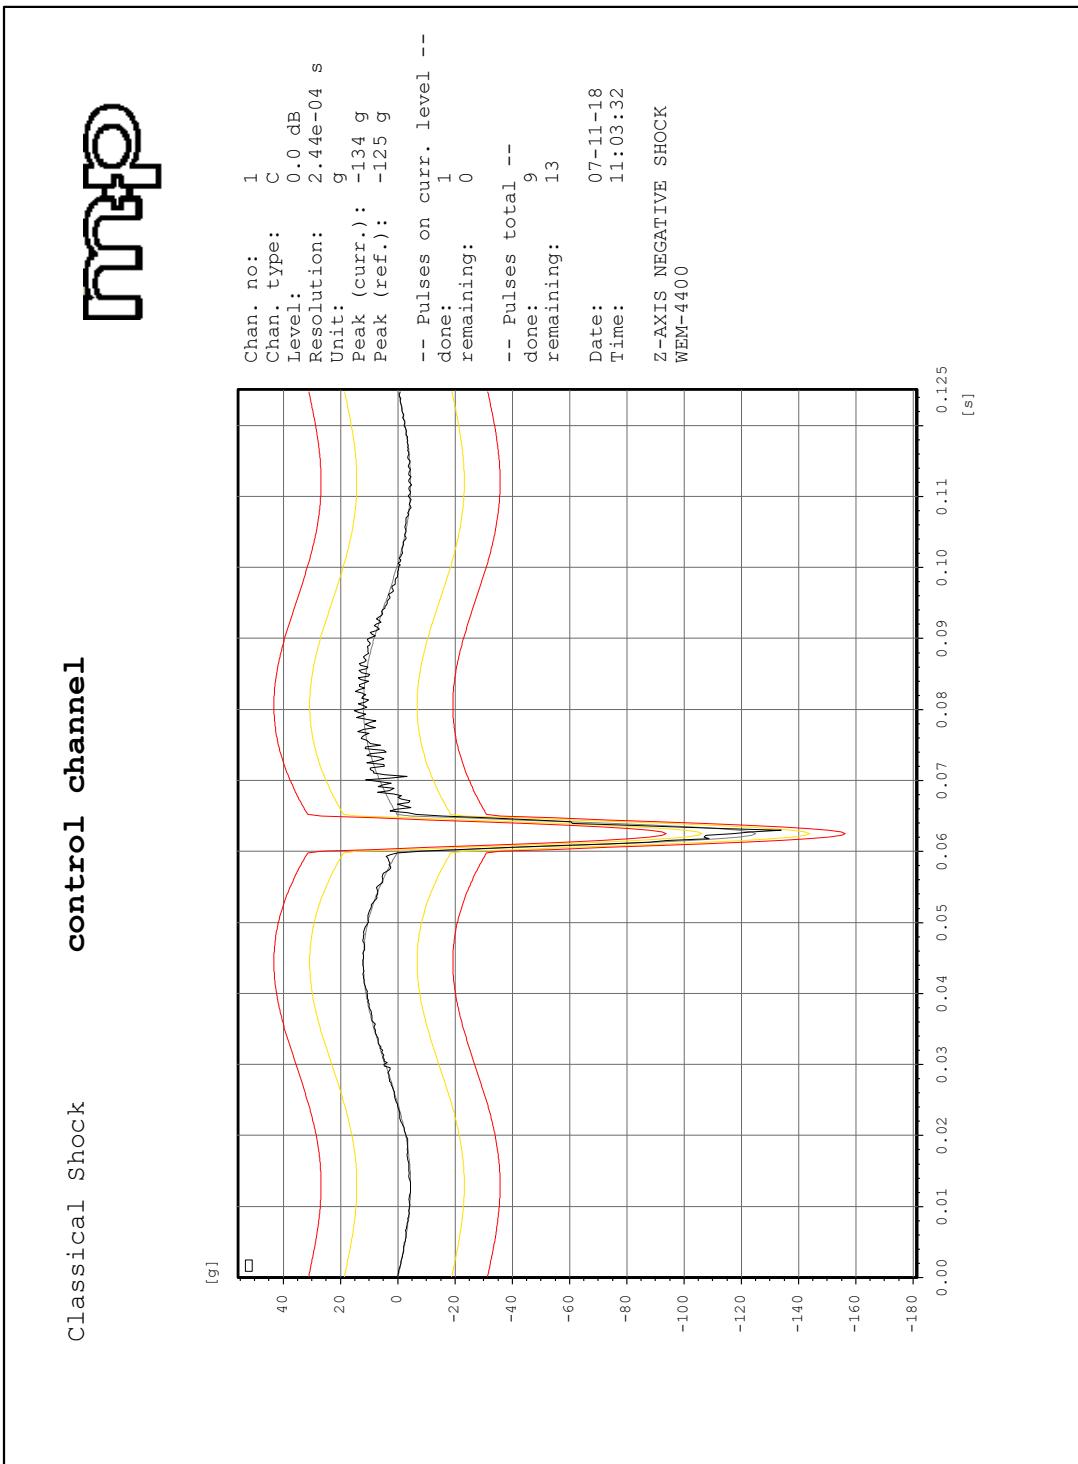
Chart 5.2.1-30: Vertical axis Shock Profile, P/N WEM-4400, Negative 1

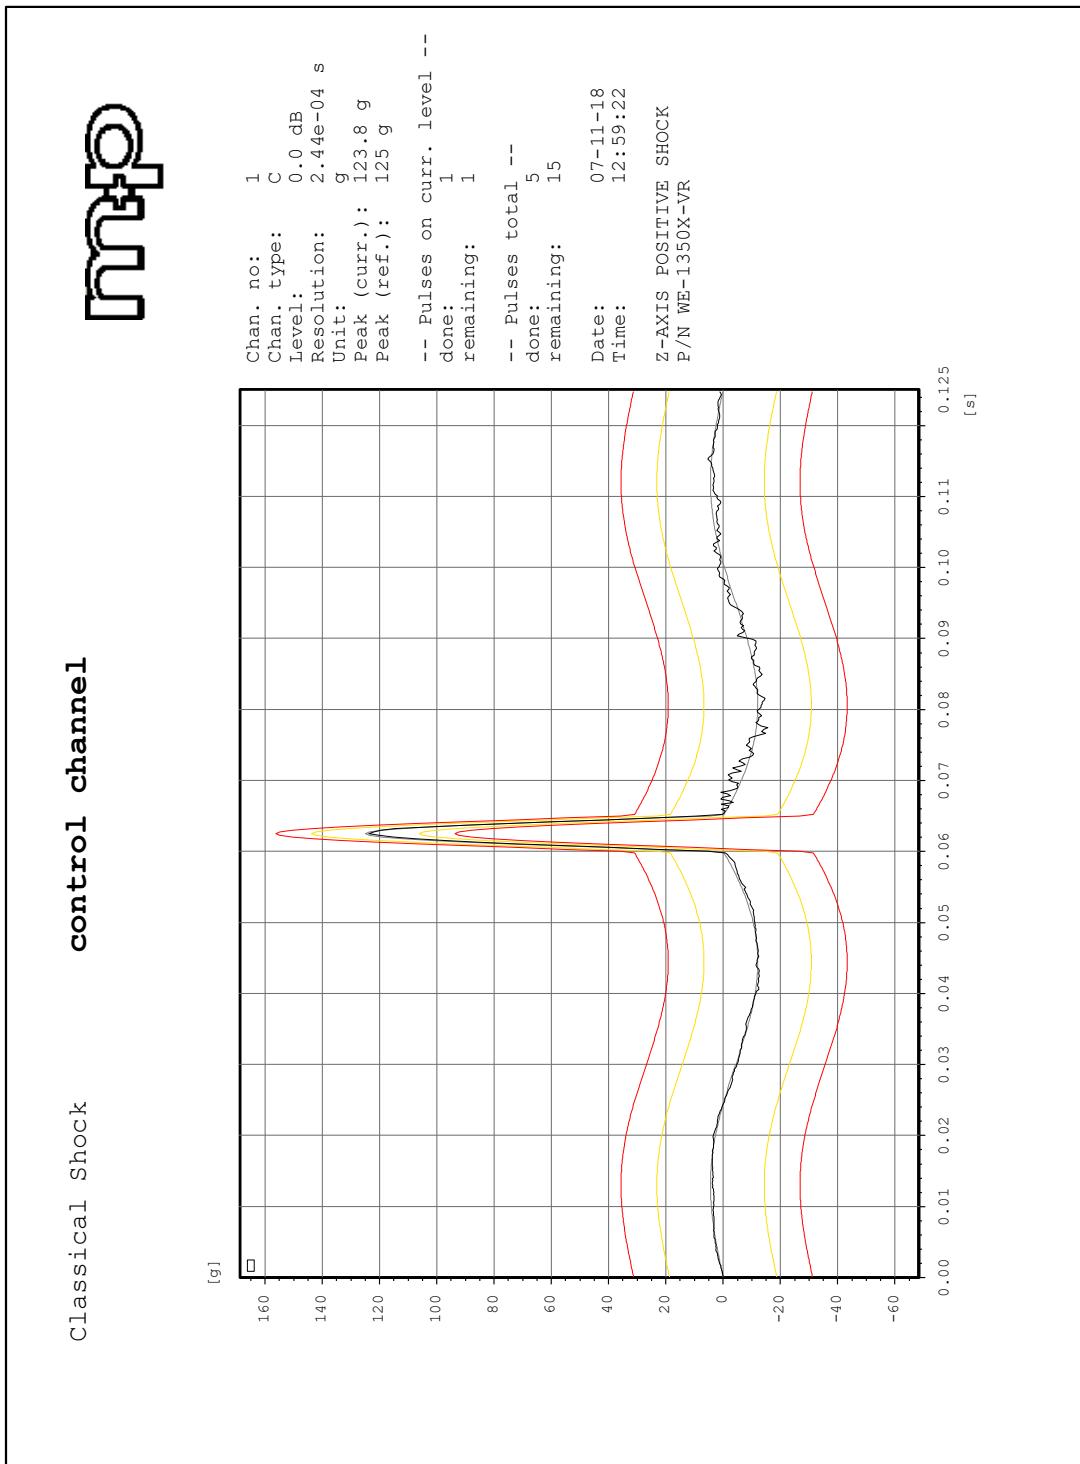
Chart 5.2.1-31: Vertical axis Shock Profile, P/N WE-1350X-VR, Positive 1

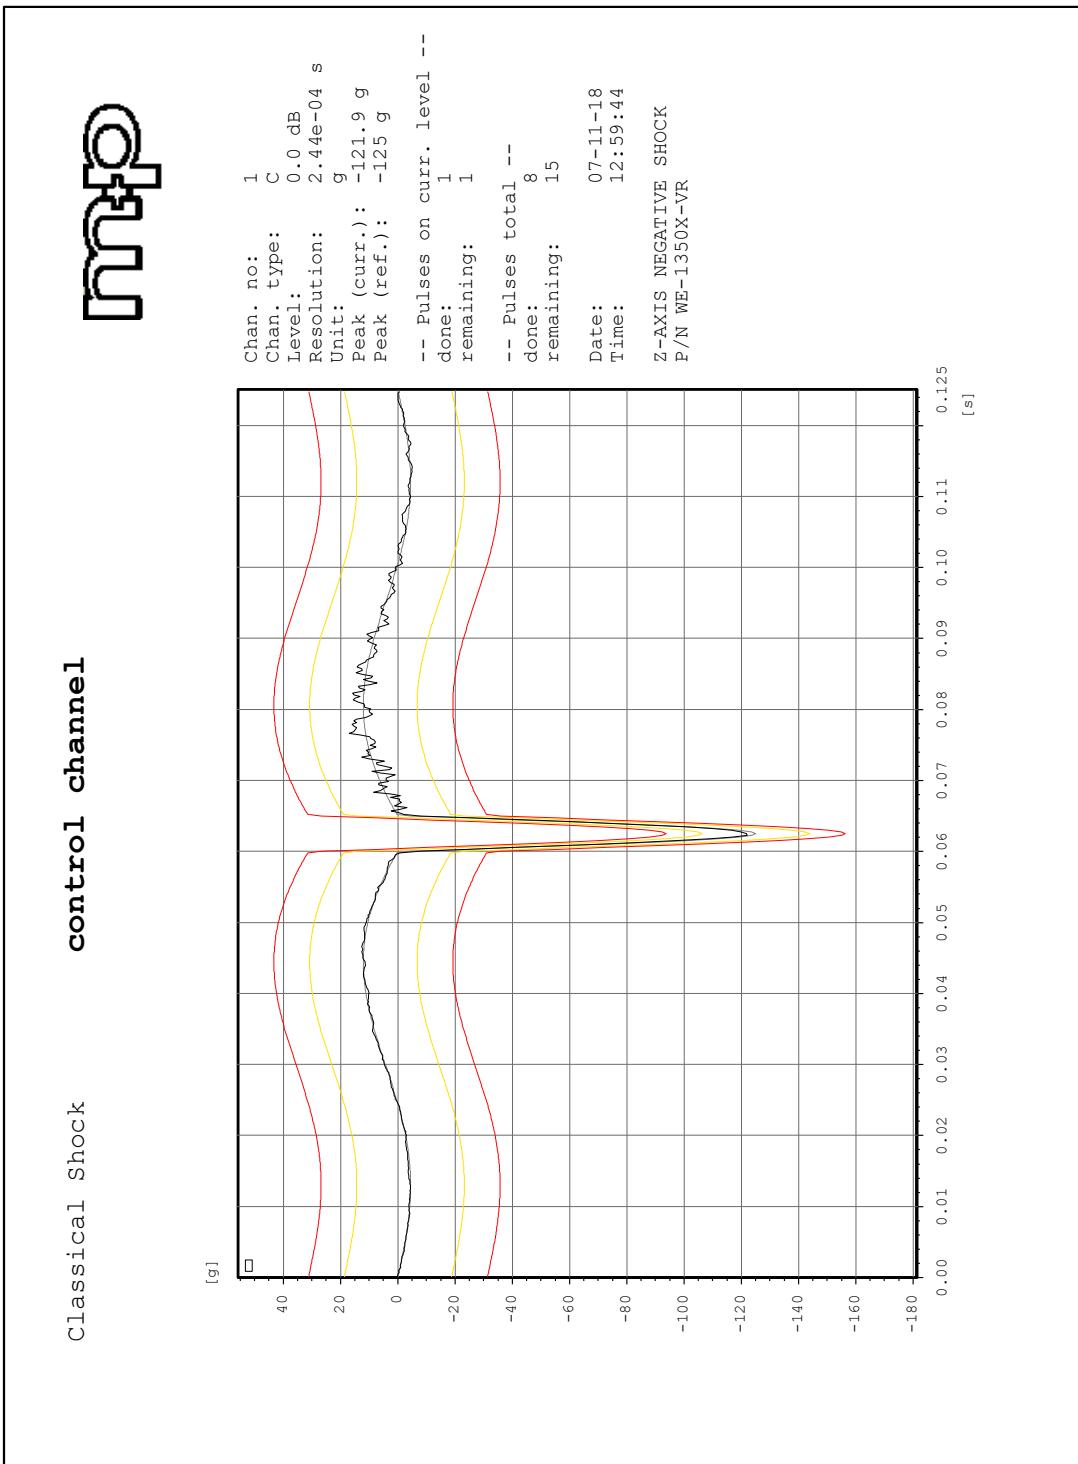
Chart 5.2.1-32: Vertical axis Shock Profile, P/N WE-1350X-VR, Negative 1

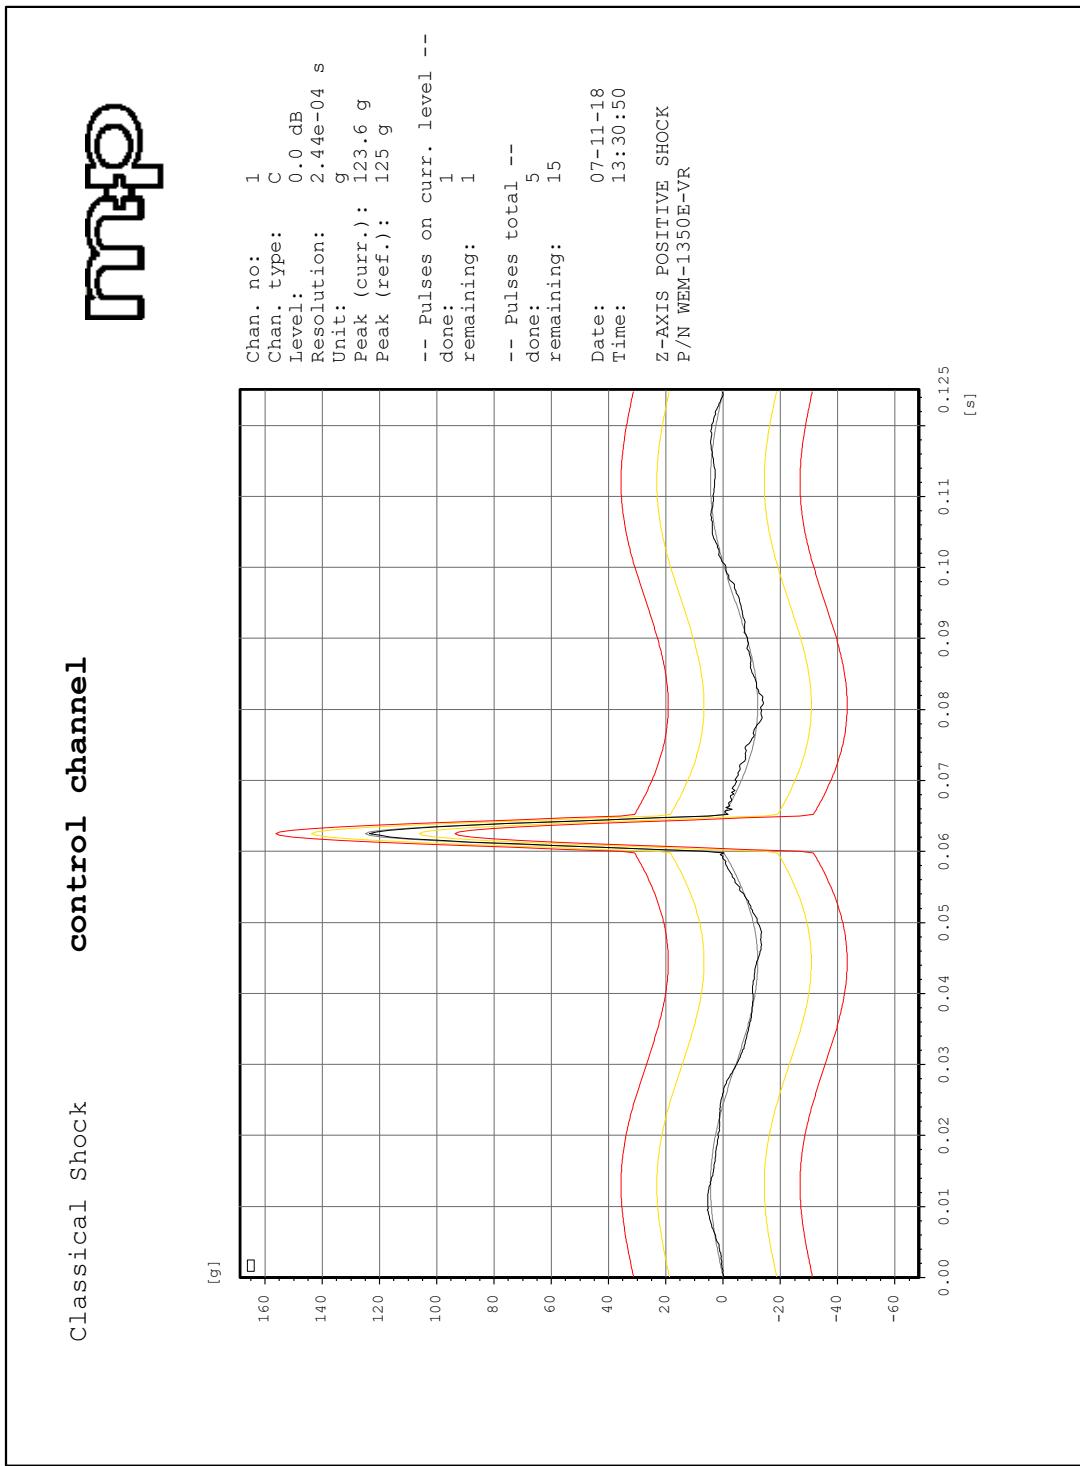
Chart 5.2.1-33: Vertical axis Shock Profile, P/N WEM-1350E-VR, Positive 1

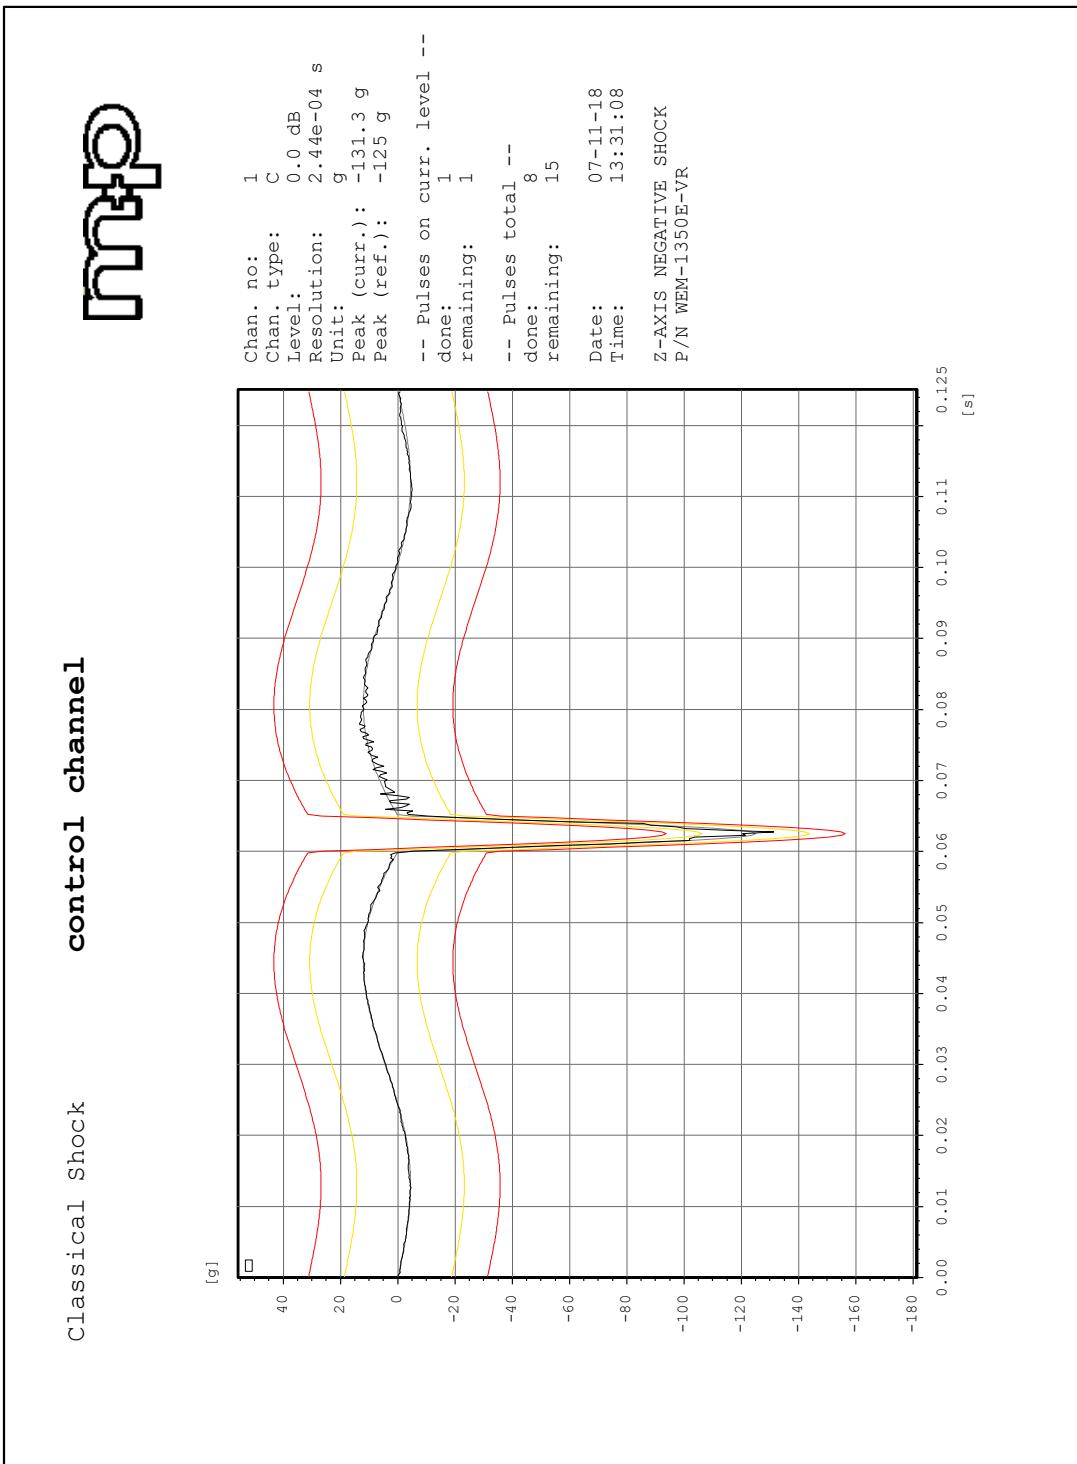
Chart 5.2.1-34: Vertical axis Shock Profile, P/N WEM-1350E-VR,Negative1

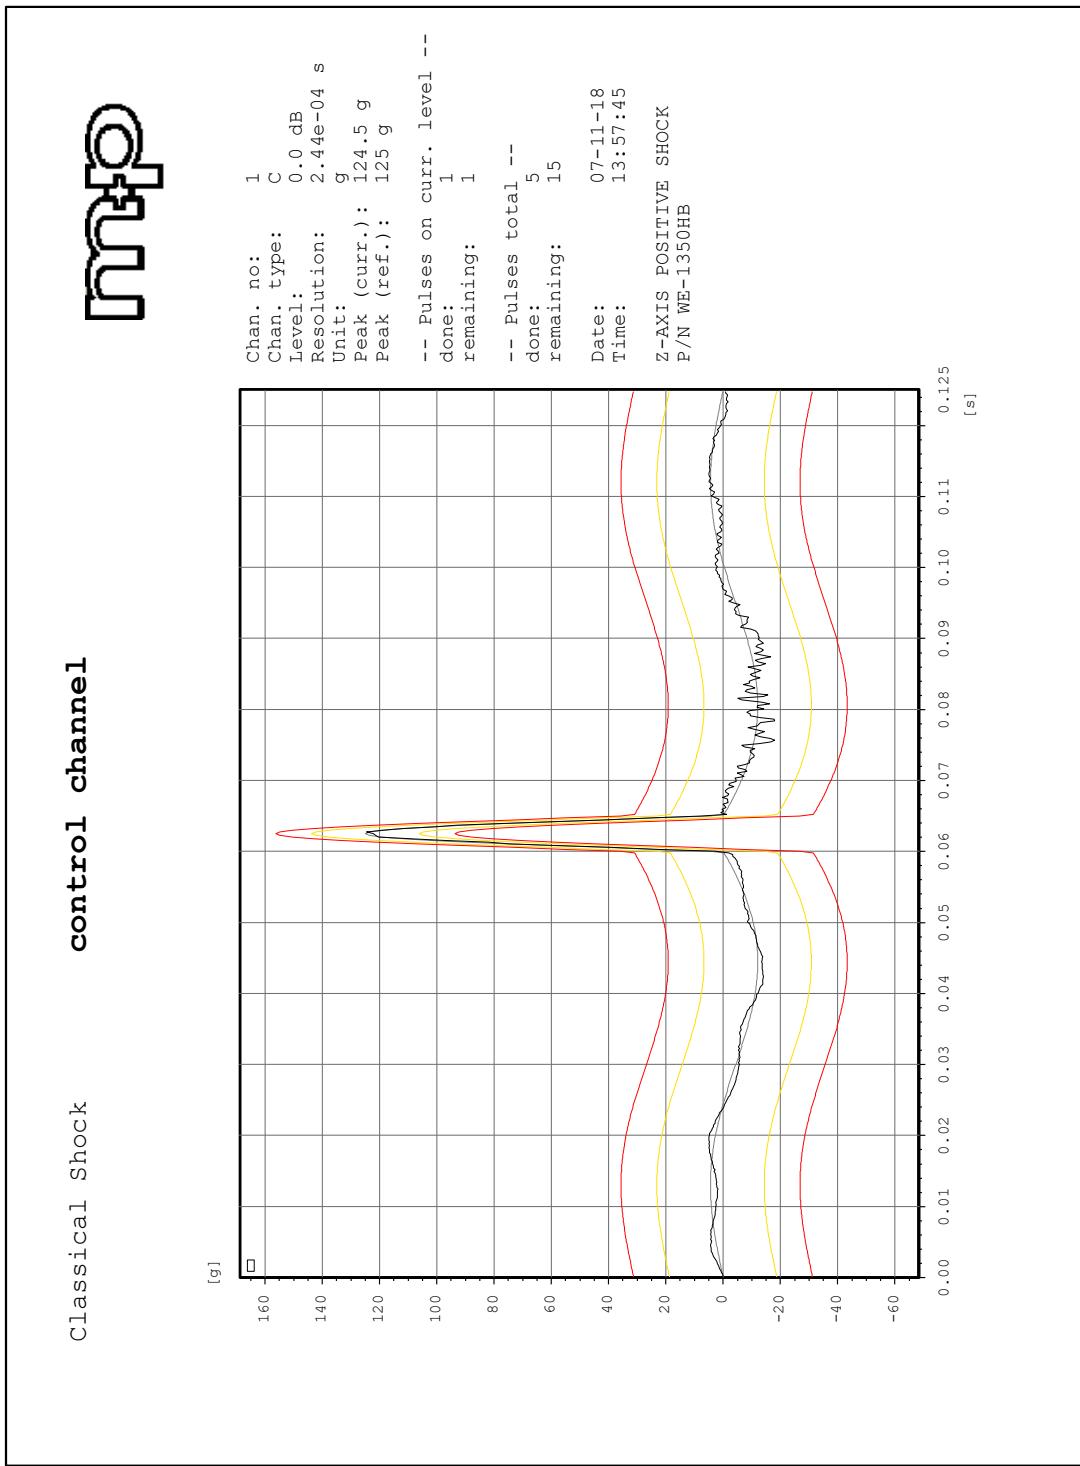
Chart 5.2.1-35: Vertical axis Shock Profile, P/N WE-1350HB, Positive 1

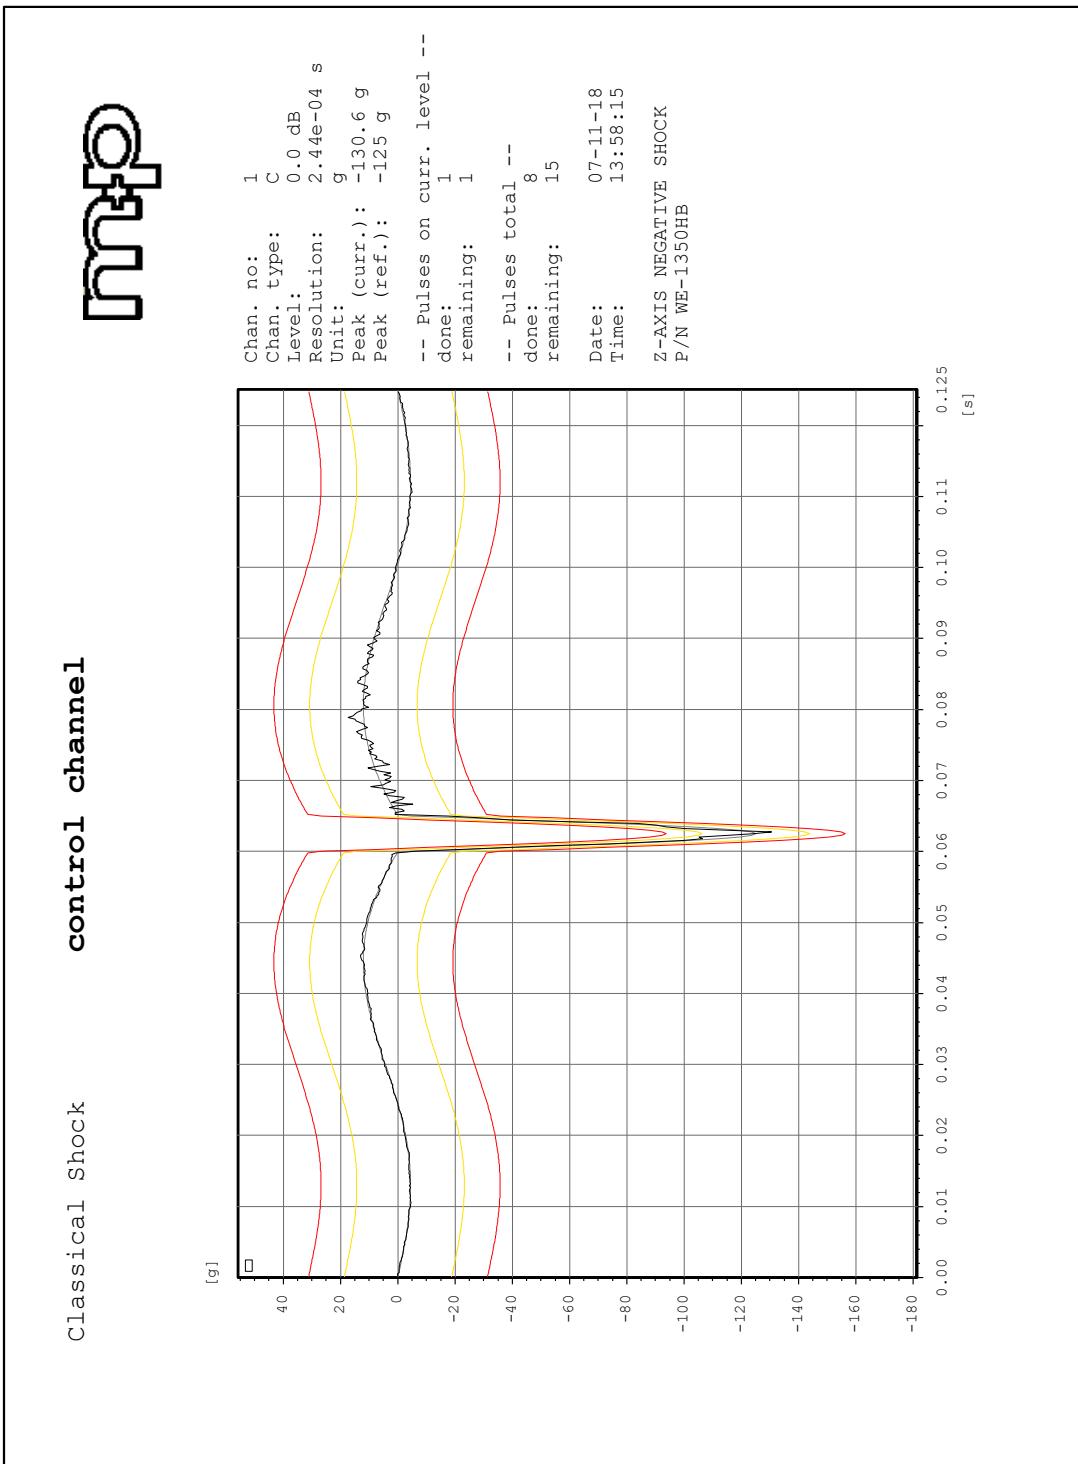
Chart 5.2.1-36: Vertical axis Shock Profile, P/N WE-1350HB, Negative 1
