ENVIRONMENTAL TEST REPORT No. 6737-A Rev 1

Shock Testing

Valve Actuators KEM, WEM, WE

IEC 60068-2-27

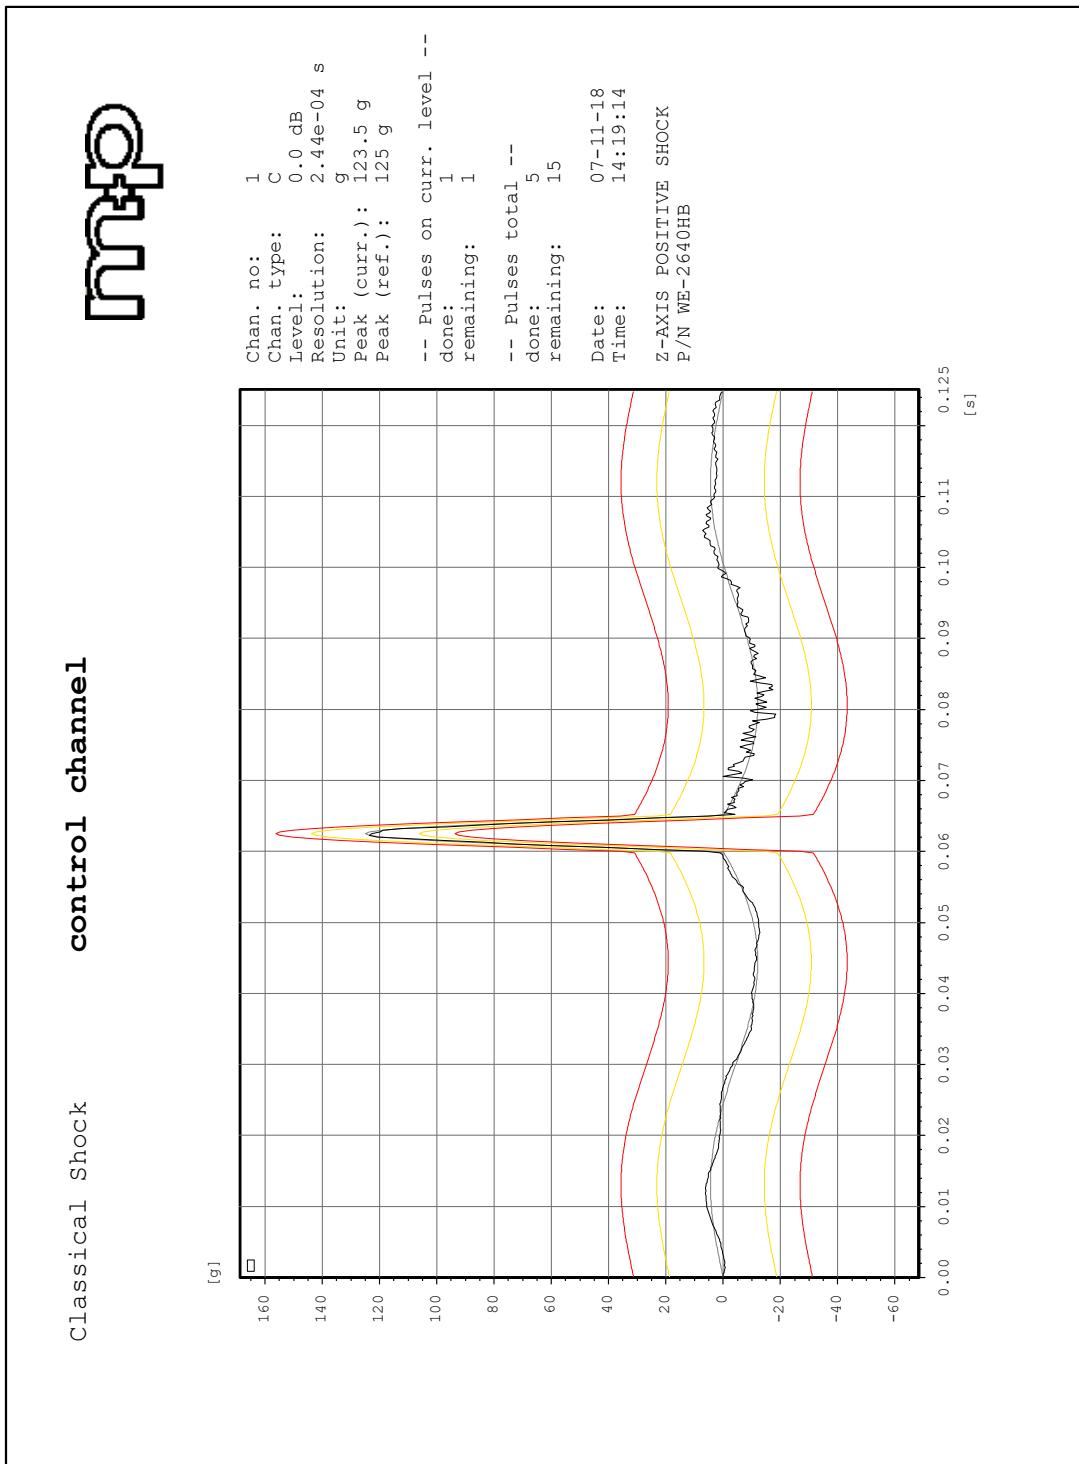
Chart 5.2.1-37: Vertical axis Shock Profile, P/N WE-2640HB, Positive 1

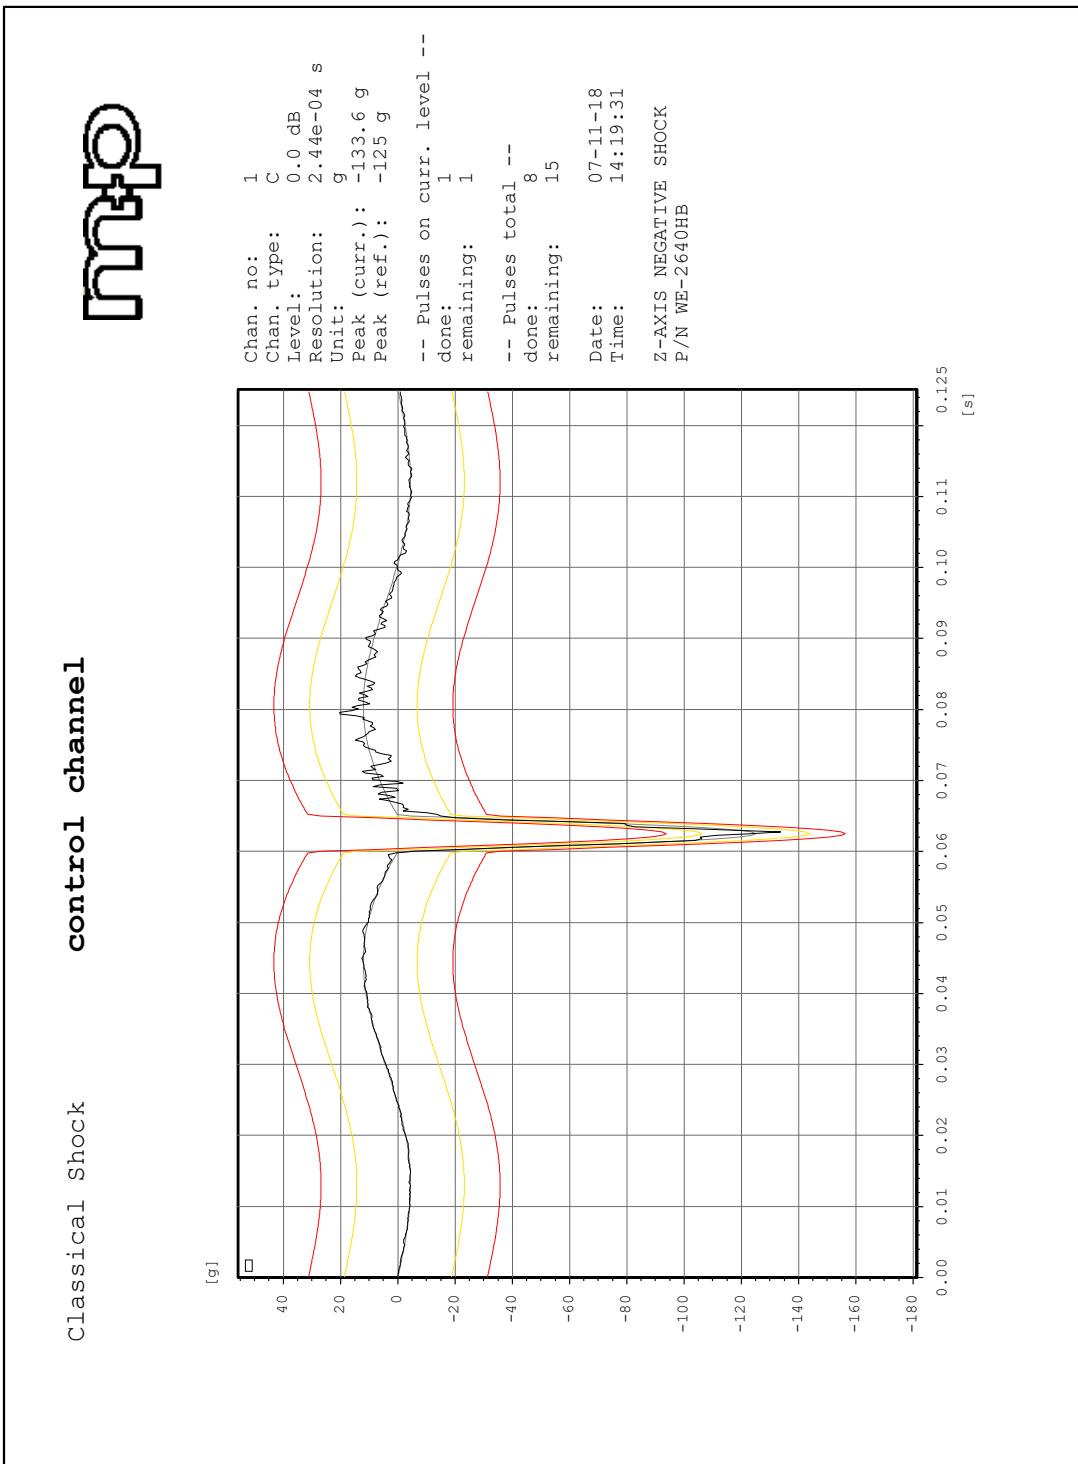
Chart 5.2.1-38: Vertical axis Shock Profile, P/N WE-2640HB, Negative 1

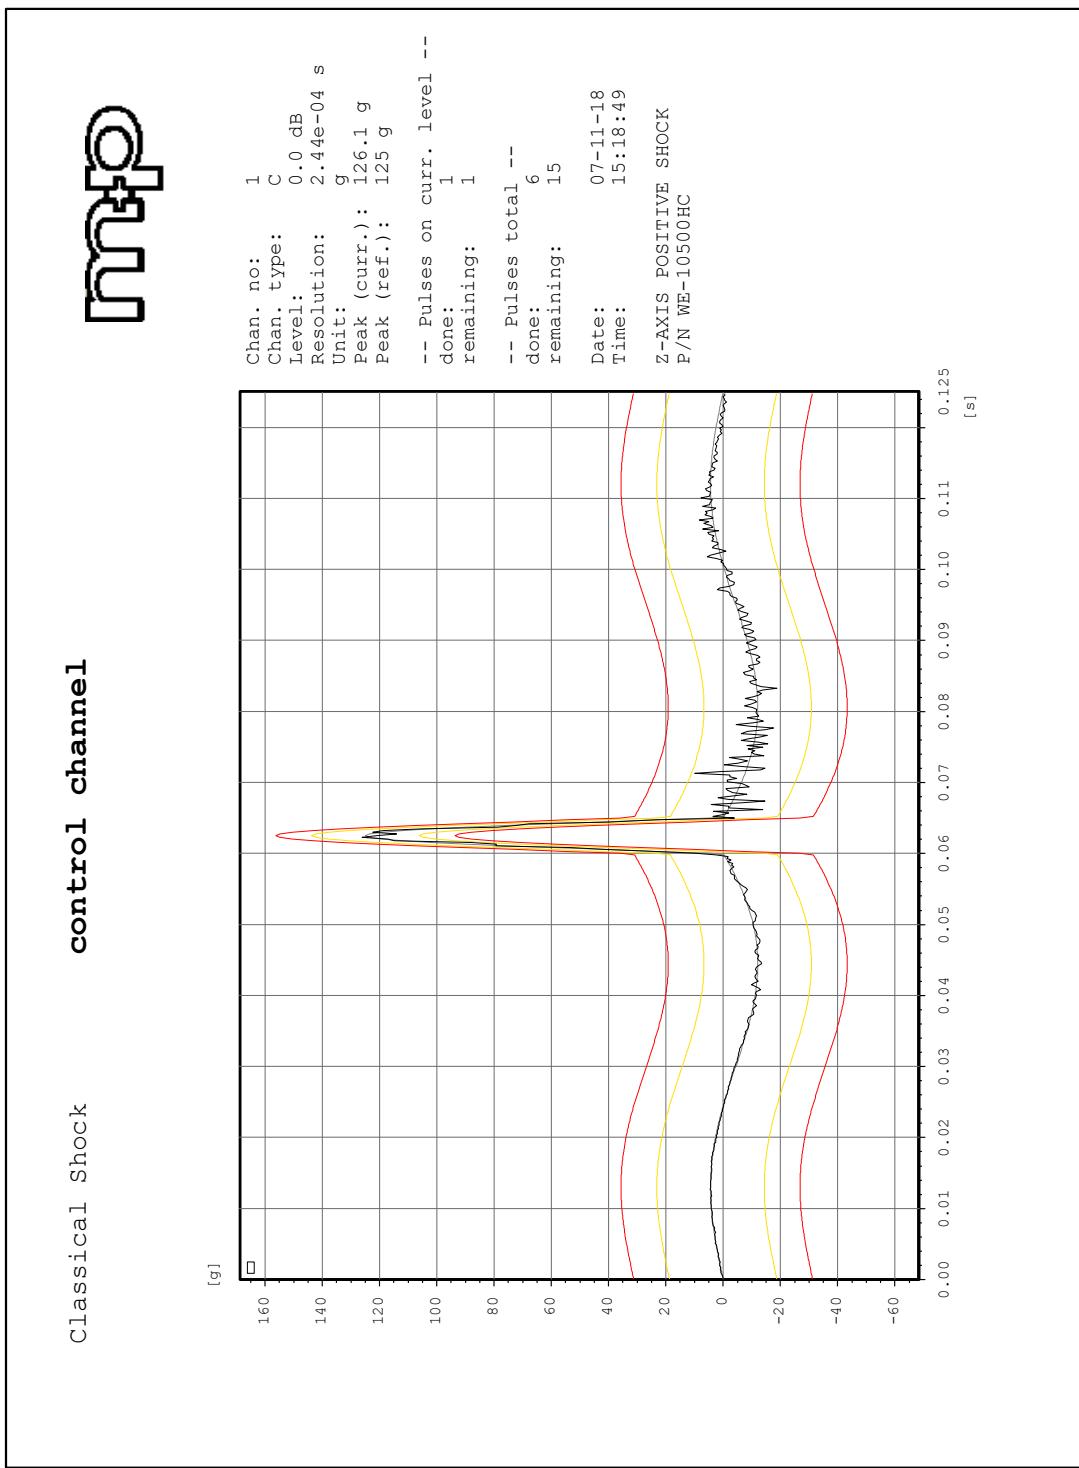
Chart 5.2.1-39: Vertical axis Shock Profile, P/N WE-10500HC, Positive 1

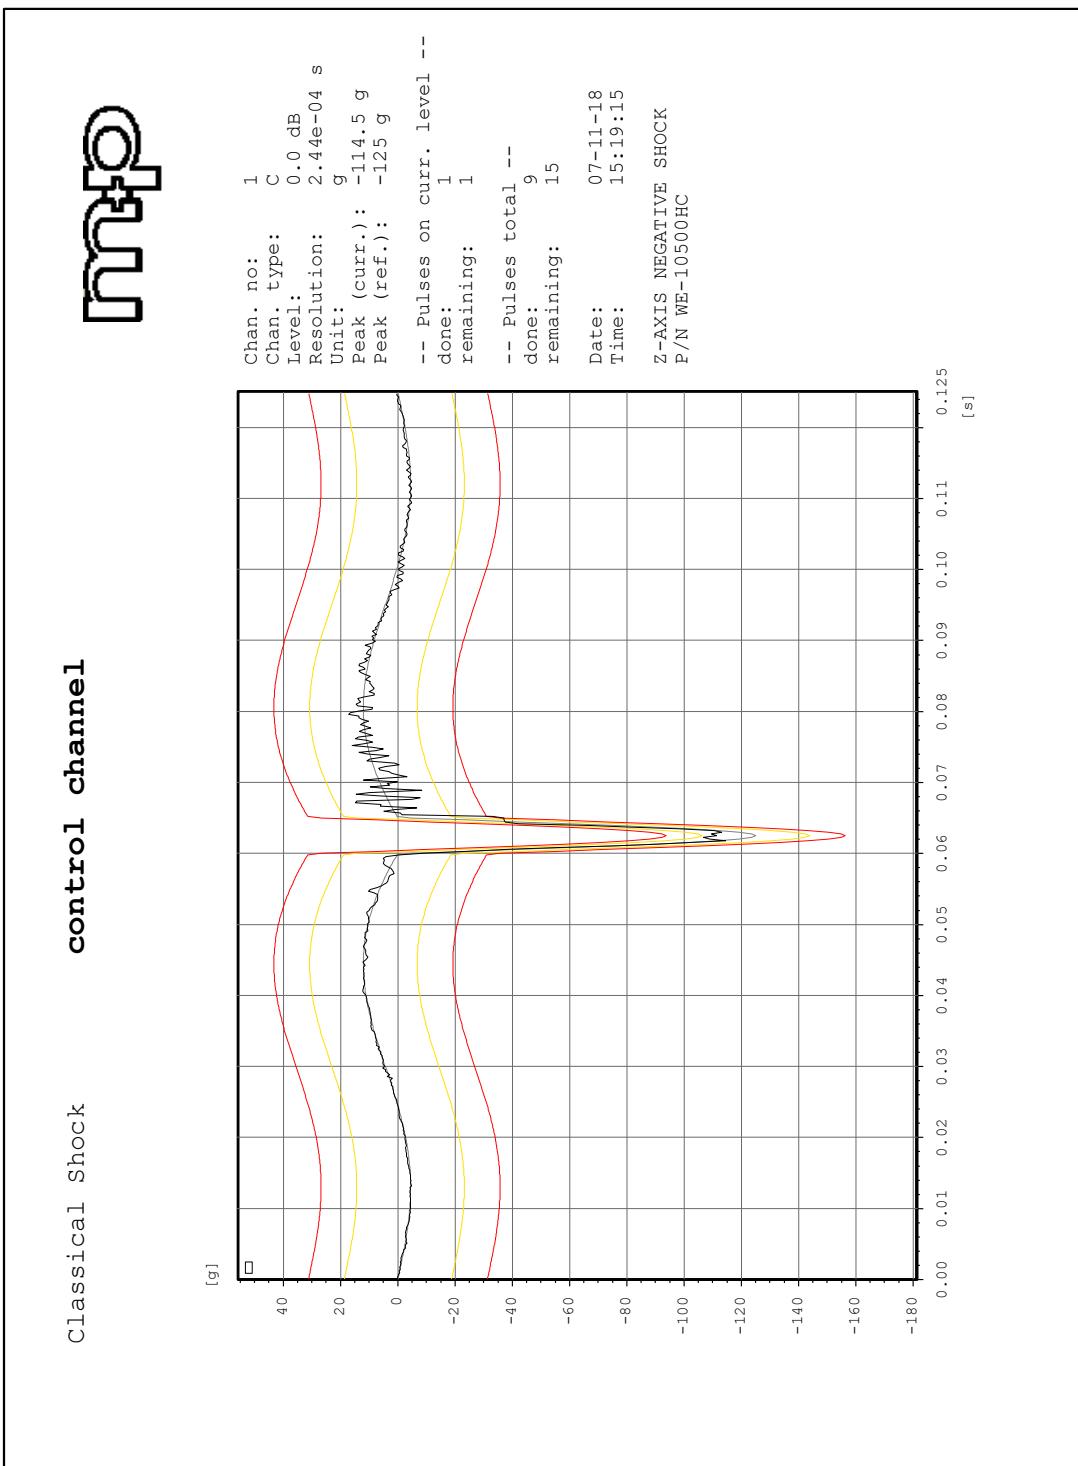
Chart 5.2.1-40: Vertical axis Shock Profile, P/N WE-10500HC, Negative 1

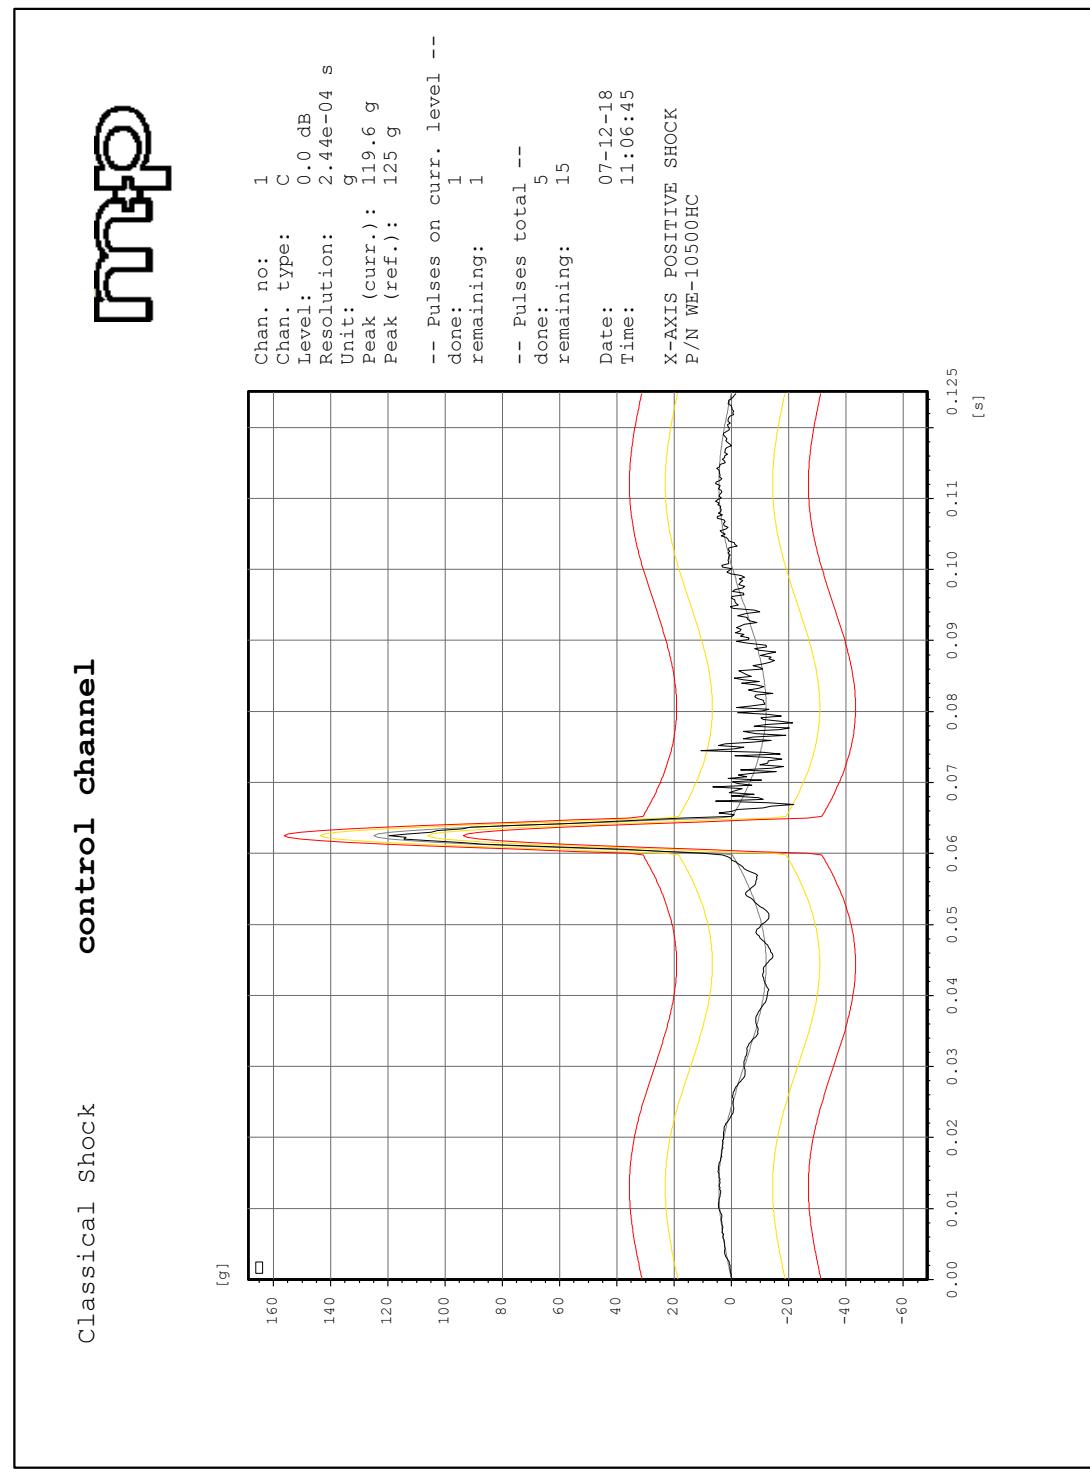
Chart 5.2.1-41:Longitudinal axis Shock Profile, P/N WE-10500HC,Positive

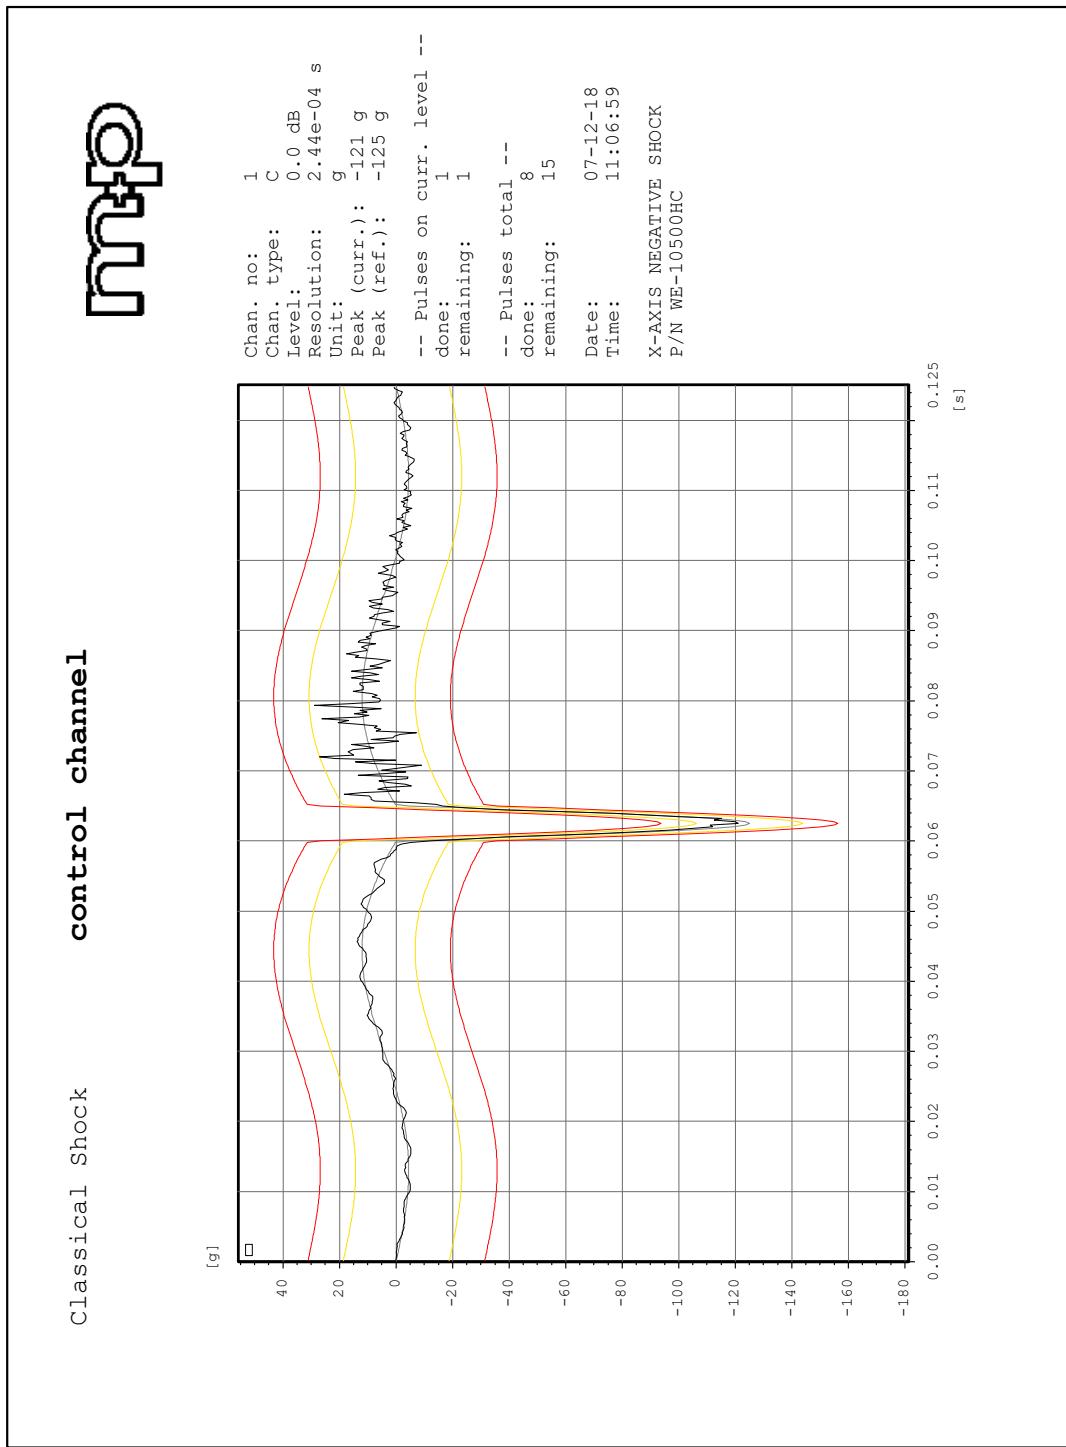
Chart 5.2.1-42:Longitudinal axis Shock Profile, P/N WE-10500HC,Negative1

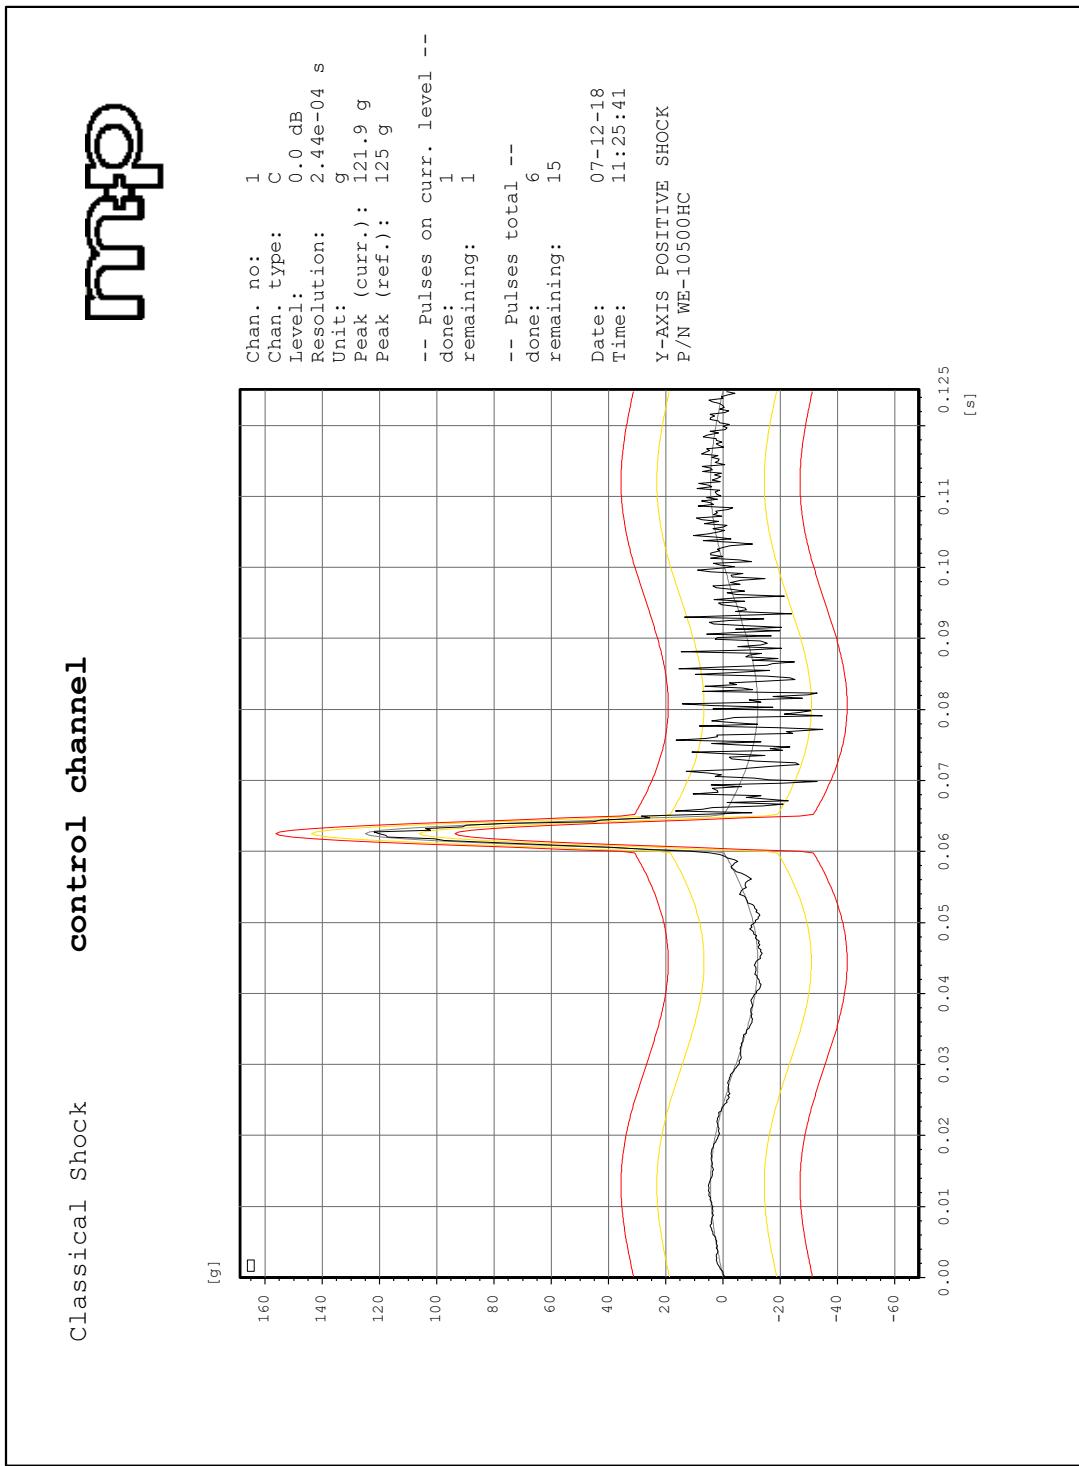
Chart 5.2.1-43:Transverse axis Shock Profile, P/N WE-10500HC,Positive 1

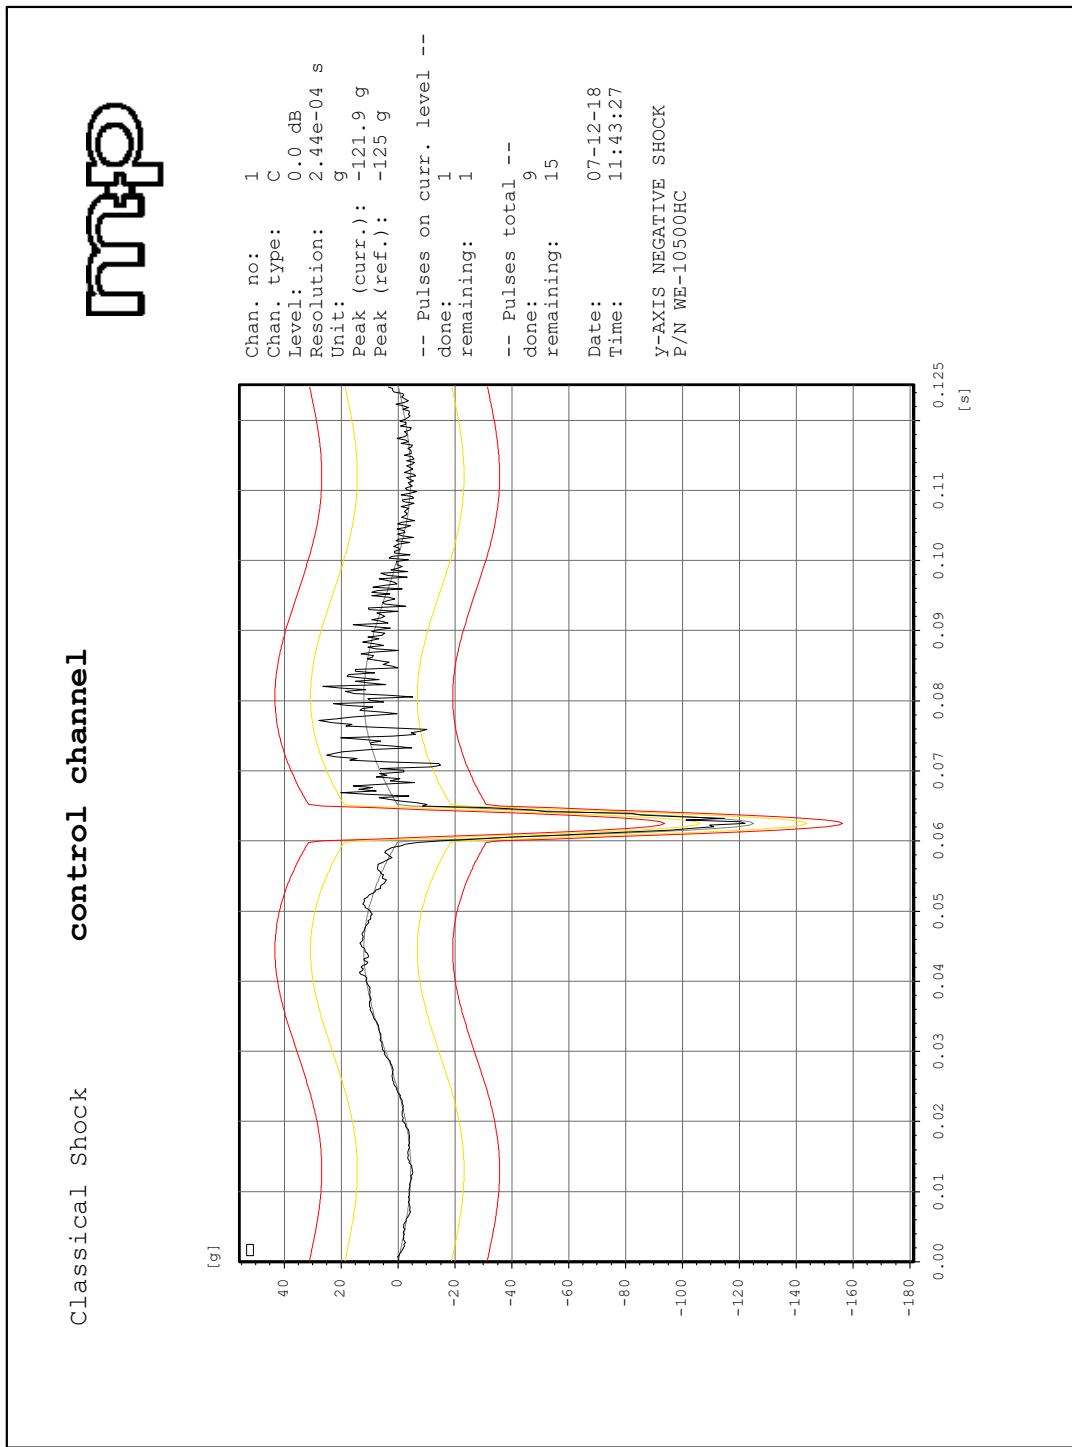
**Chart 5.2.1-44:Transverse axis Shock Profile, P/N WE-
10500h=HC,Negative 1**

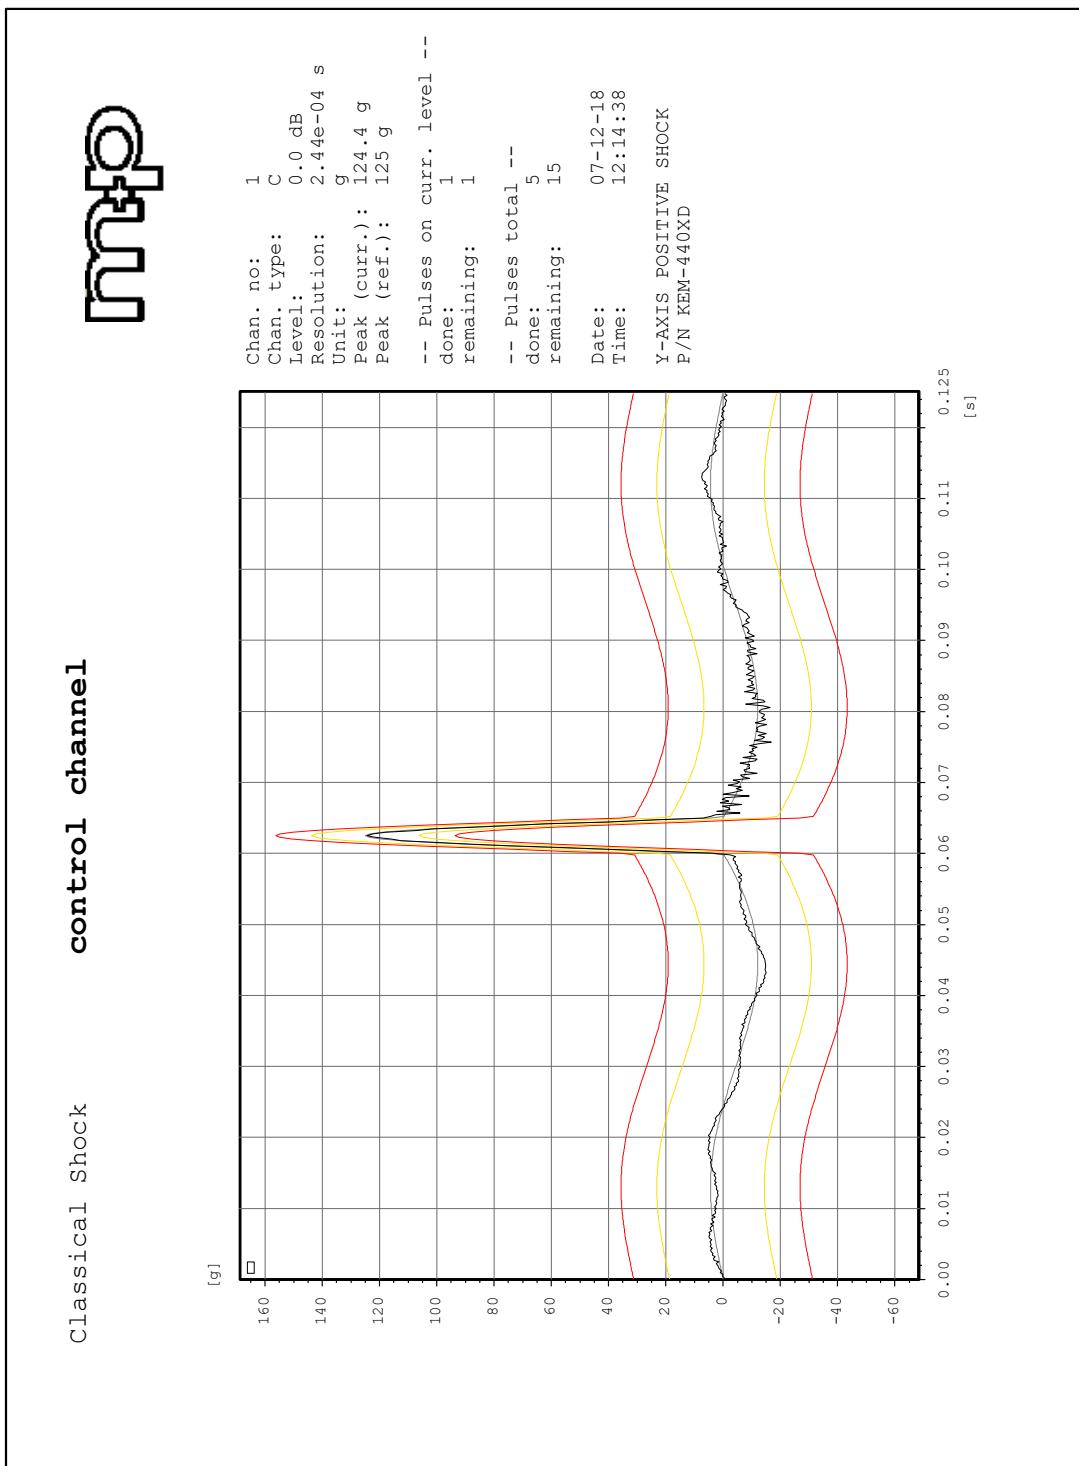
Chart 5.2.1-45:Transverse axis Shock Profile, P/N KEM-440XD,Positive 1

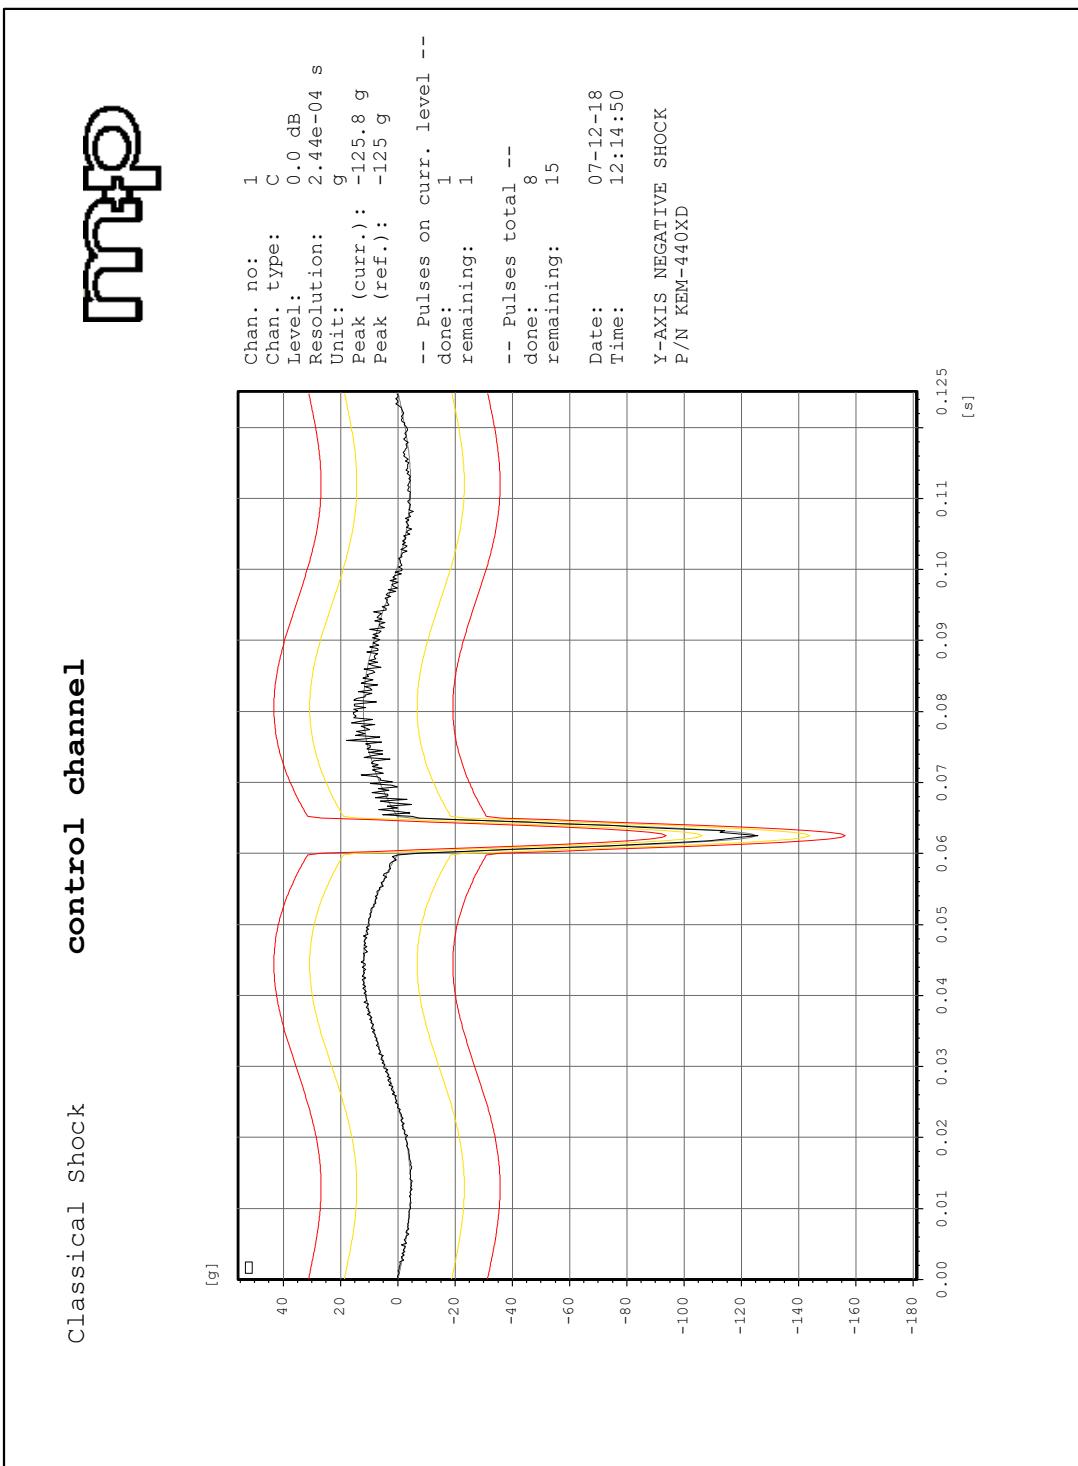
Chart 5.2.1-46:Transverse axis Shock Profile, P/N KEM-440XD,Negative 1

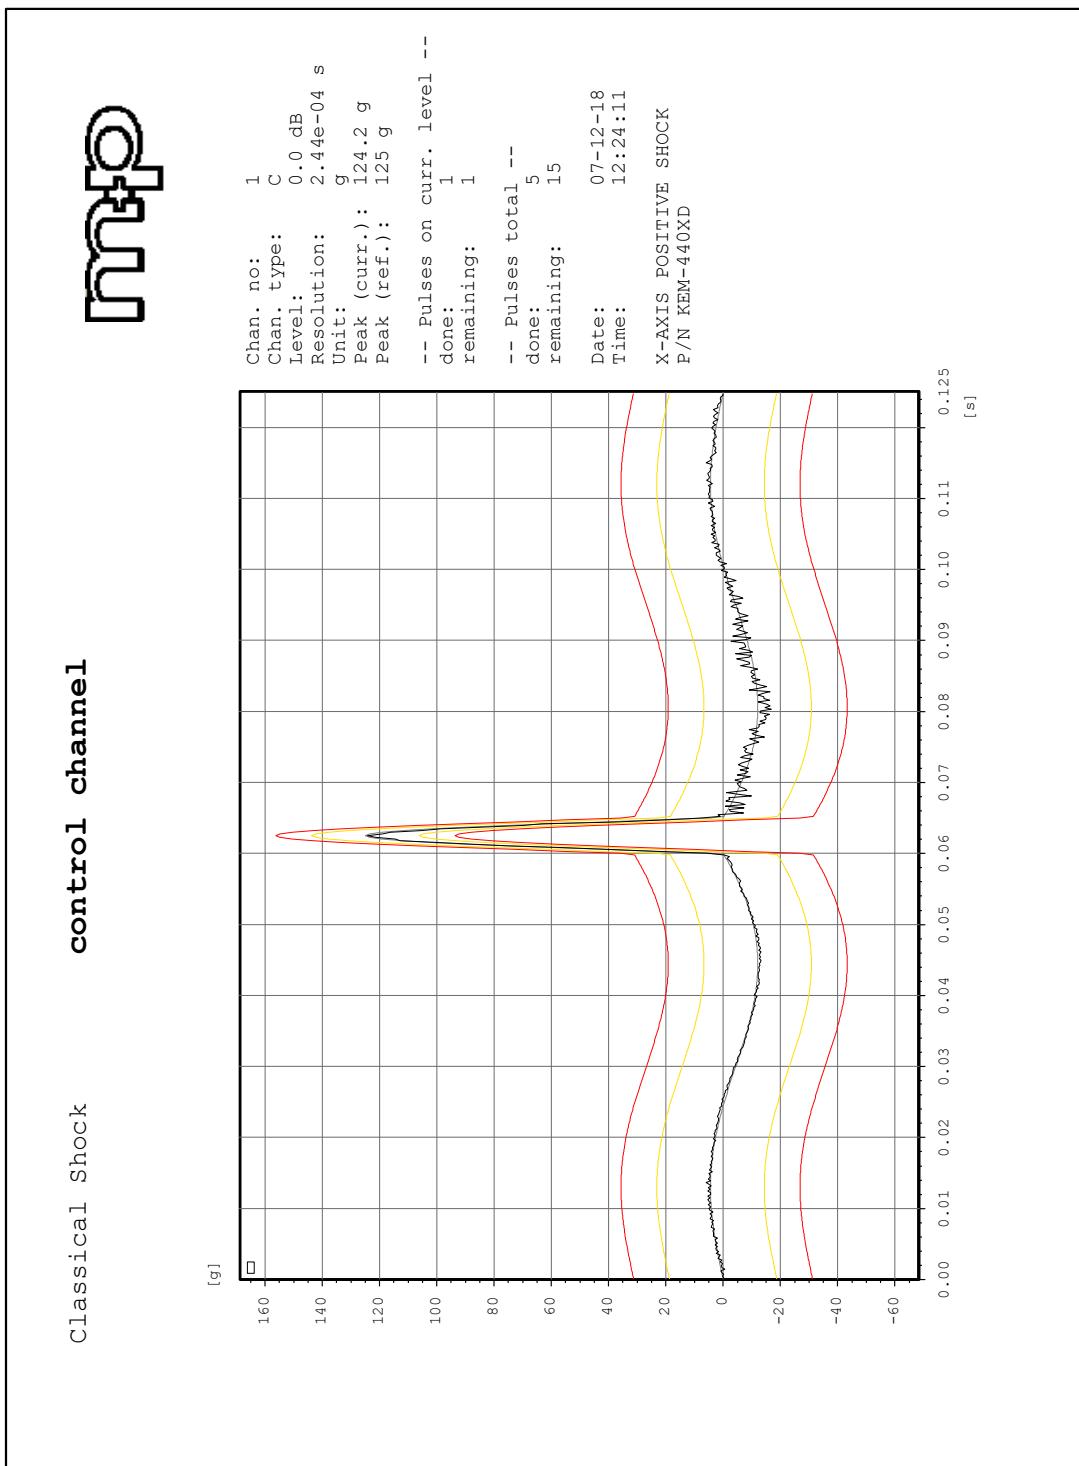
Chart 5.2.1-47:Longitudinal axis Shock Profile, P/N KEM-440XD,Positive 1

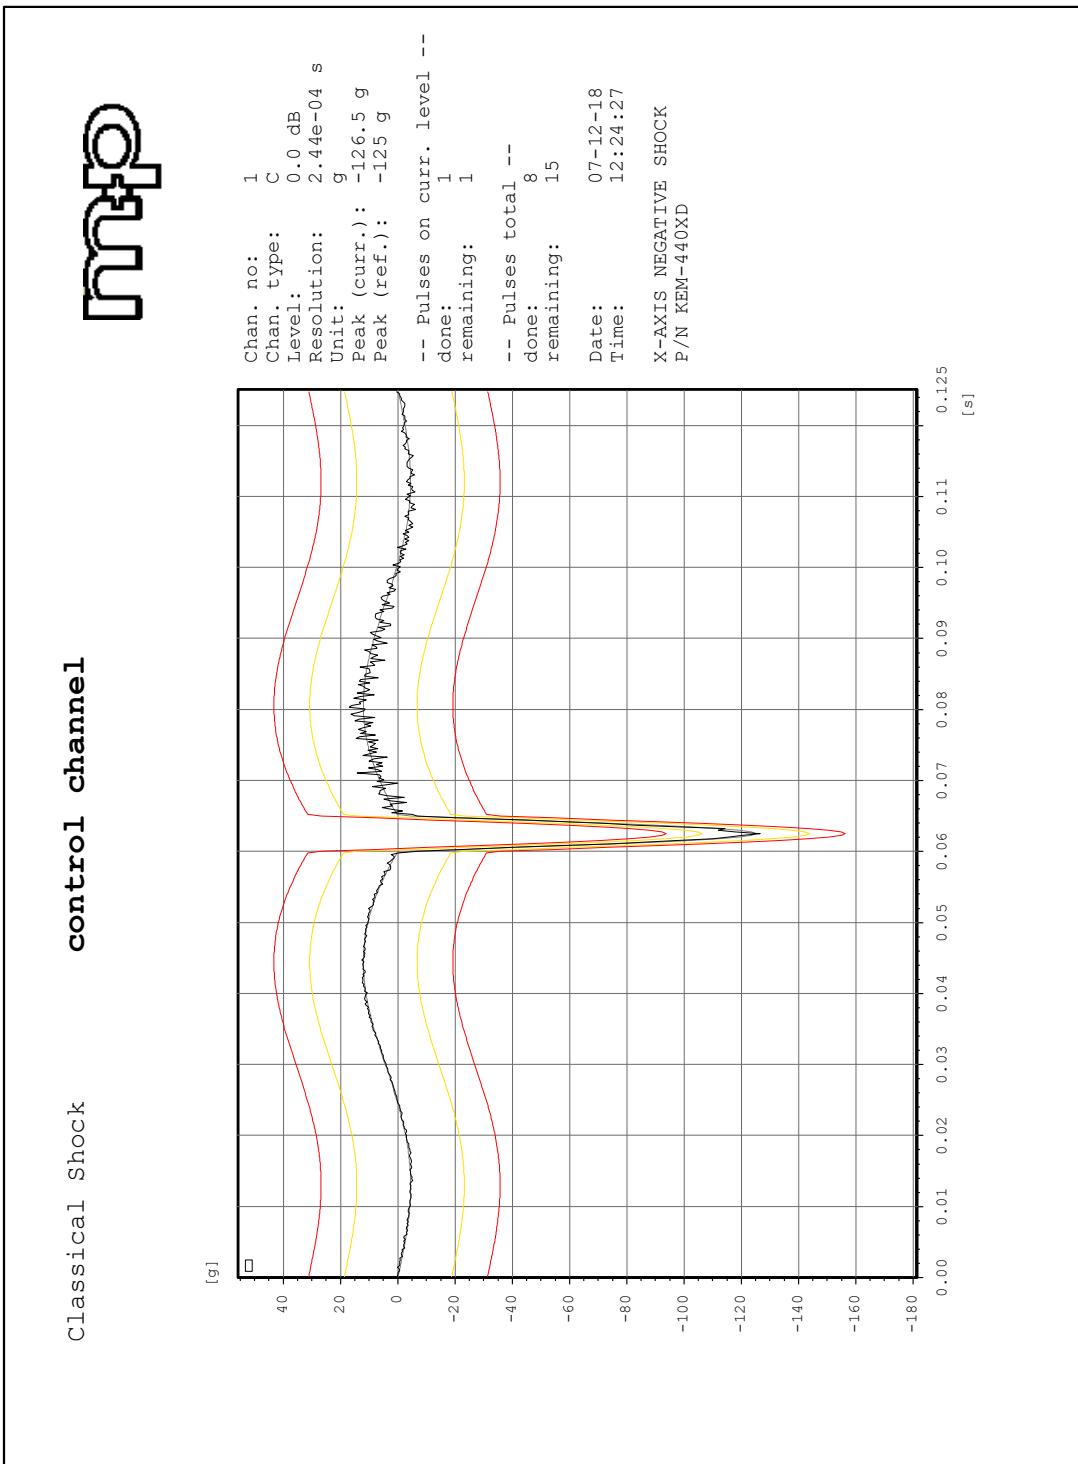
Chart 5.2.1-48:Longitudinal axis Shock Profile, P/N KEM-440XD,Negative 1

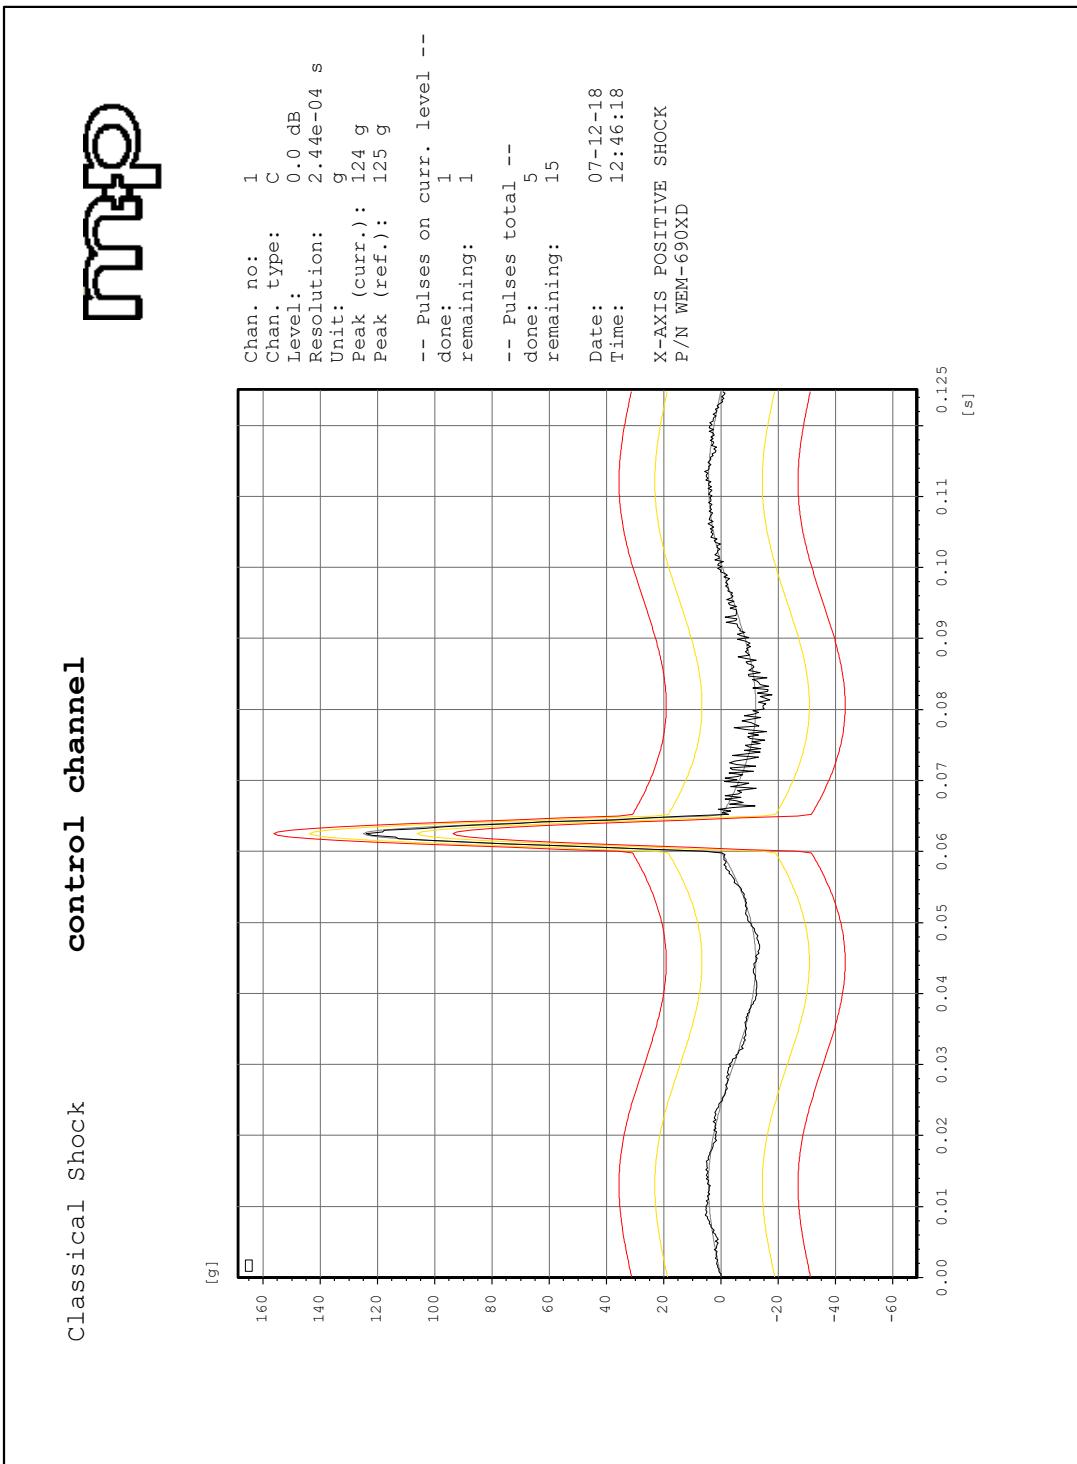
Chart 5.2.1-49:Longitudinal axis Shock Profile, P/N WEM-690XD,Positive 1

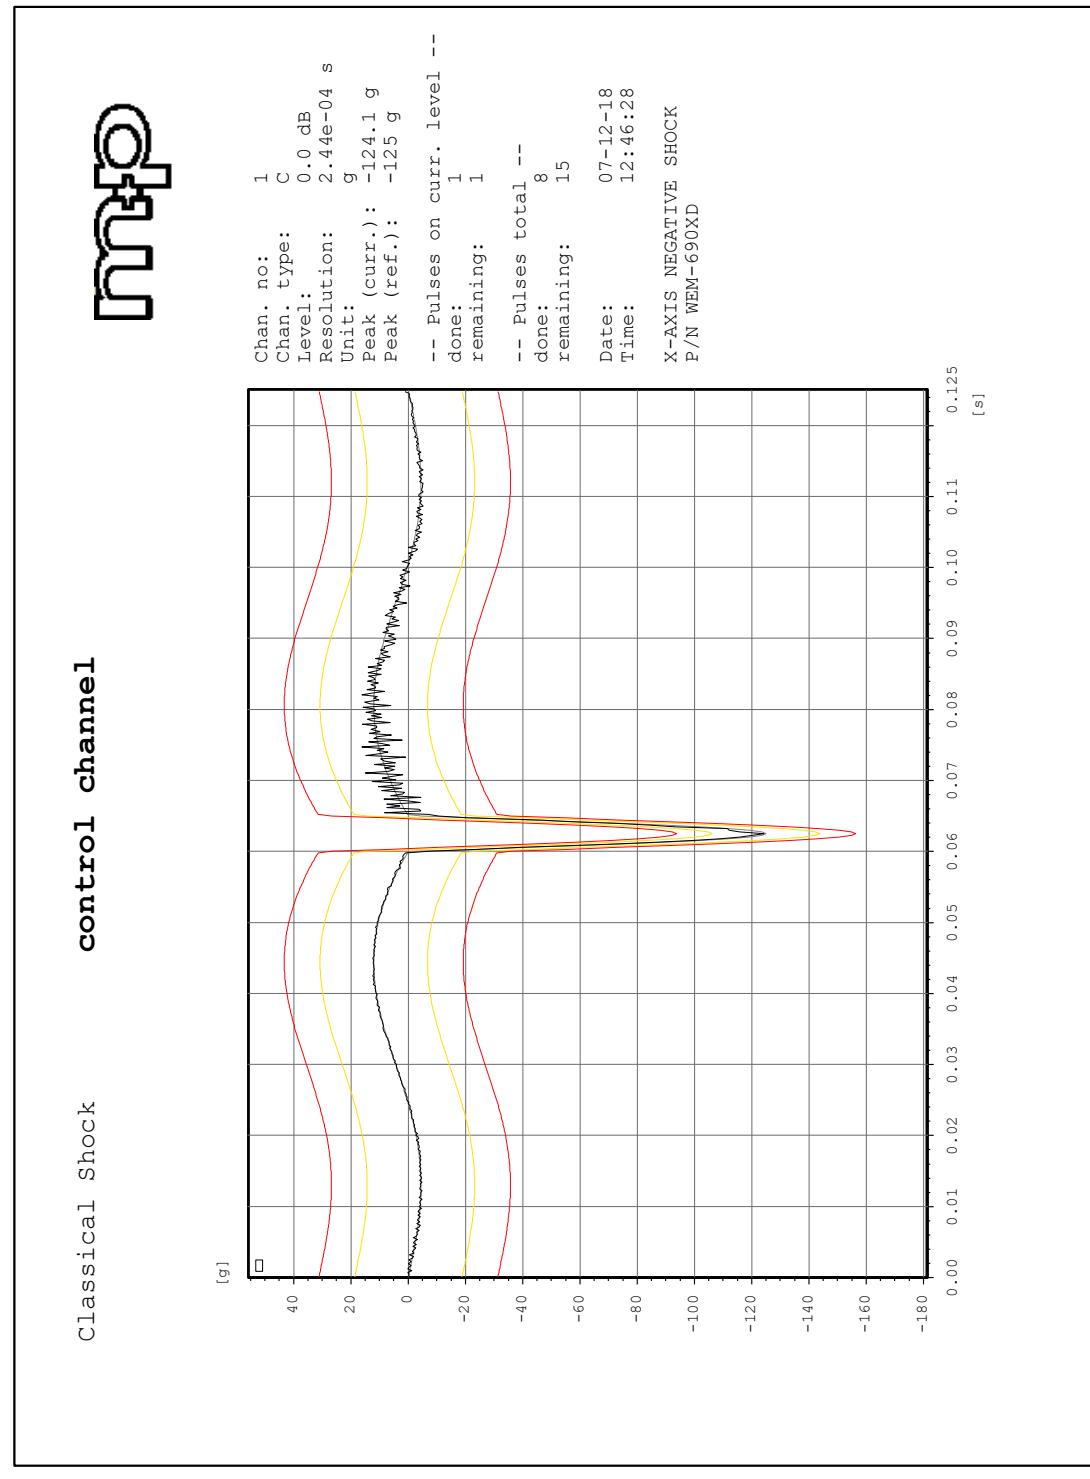
Chart 5.2.1-50:Longitudinal axis Shock Profile, P/N WEM-690XD,Negative
