ENVIRONMENTAL TEST REPORT No. 6737-A Rev 1

Shock Testing

Valve Actuators KEM, WEM, WE

IEC 60068-2-27

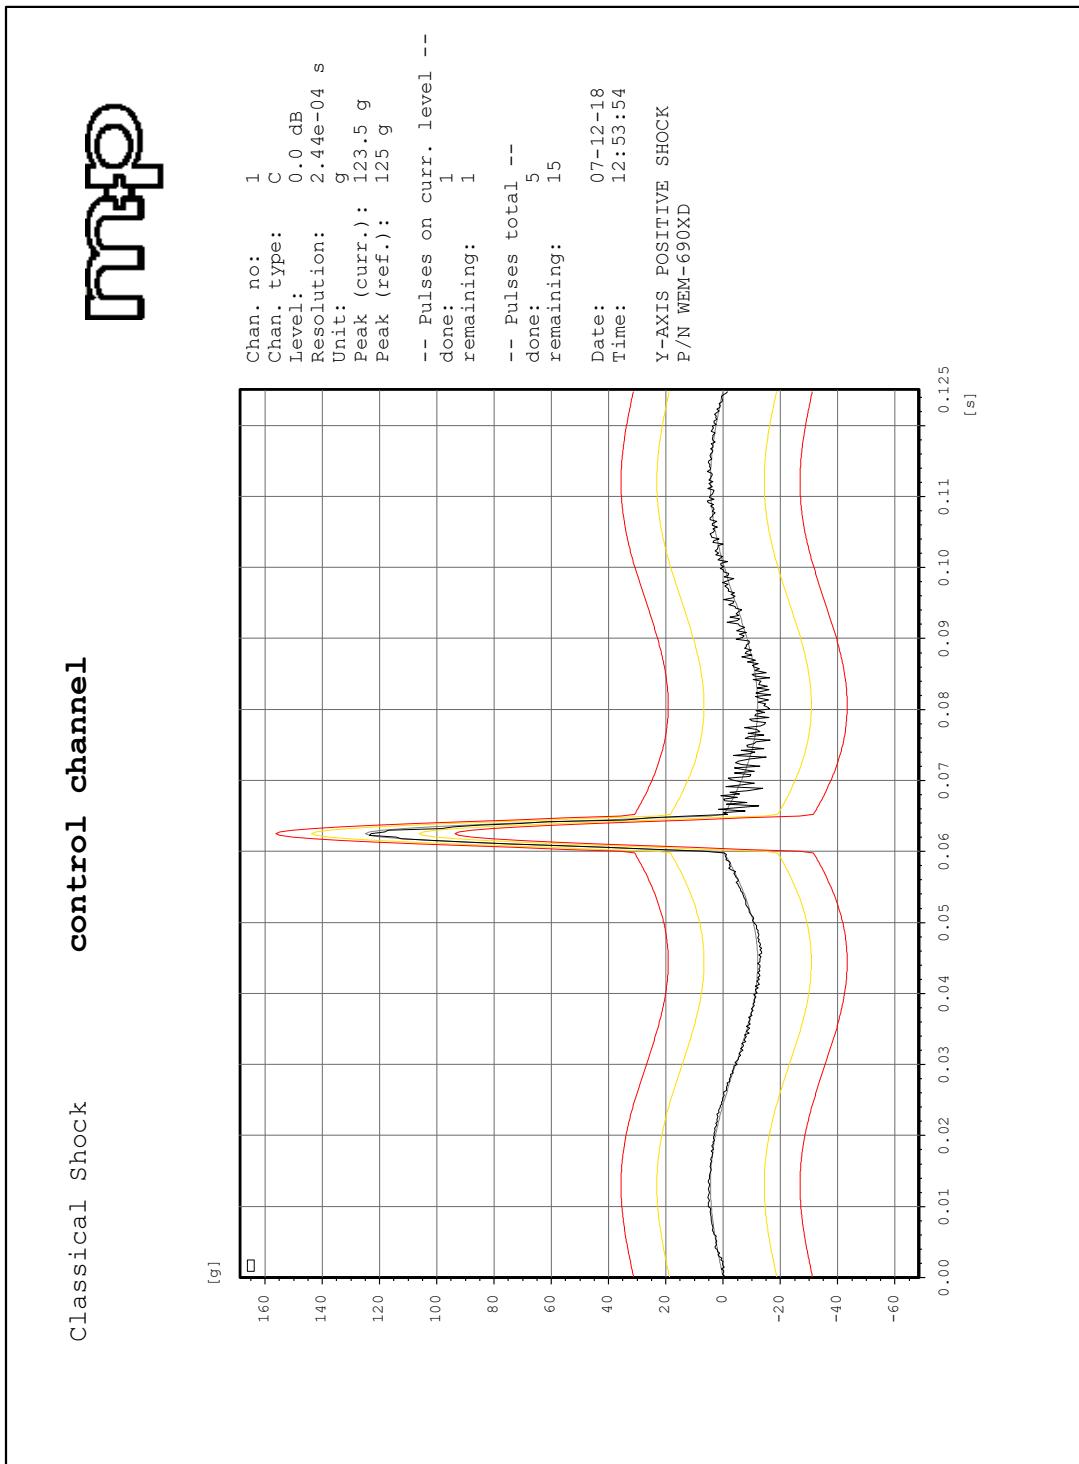
Chart 5.2.1-51:Transverse axis Shock Profile, P/N WEM-690XD,Positive 1

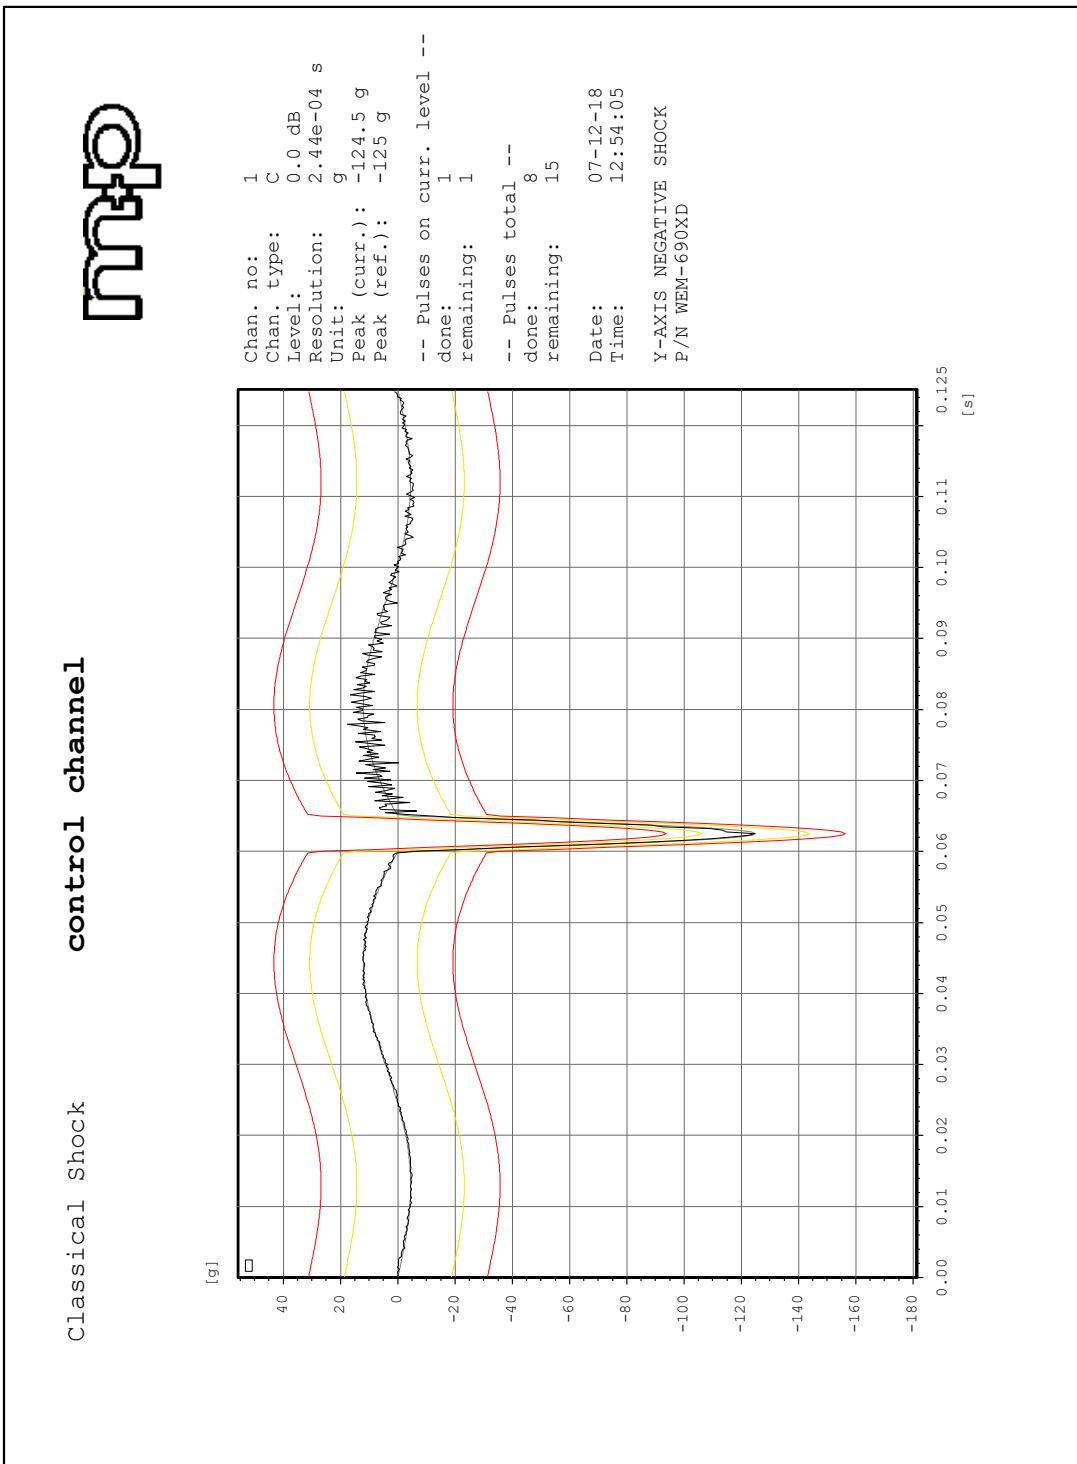
Chart 5.2.1-52: Transverse axis Shock Profile, P/N WEM-690XD, Negative 1

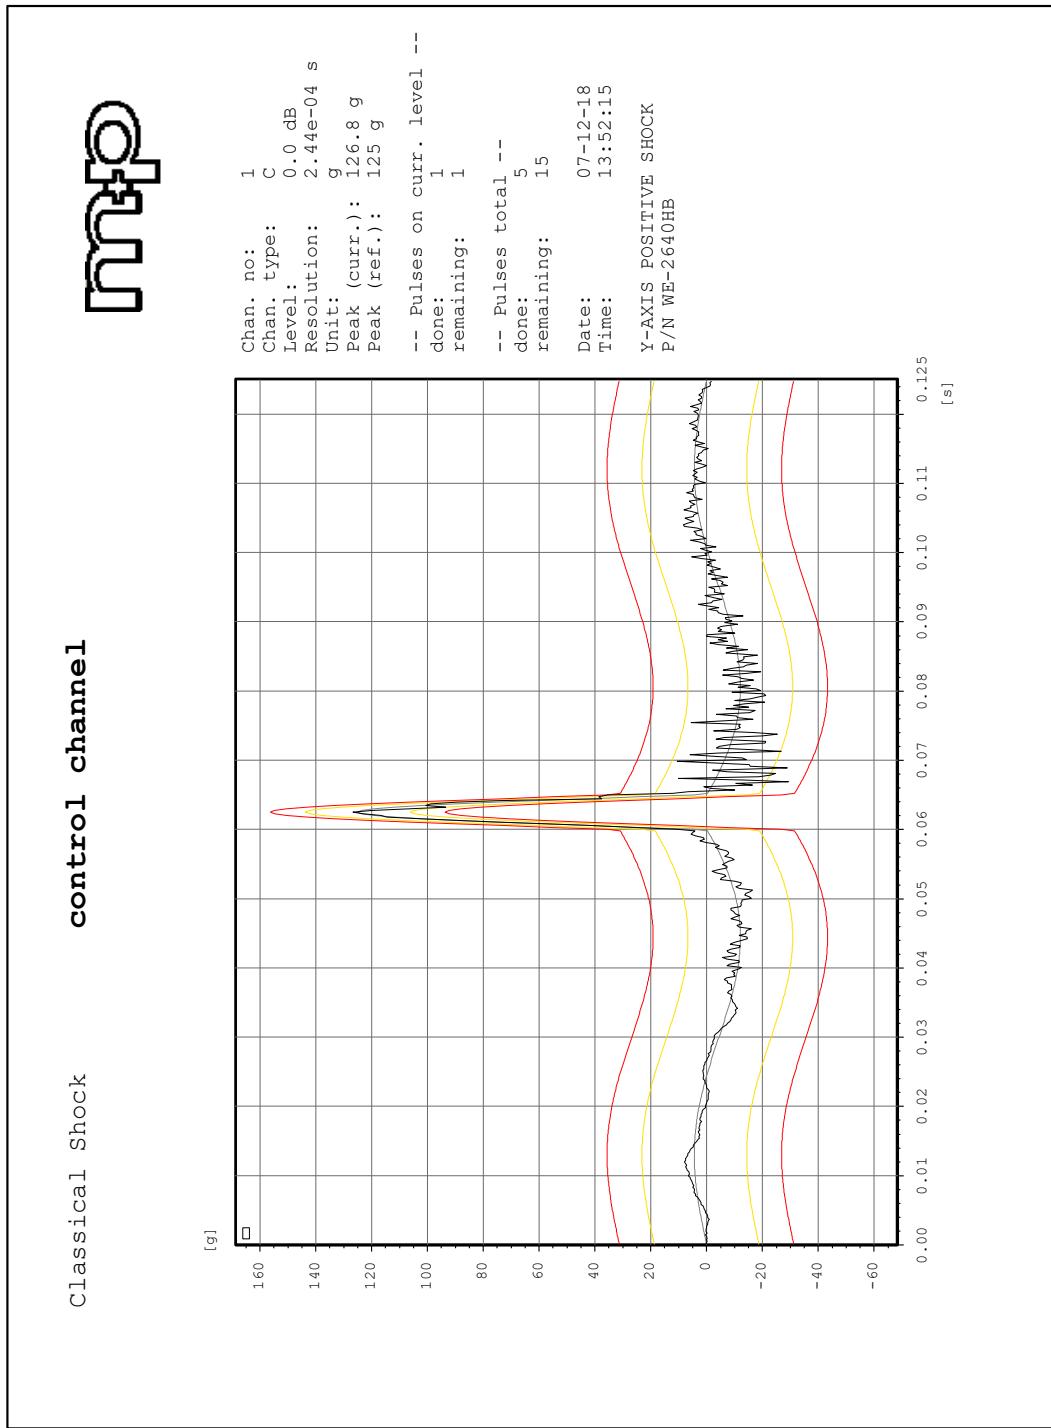
Chart 5.2.1-53:Transverse axis Shock Profile, P/N WE-2640HB,Positive 1

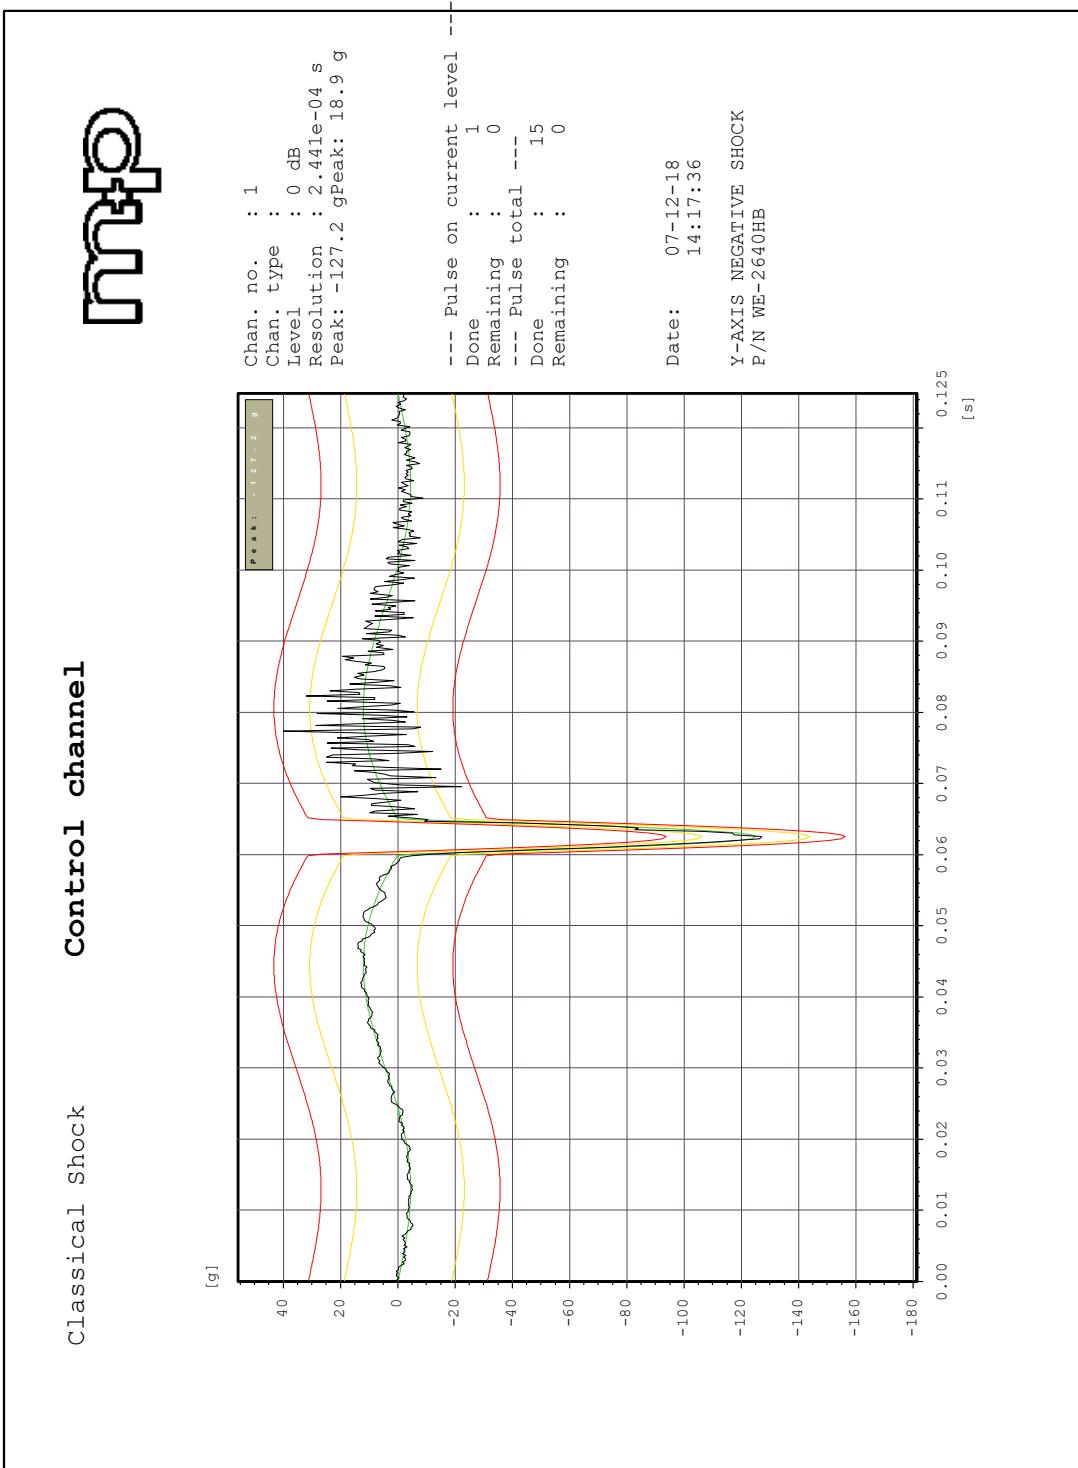
Chart 5.2.1-54:Transverse axis Shock Profile, P/N WE-2640HB,Negative 1

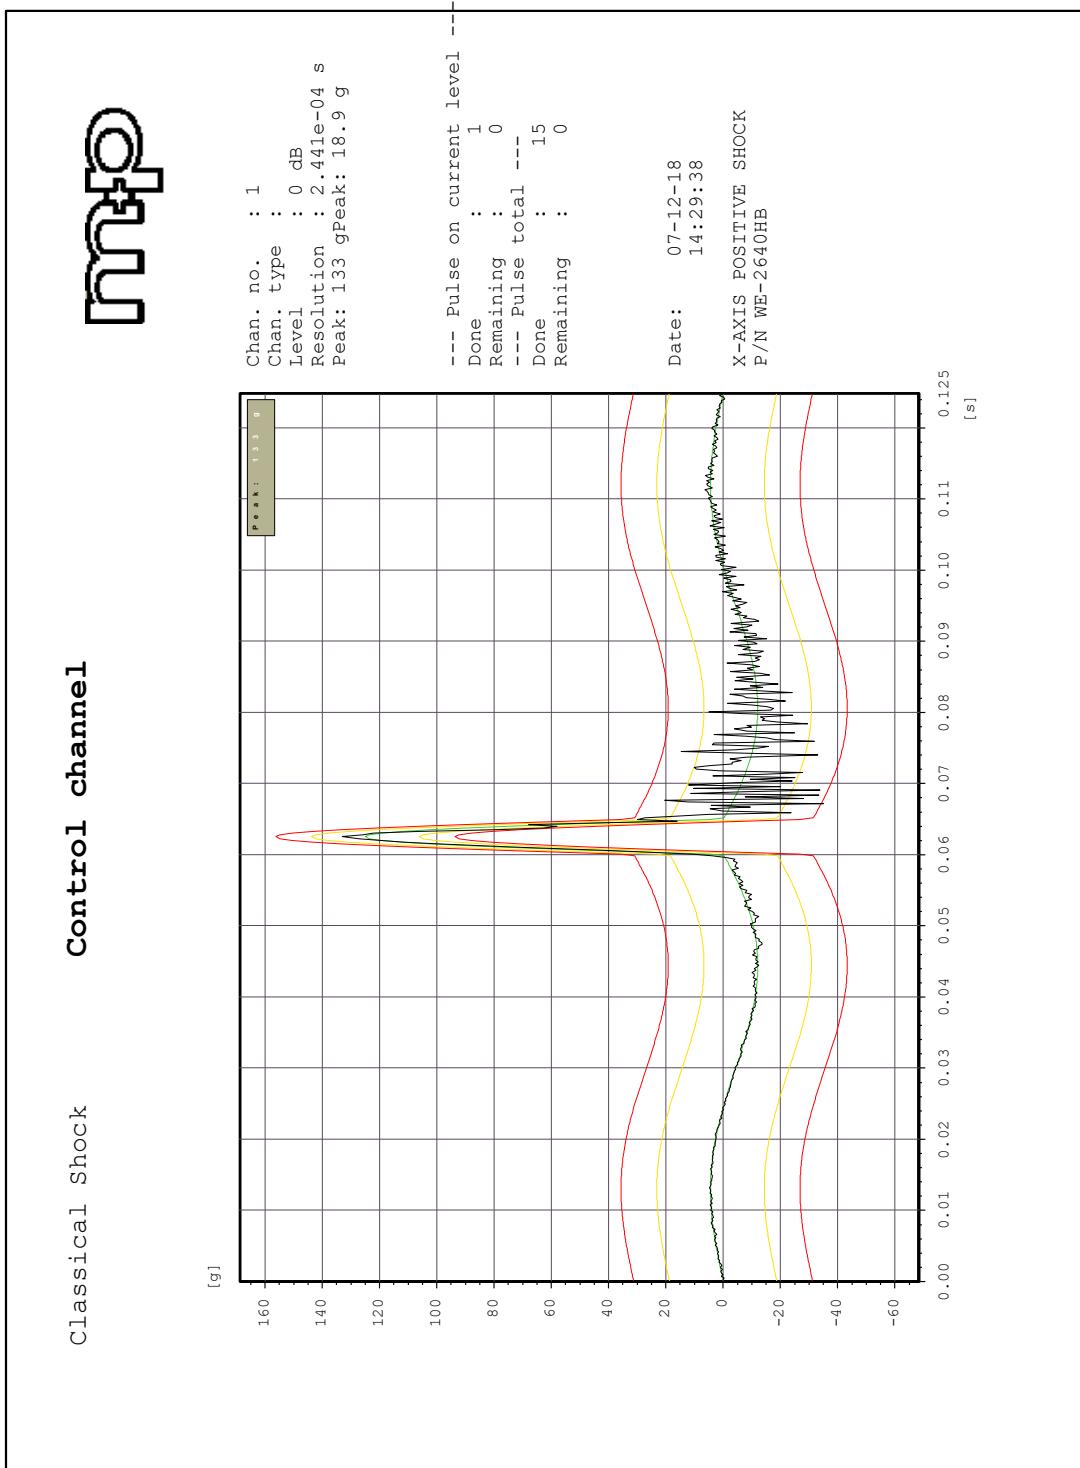
Chart 5.2.1-55:Longitudinal axis Shock Profile, P/N WE-2640HB,Positive 1

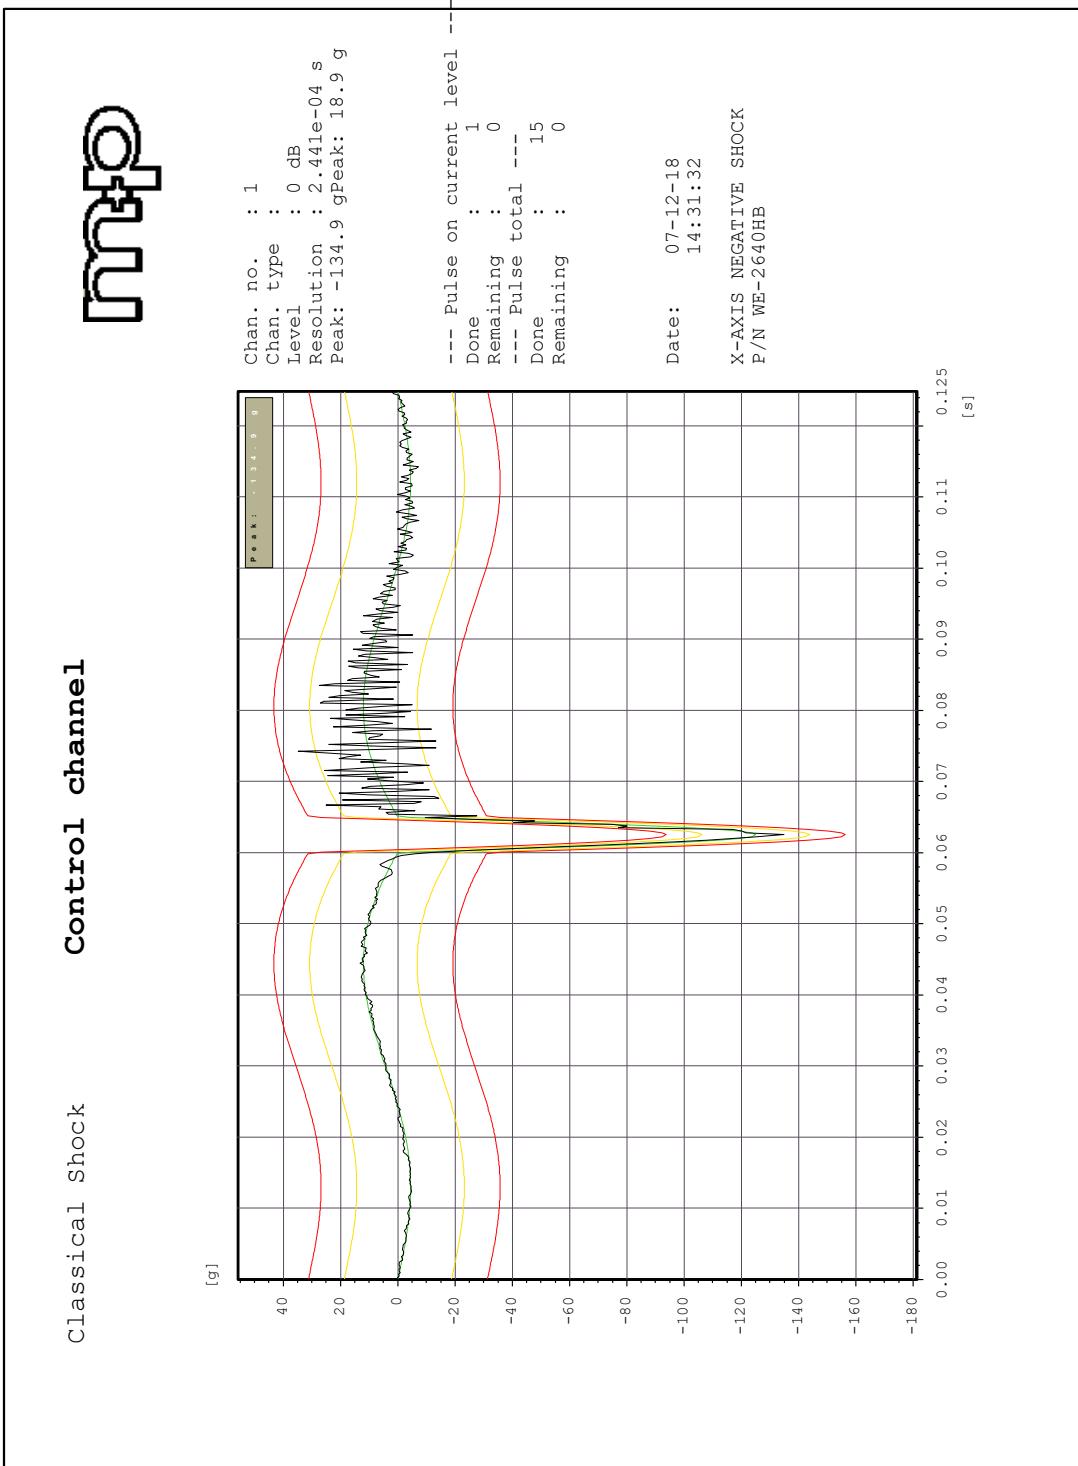
Chart 5.2.1-56:Longitudinal axis Shock Profile, P/N WE-2640HB,Negative 1

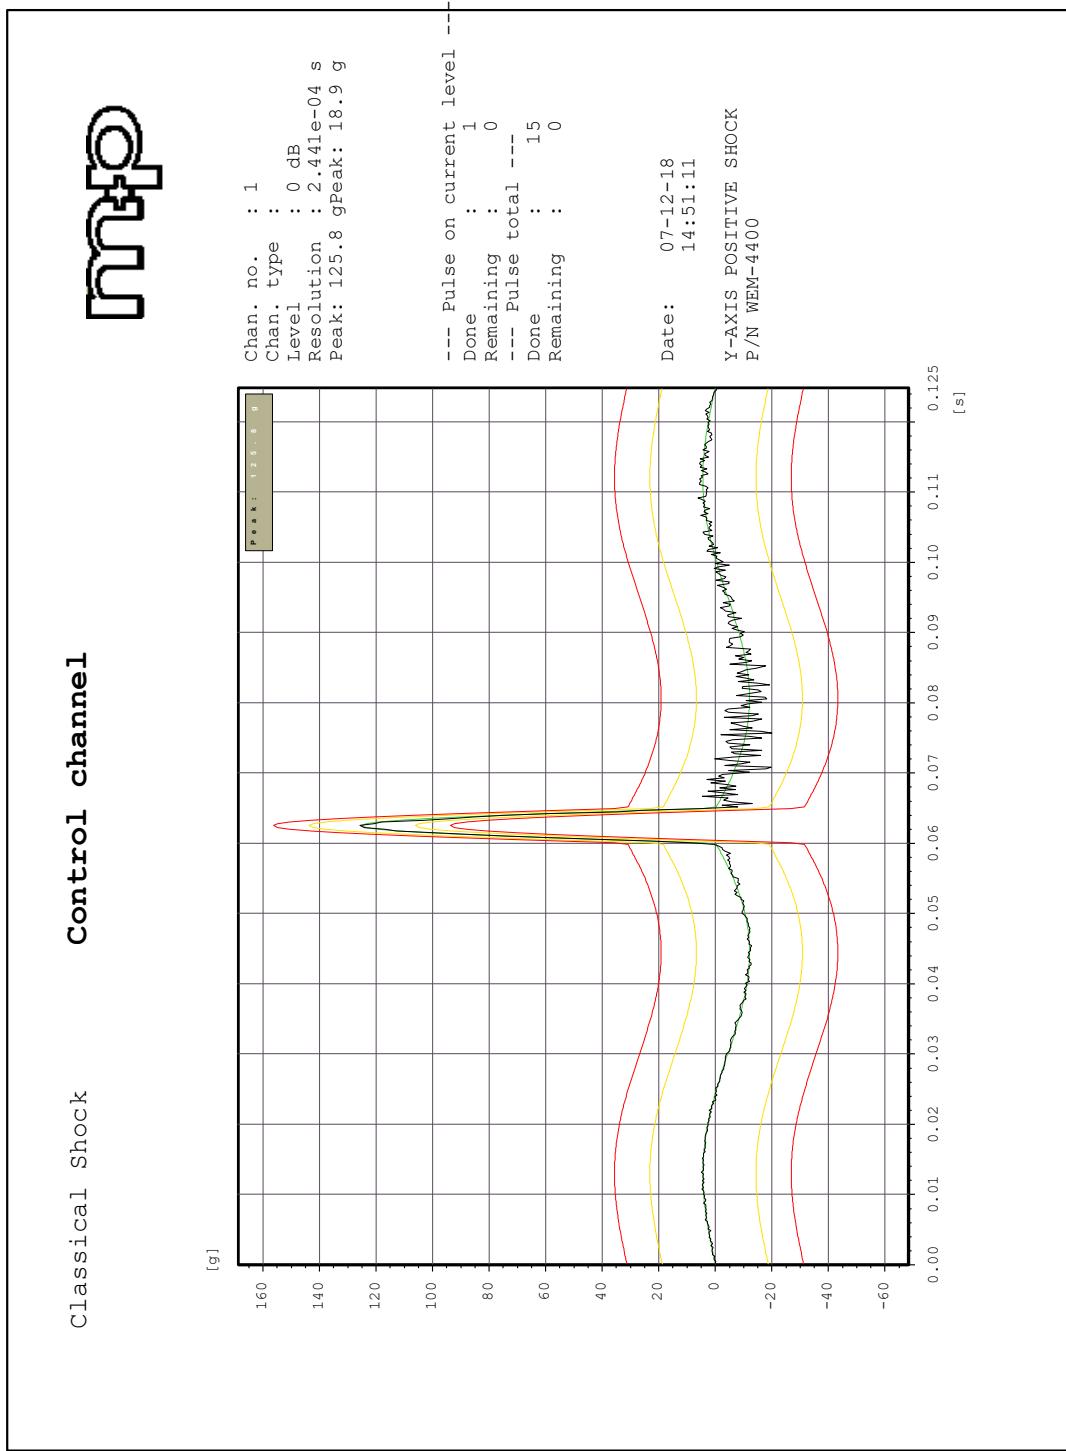
Chart 5.2.1-57:Transverse axis Shock Profile, P/N WEM-4400,Positive 1

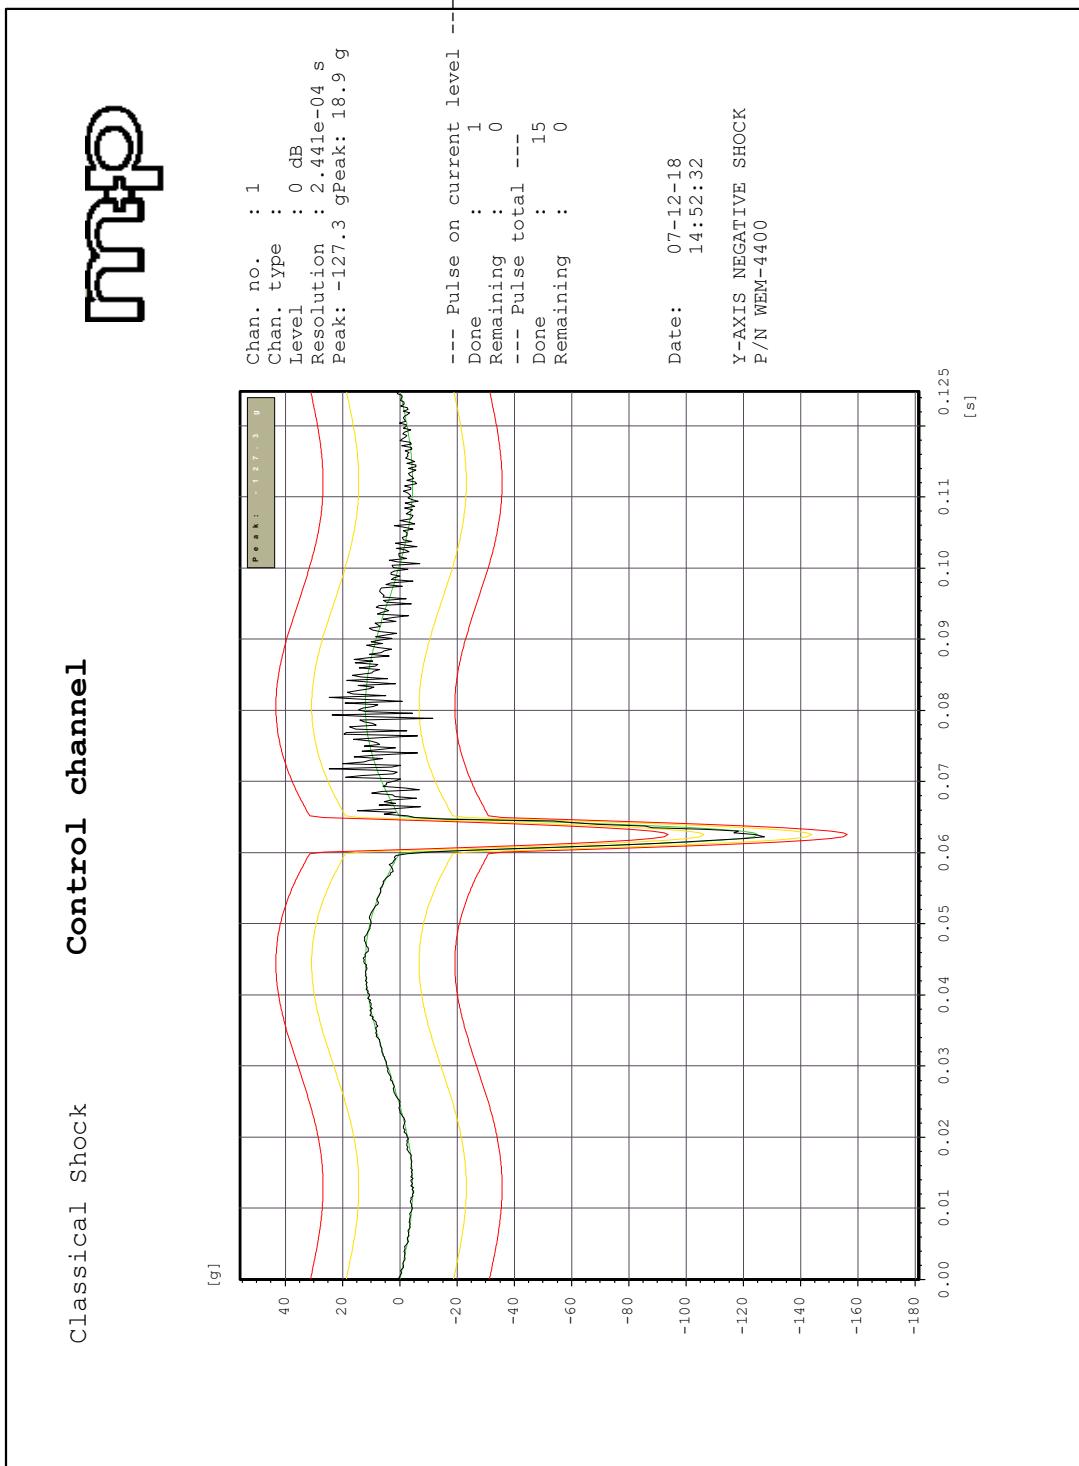
Chart 5.2.1-58:Transverse axis Shock Profile, P/N WEM-4400,Negative 1

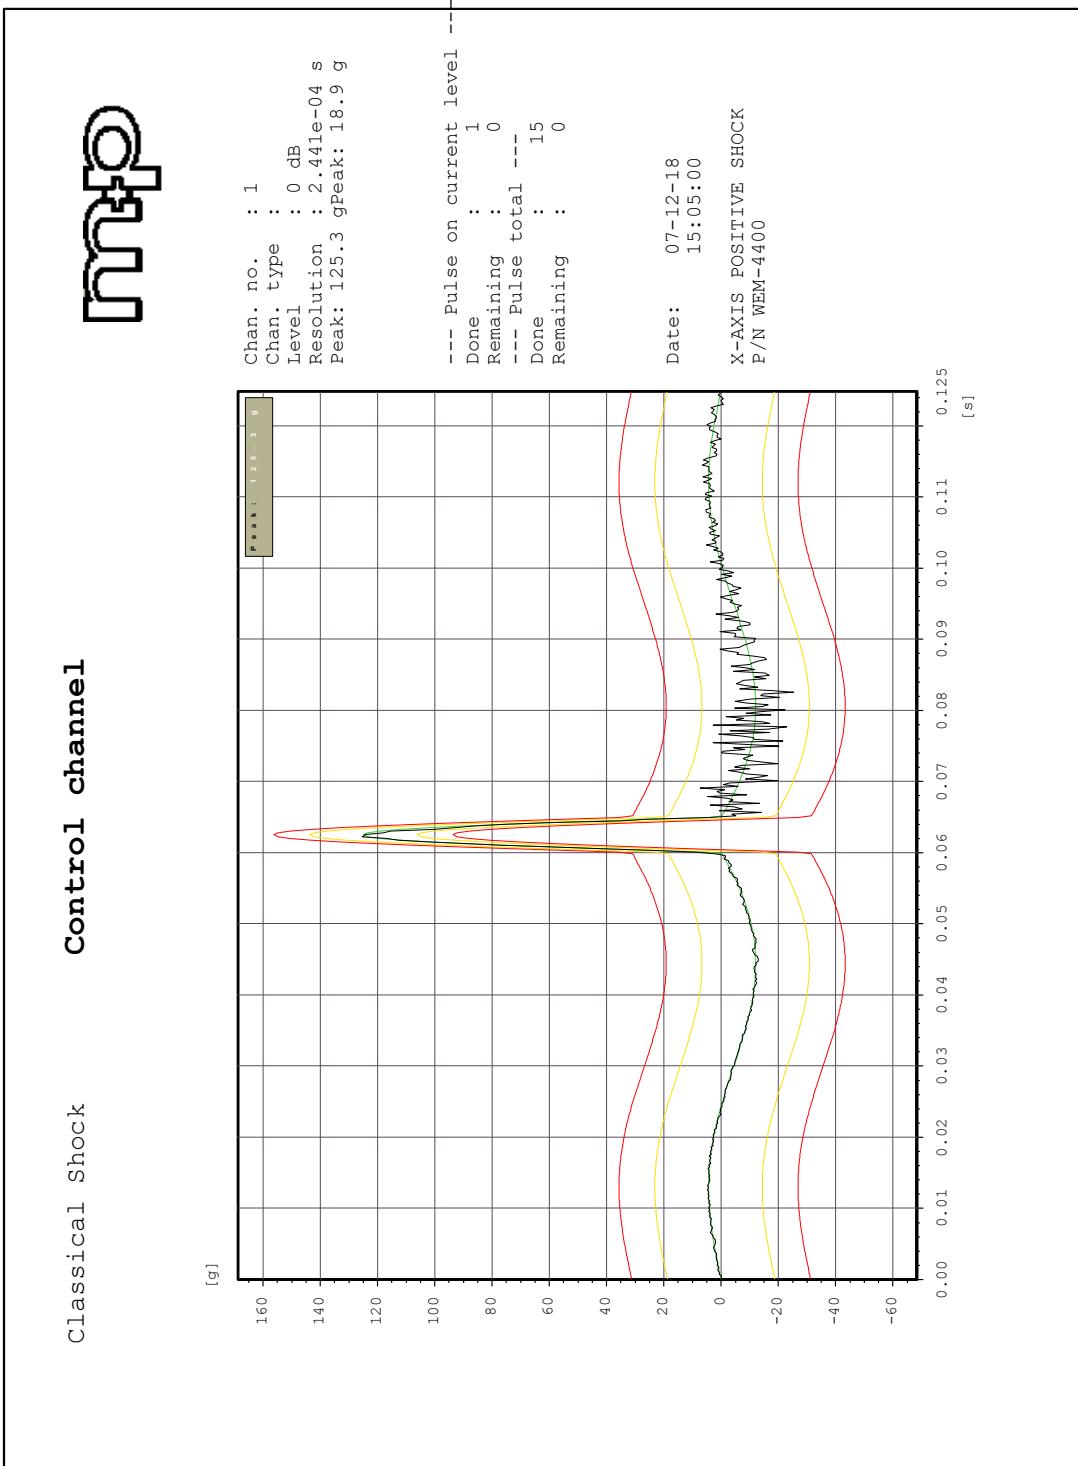
Chart 5.2.1-59:Longitudinal axis Shock Profile, P/N WEM-4400,Positive 1

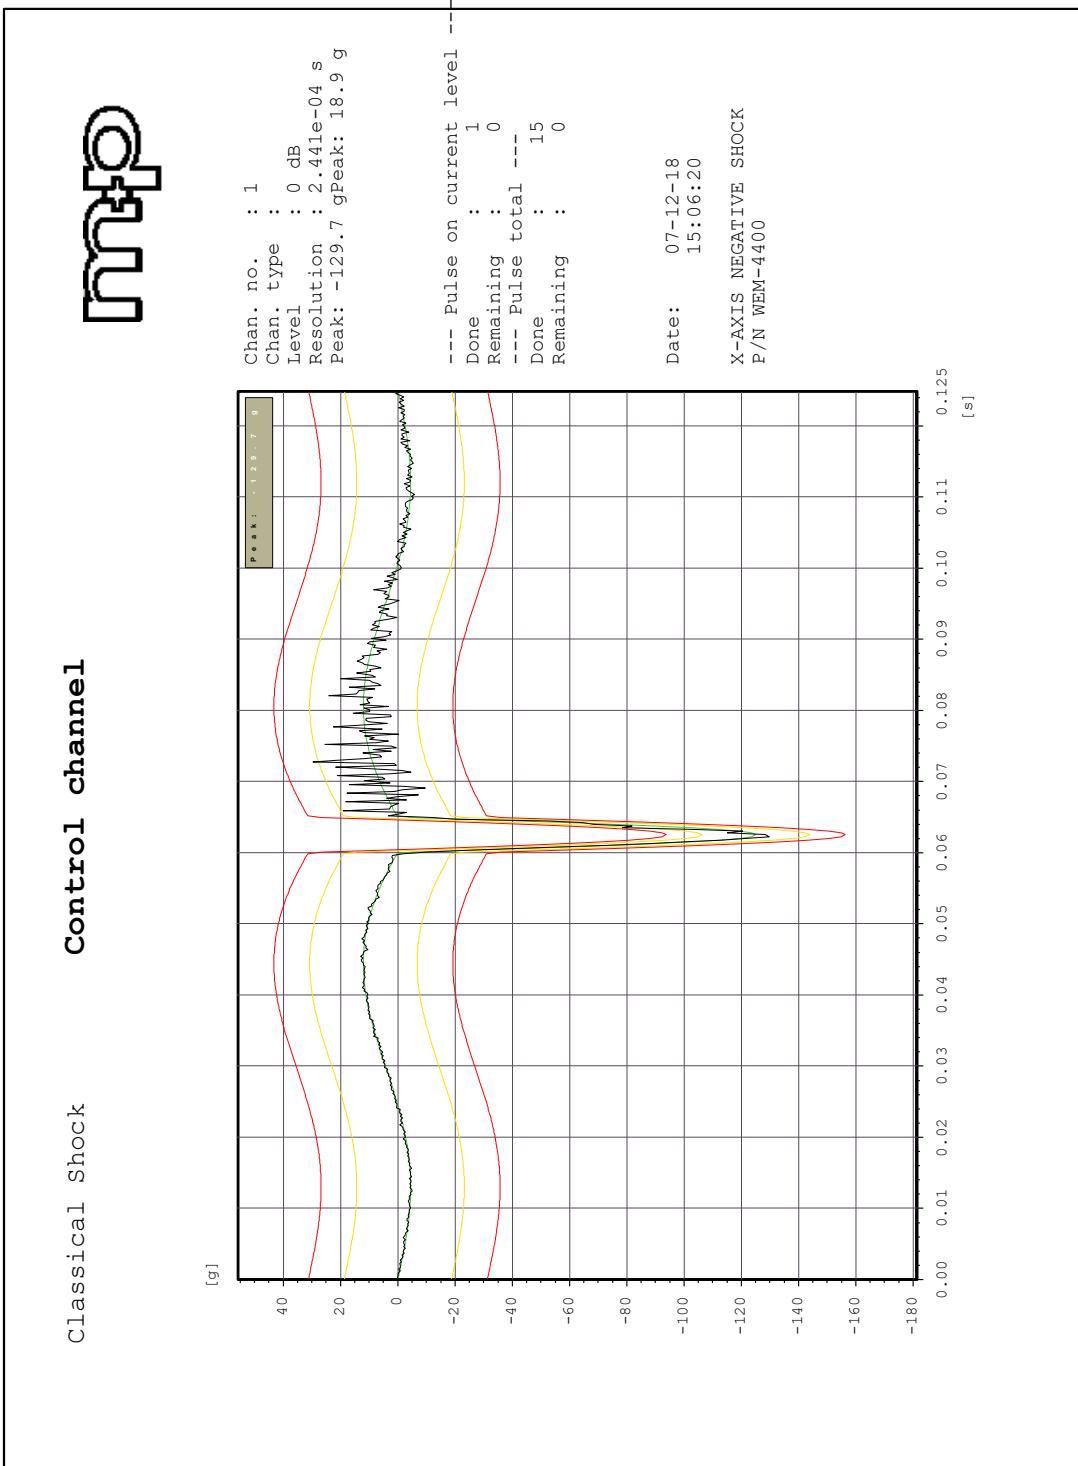
Chart 5.2.1-60:Longitudinal axis Shock Profile, P/N WEM-4400,Negative 1

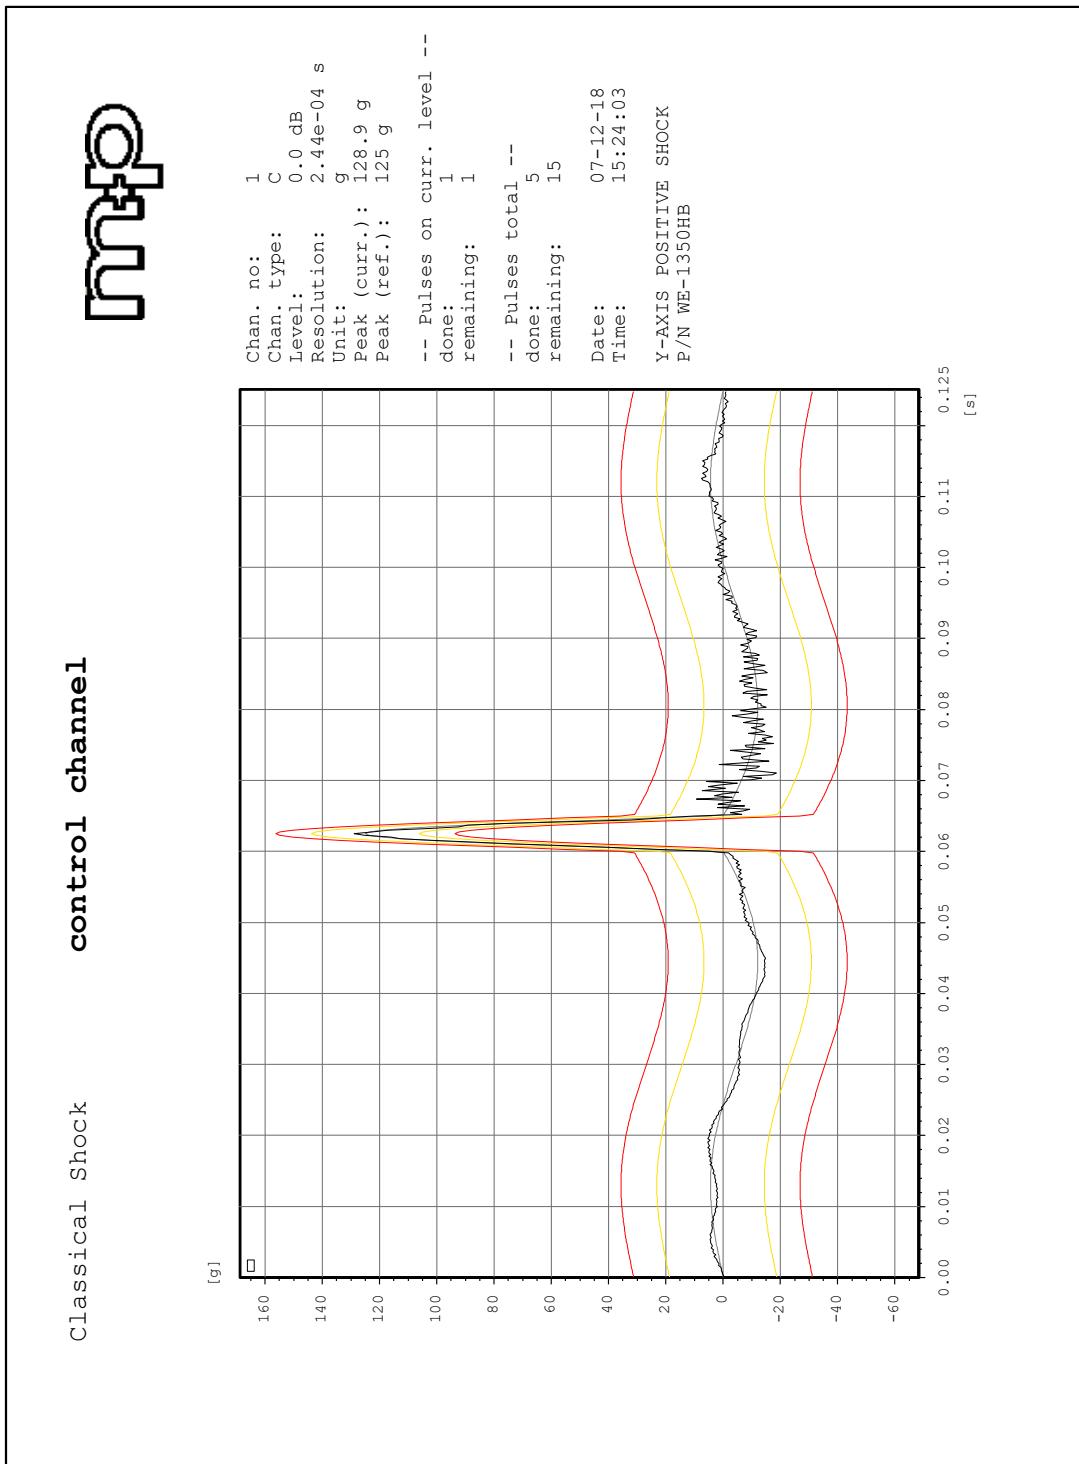
Chart 5.2.1-61:Transverse axis Shock Profile, P/N WE-1350HB,Positive 1

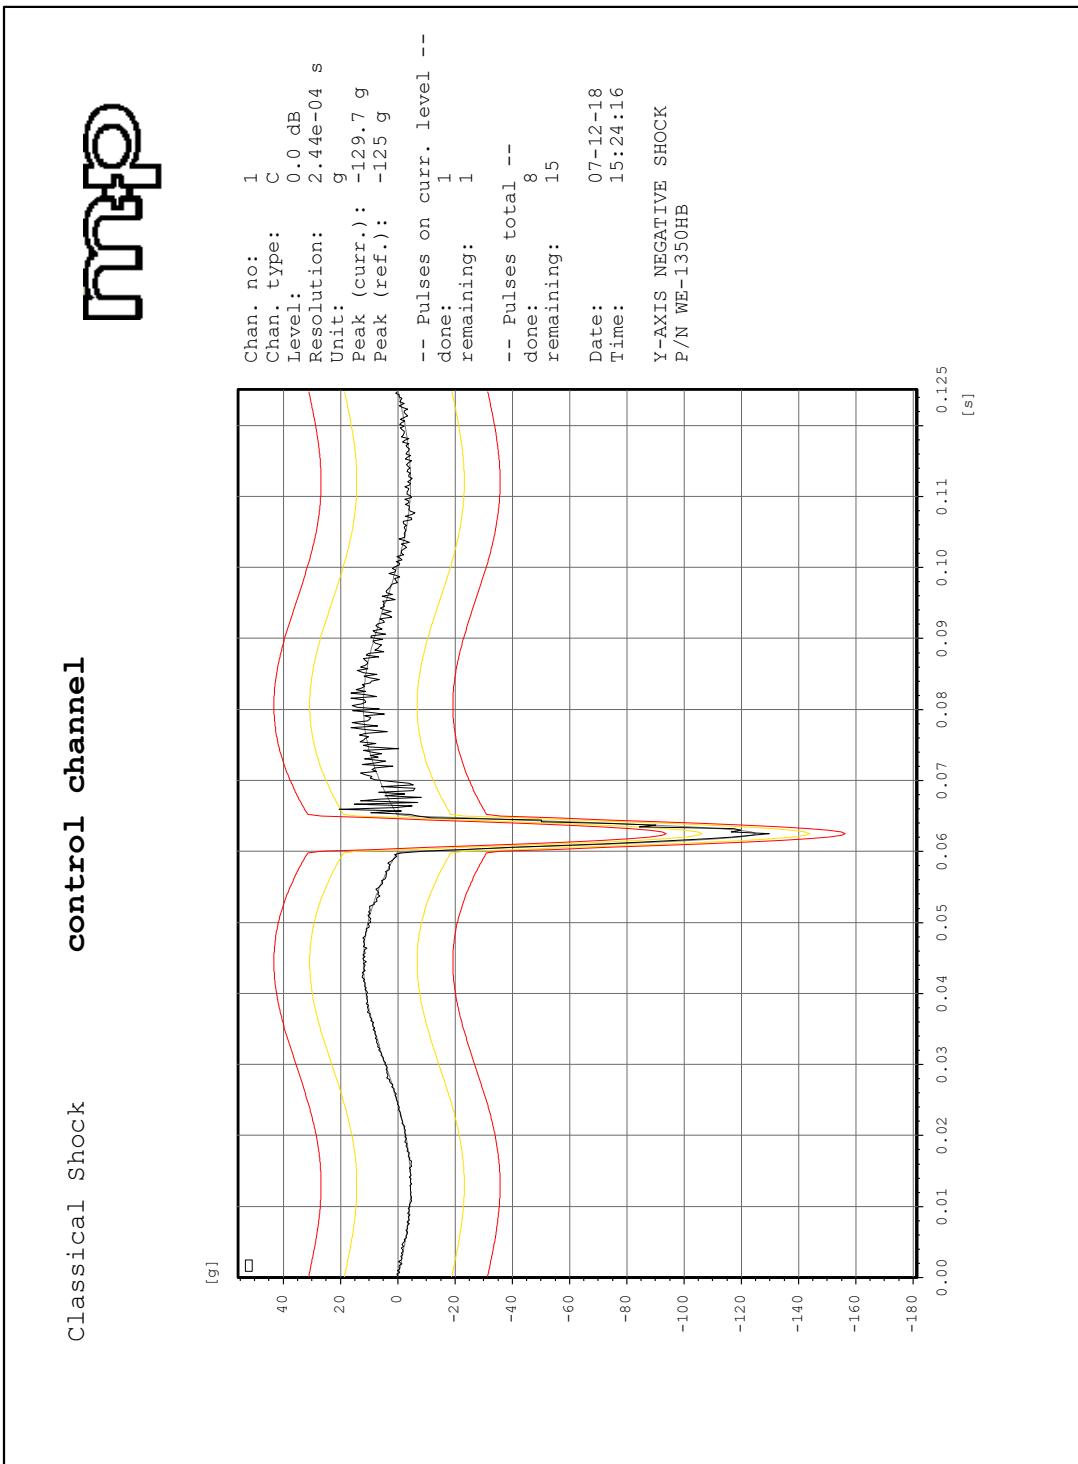
Chart 5.2.1-62:Transverse axis Shock Profile, P/N WE-1350HB,Negative 1

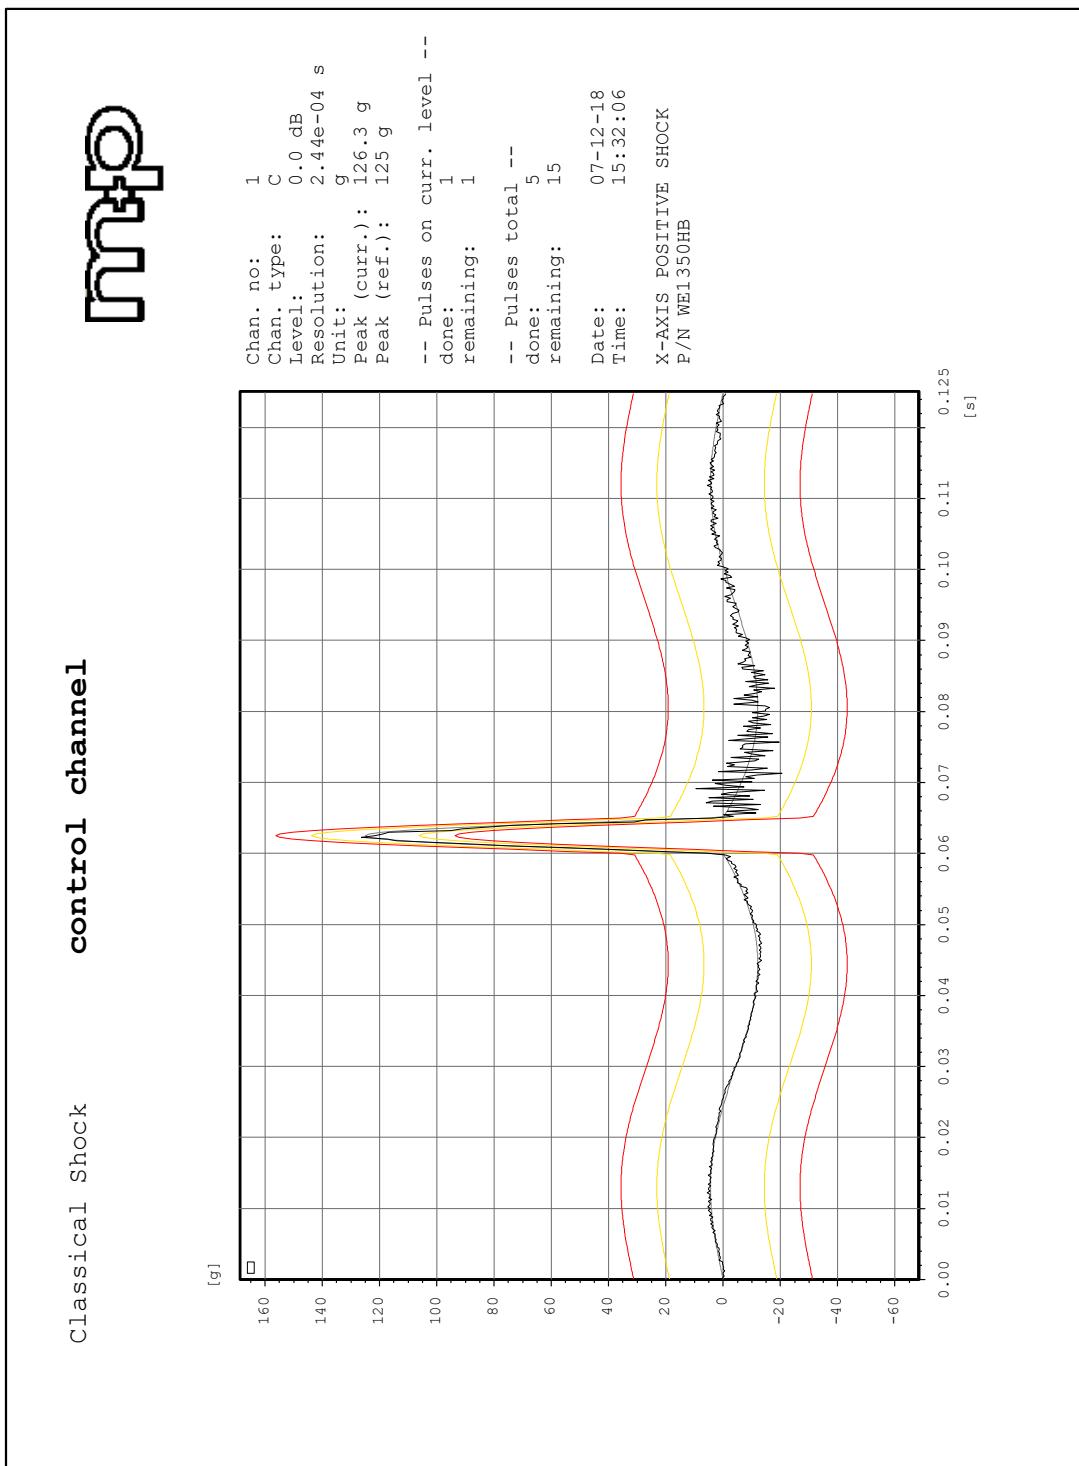
Chart 5.2.1-63:Longitudinal axis Shock Profile, P/N WE-1350HB,Positive 1

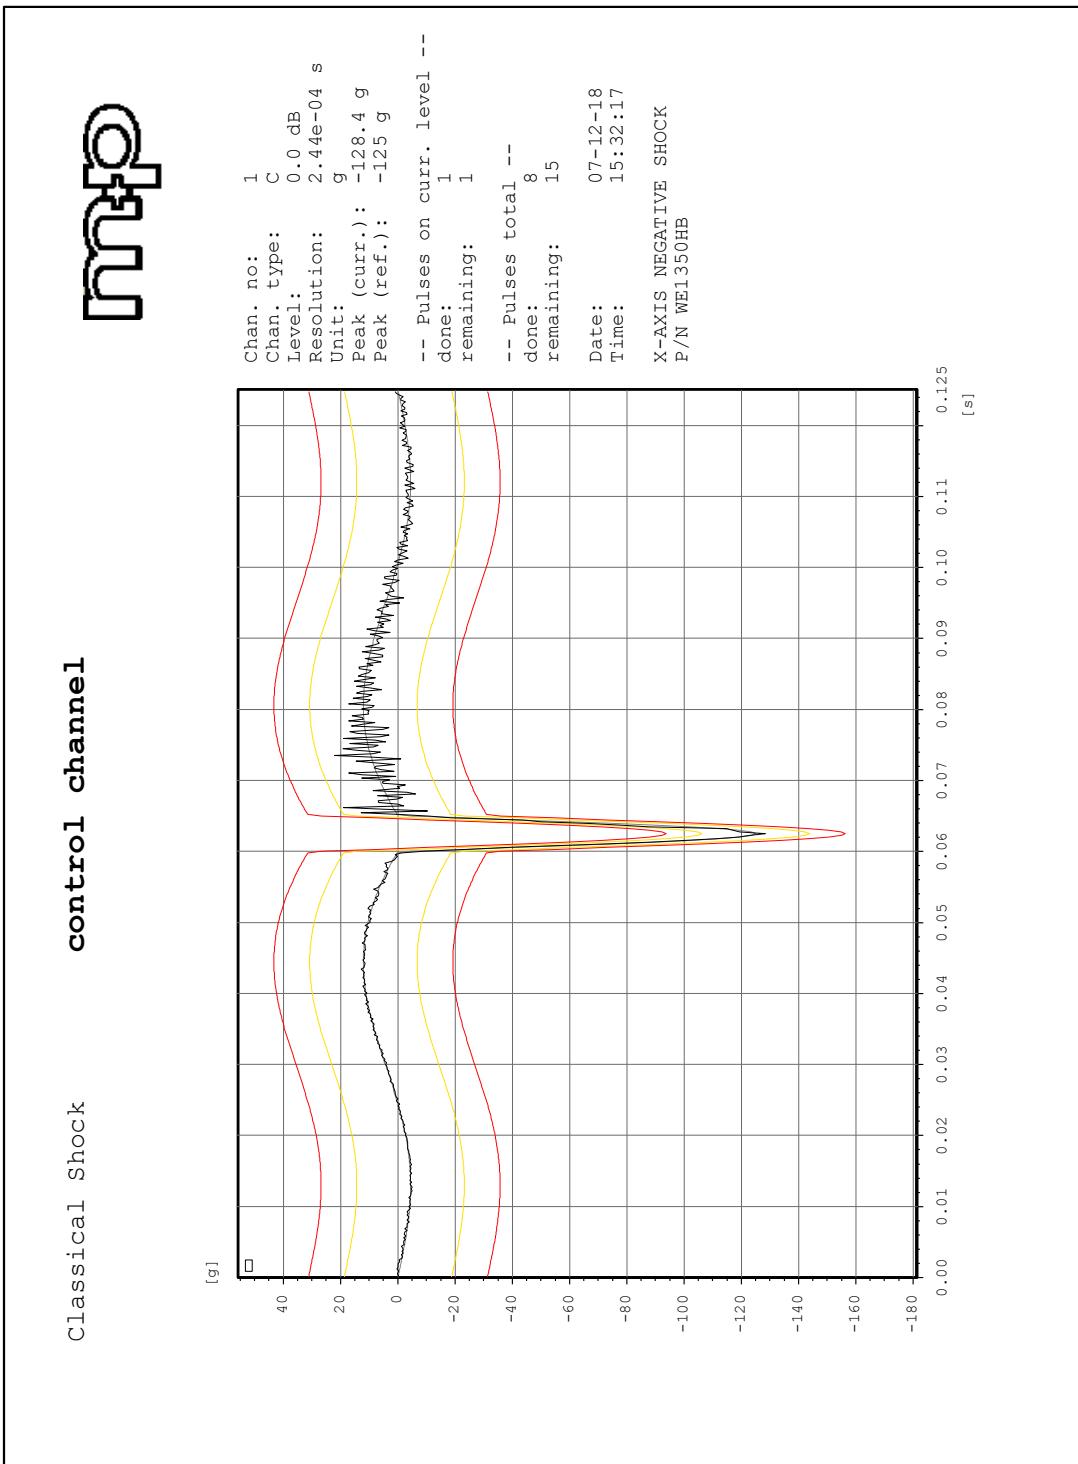
Chart 5.2.1-64:Longitudinal axis Shock Profile, P/N WE-1350HB,Negative 1
