ENVIRONMENTAL TEST REPORT No. 6737-A Rev 1

Shock Testing

Valve Actuators KEM, WEM, WE

IEC 60068-2-27

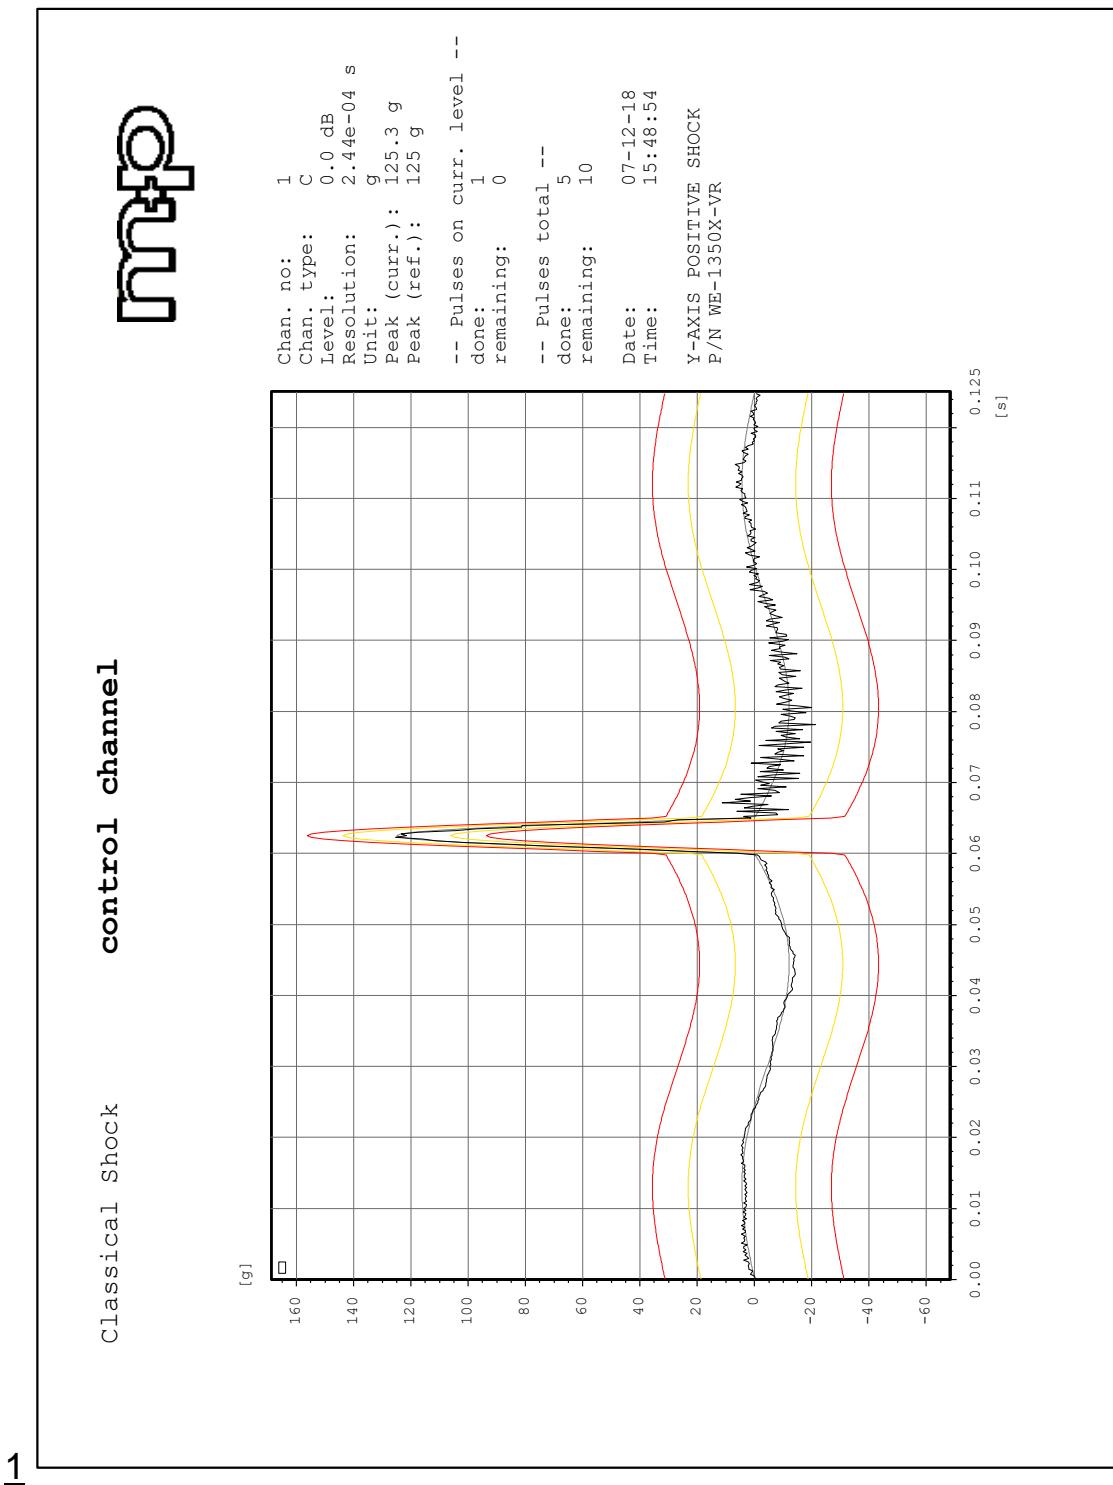
Chart 5.2.1-65:Transverse axis Shock Profile, P/N WE-1350X-VR,Positive

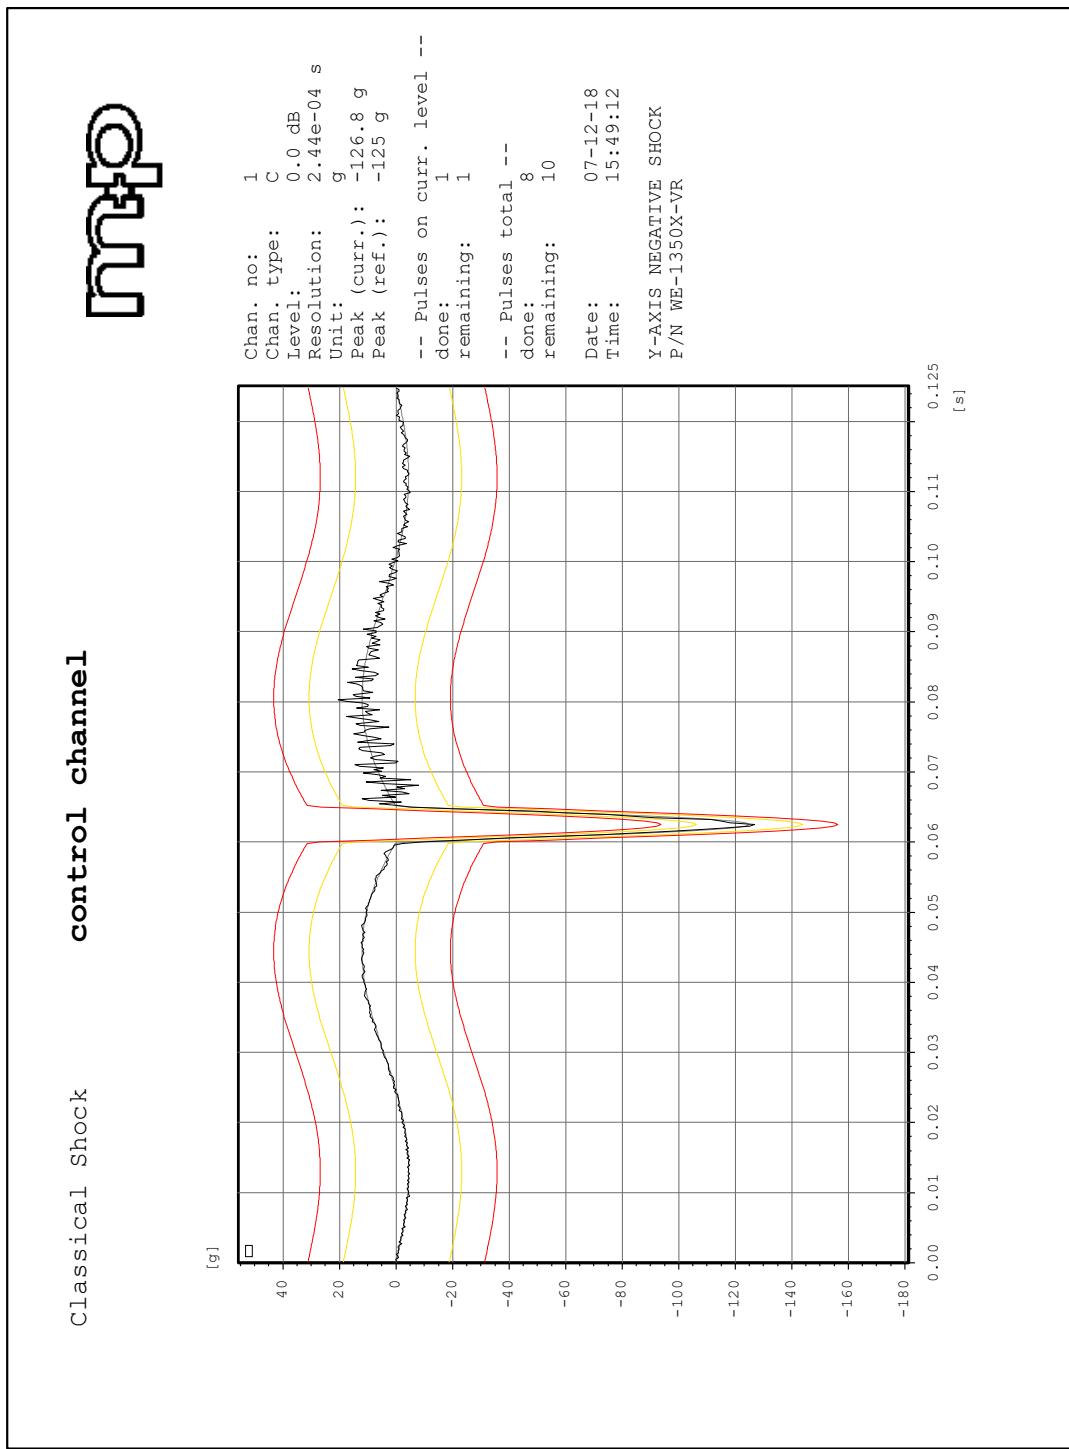
Chart 5.2.1-66:Transverse axis, P/N WE-1350X-VR,Negative1

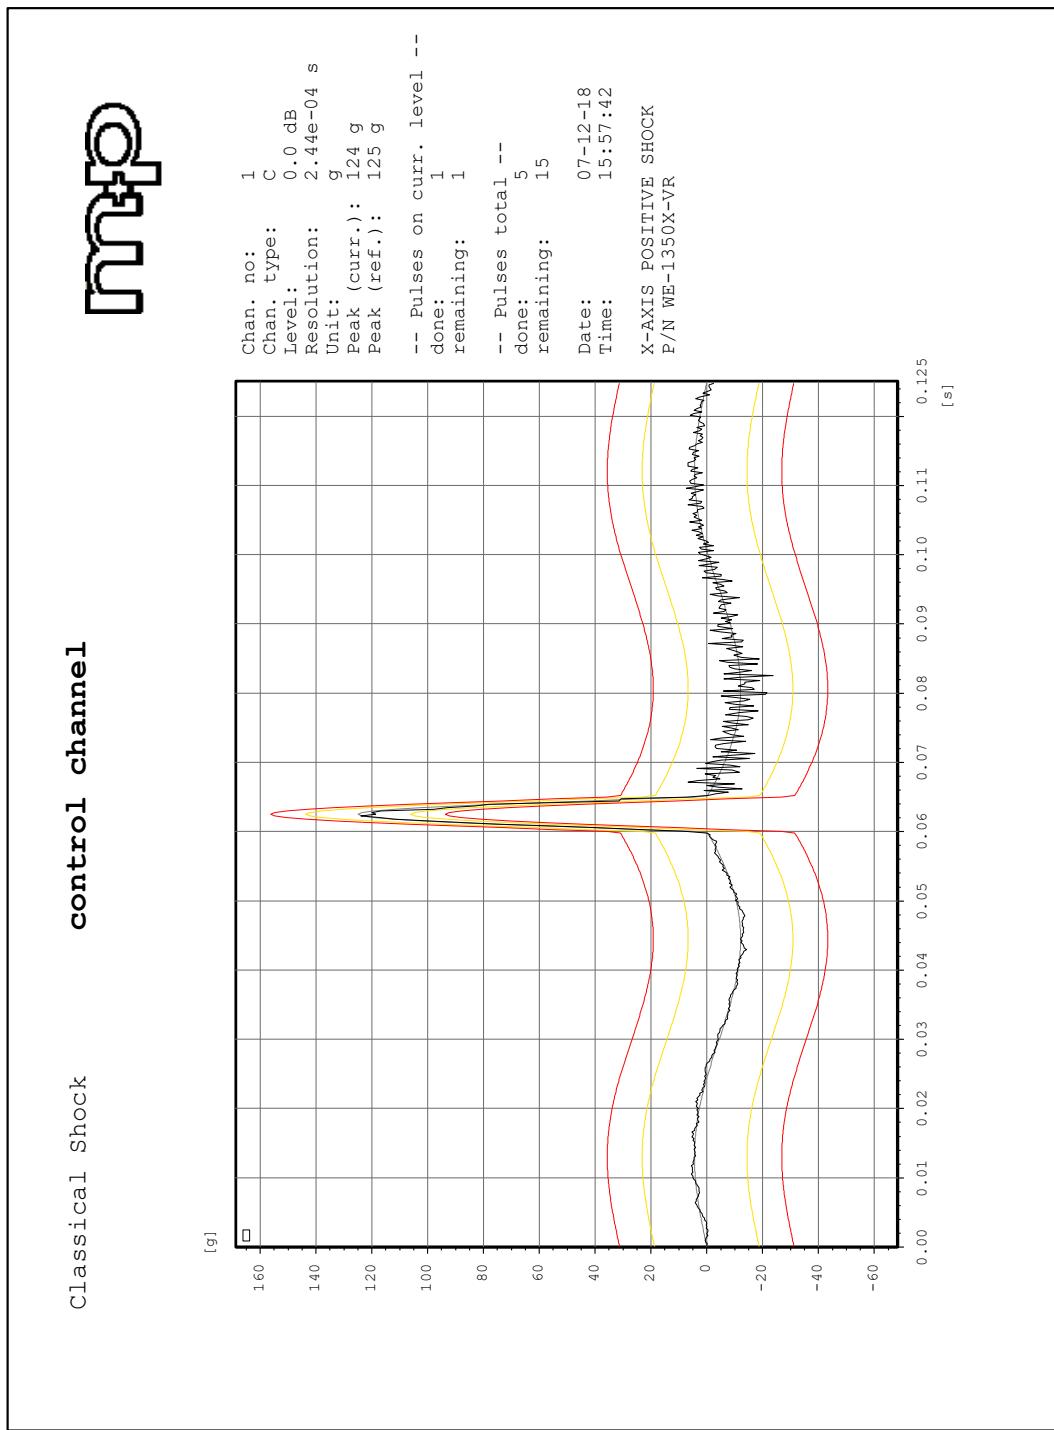
Chart 5.2.1-67:Longitudinal axis Shock Profile, P/N WE-1350X-VR,Positive

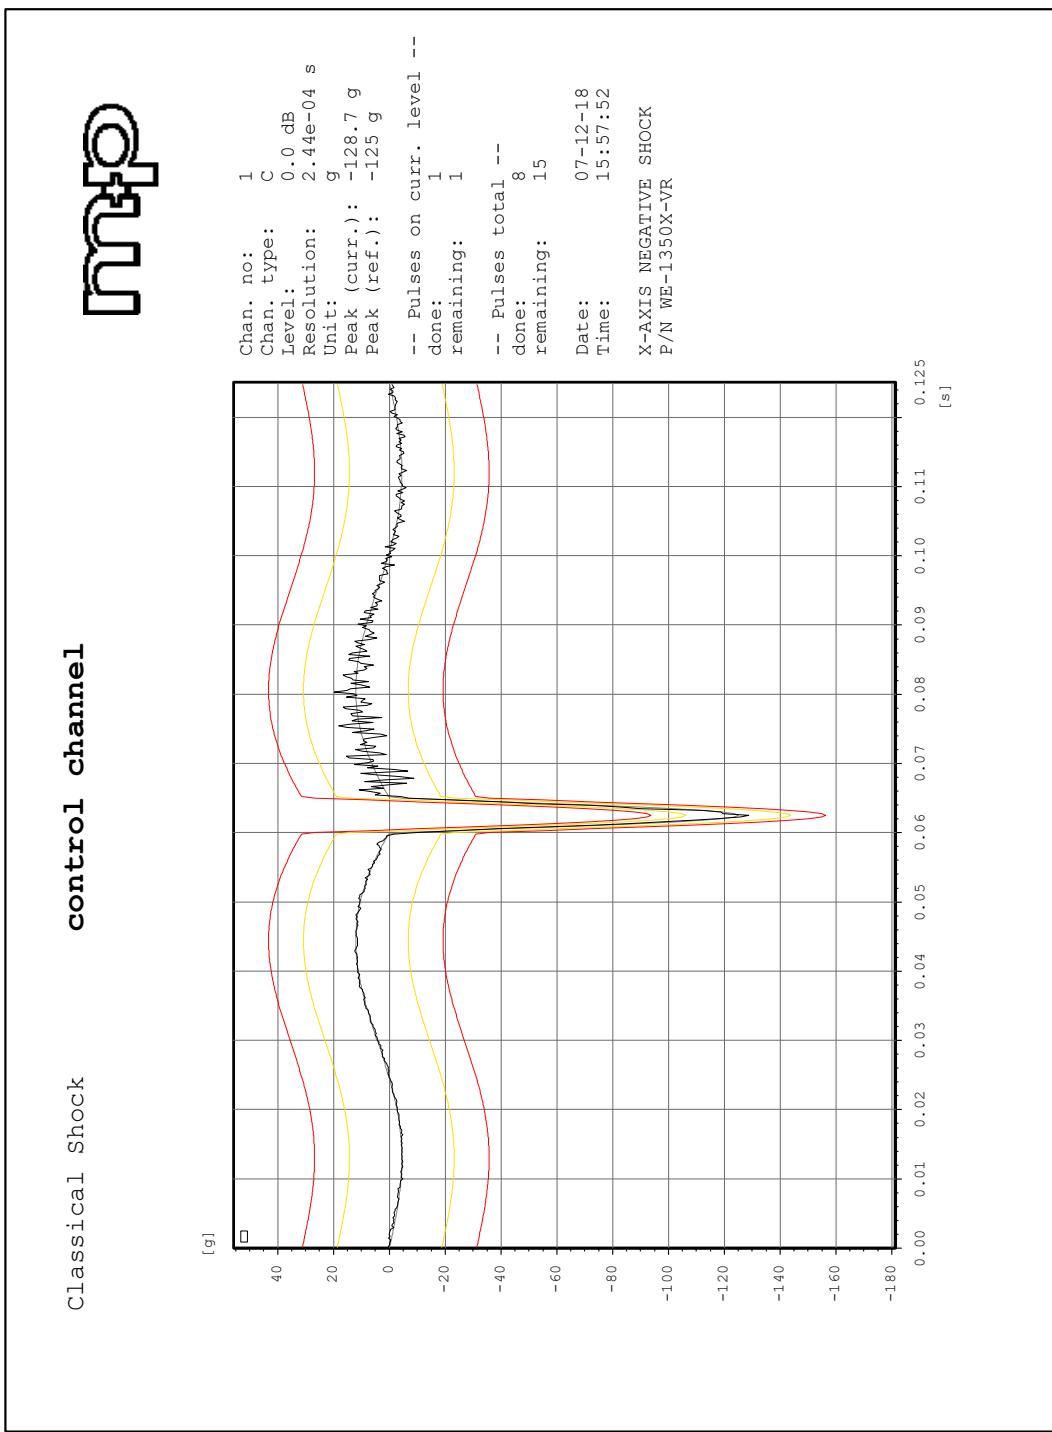
Chart 5.2.1-68:Longitudinal Axis, P/N WE-1350X-VR,Negative 1

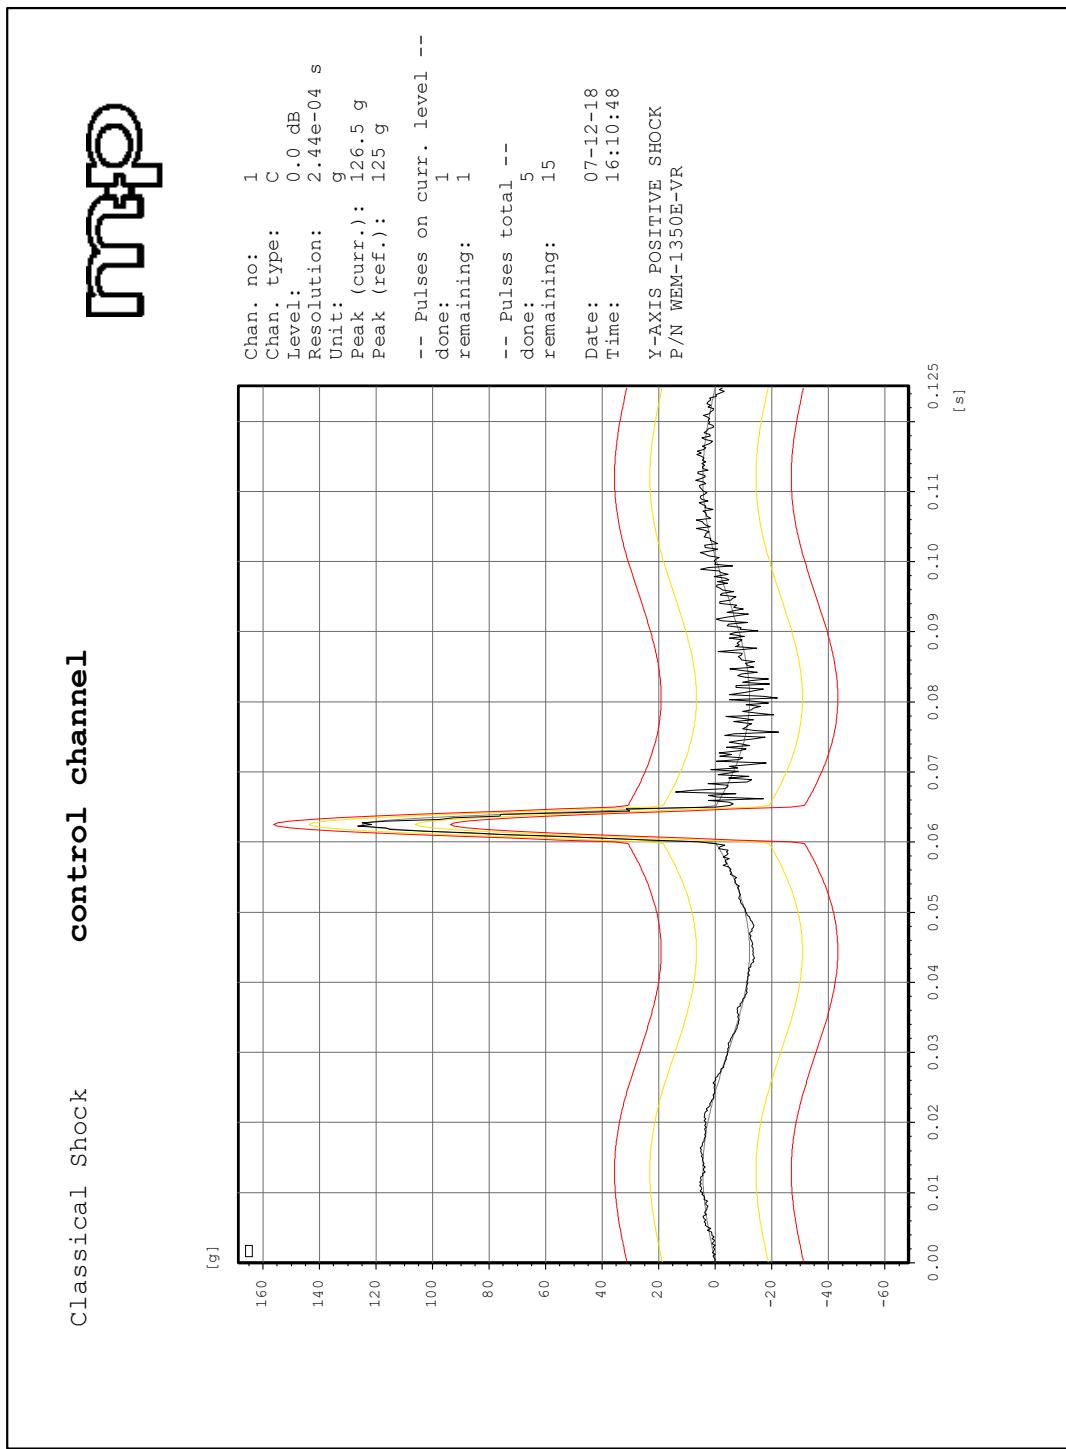
Chart 5.2.1-69:Transverse axis, P/N WEM-1350E-VR,Positive 1

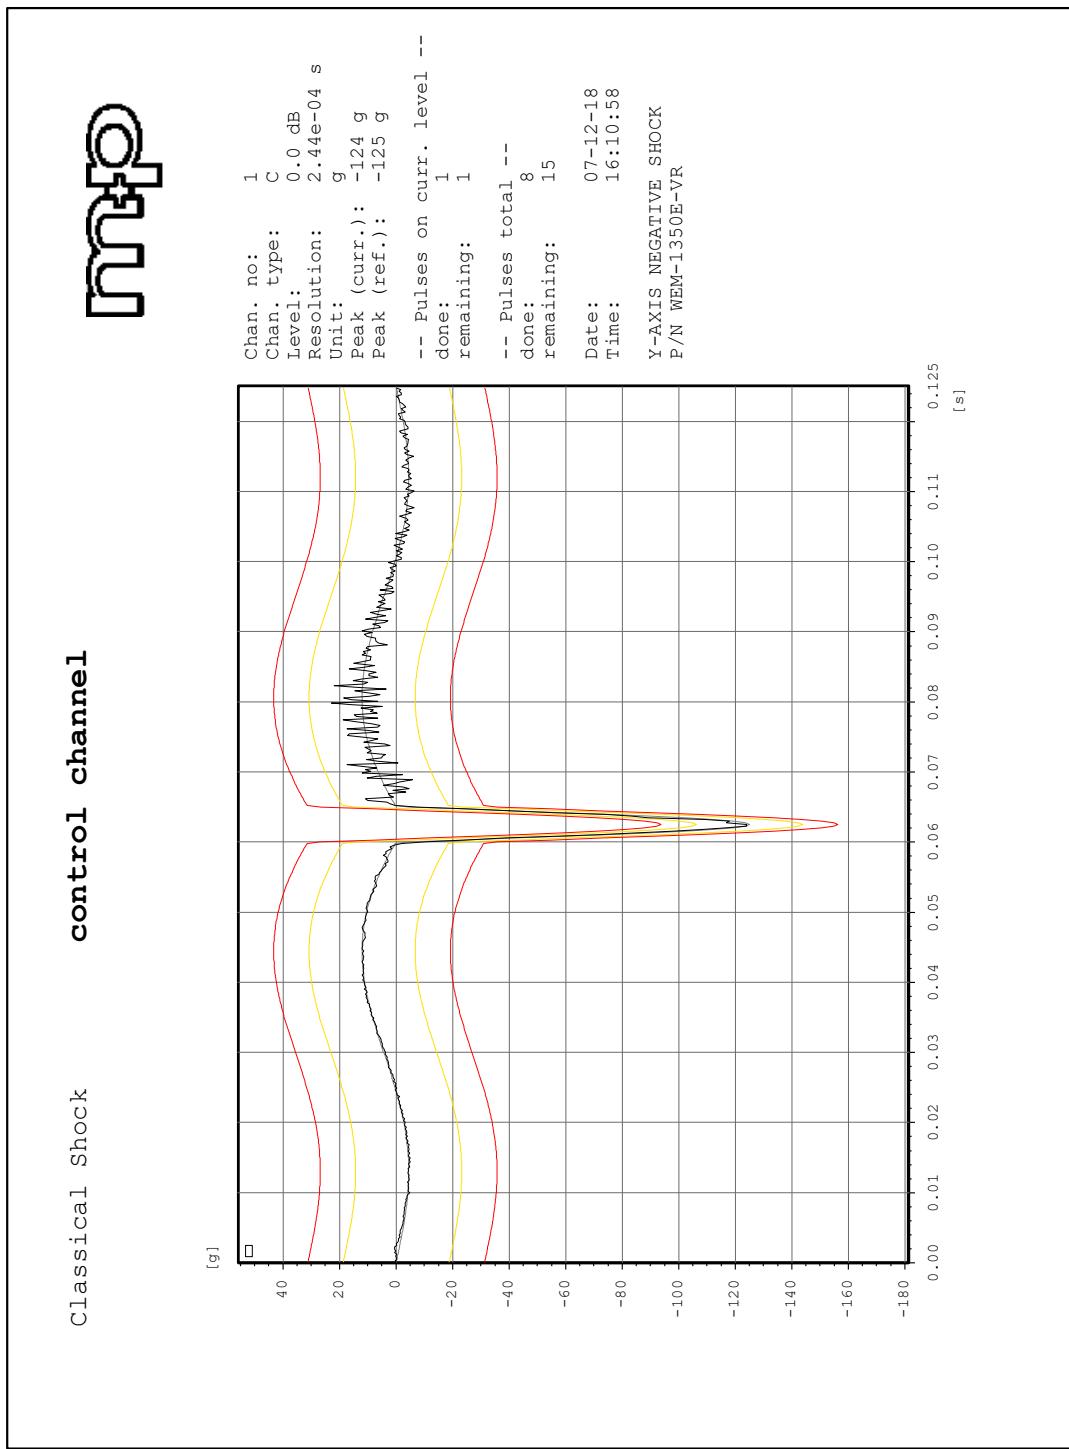
Chart 5.2.1-70:Transverse axis, P/N WEM-1350E-VR,Negative 1

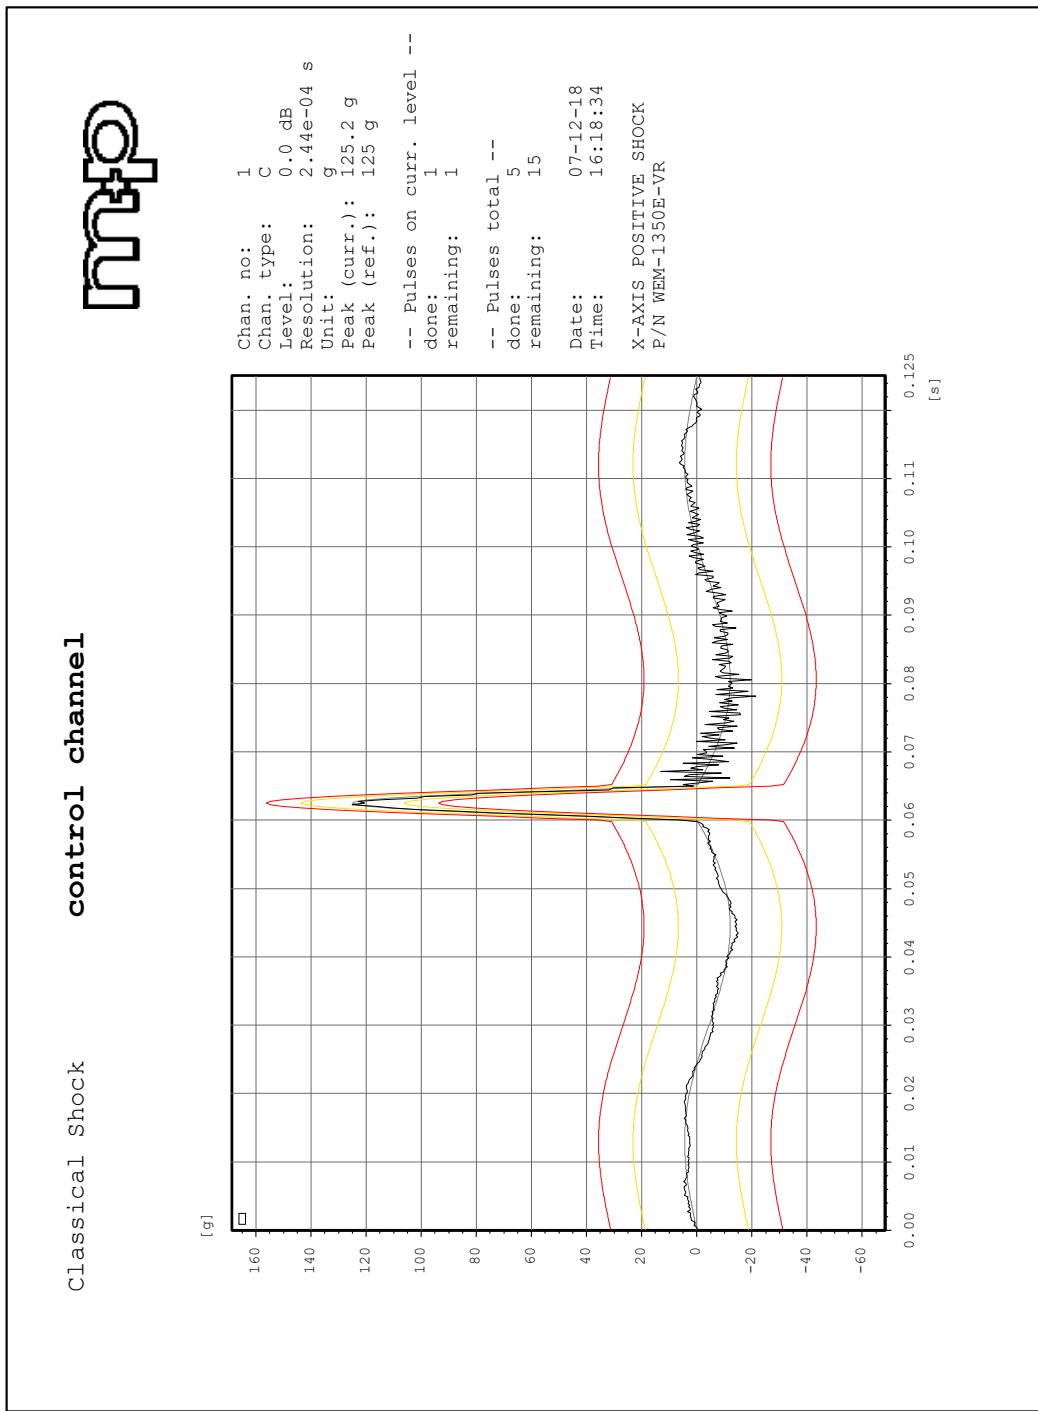
Chart 5.2.1-71:Longitudinal axis Shock Profile, P/N WEM-1350E-VR,Positive 1

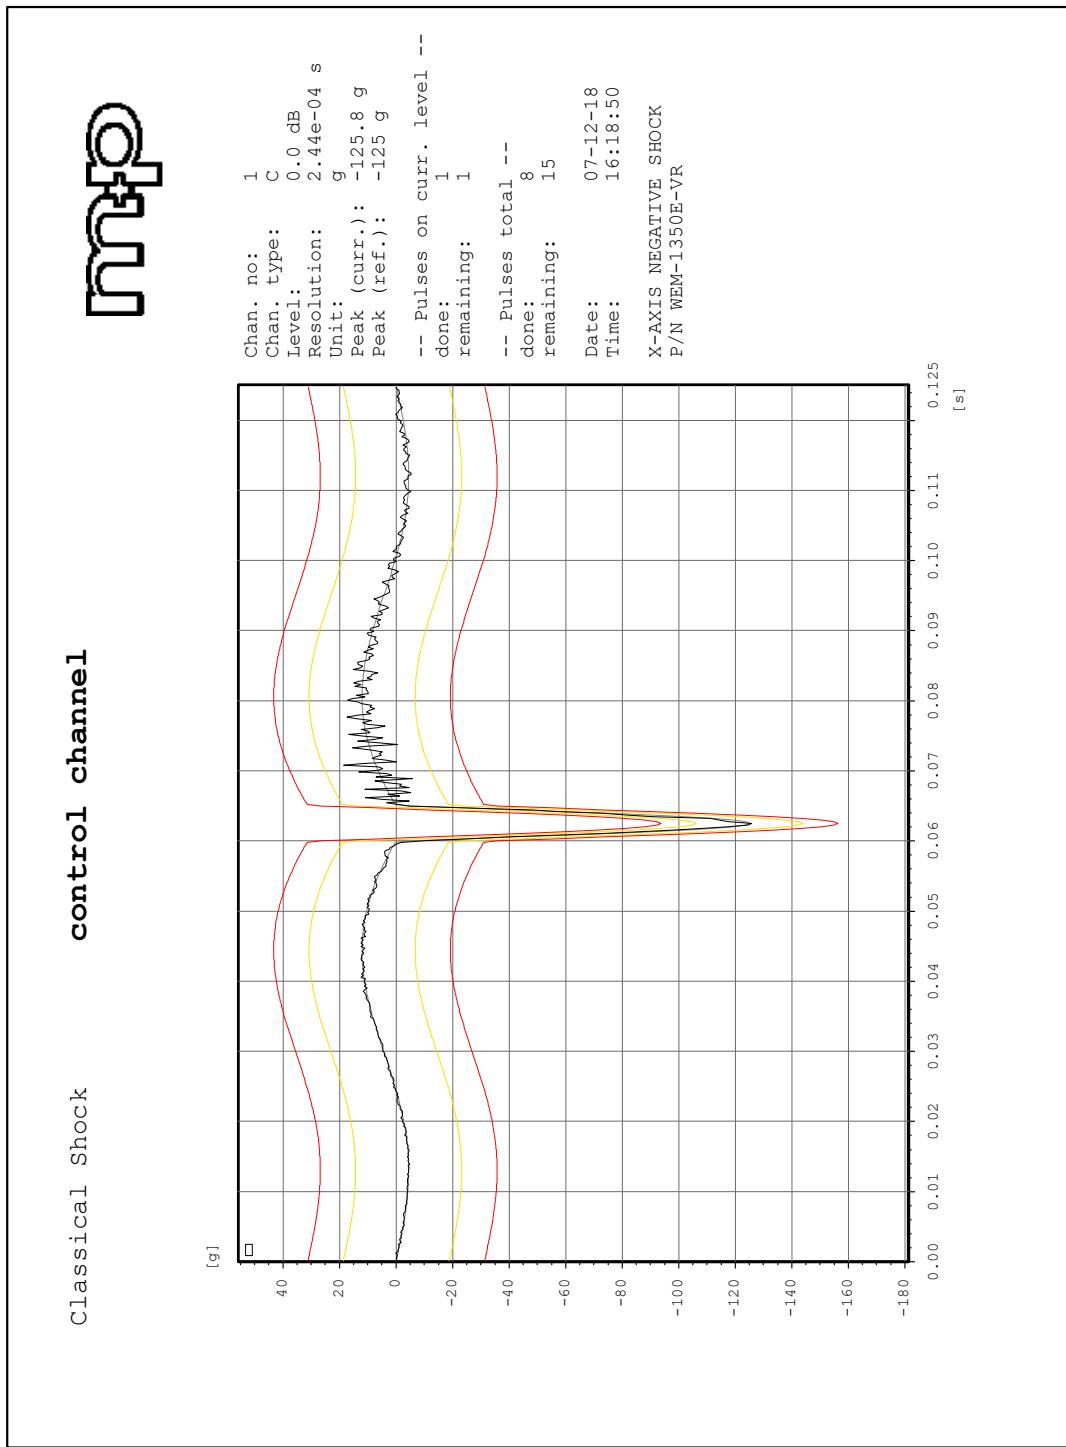
Chart 5.2.1-72:Longitudinal axis Shock Profile, P/N WEM-1350E-VR,Negative 1
