Test Report

Pneumatic Shock

TR-032221-1

Actuators

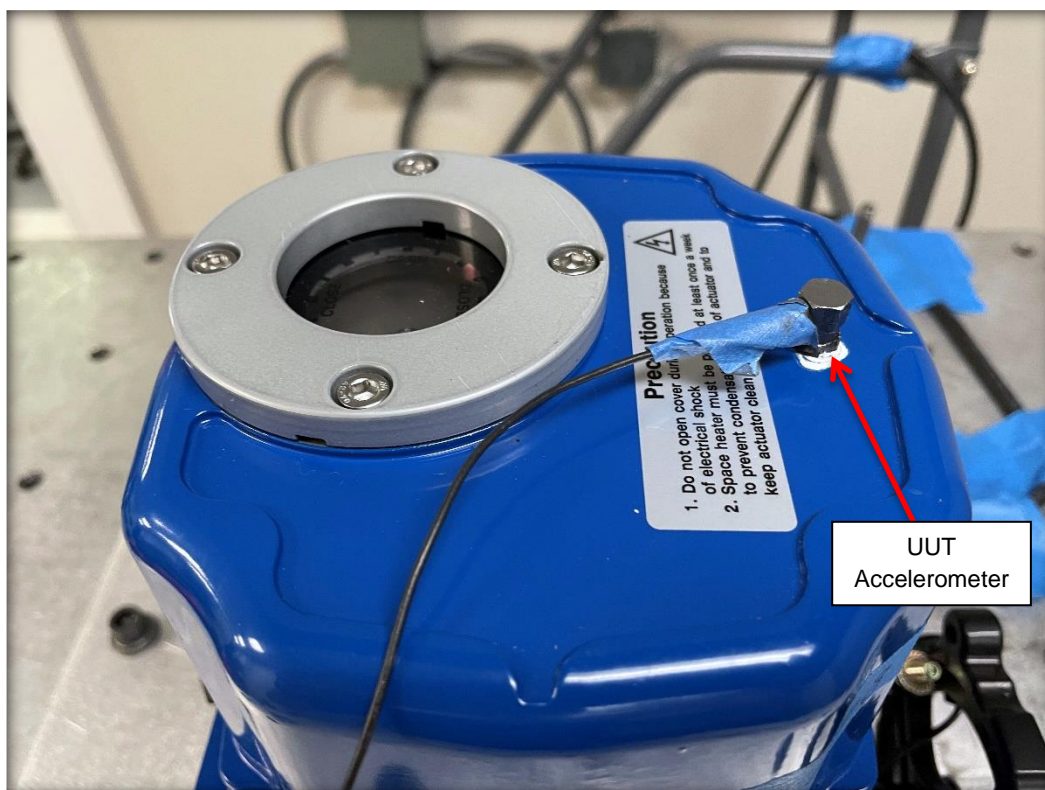
Figure 21: Detailed view of UUT accelerometer location for Z +ve axis testing – Type “SER” units

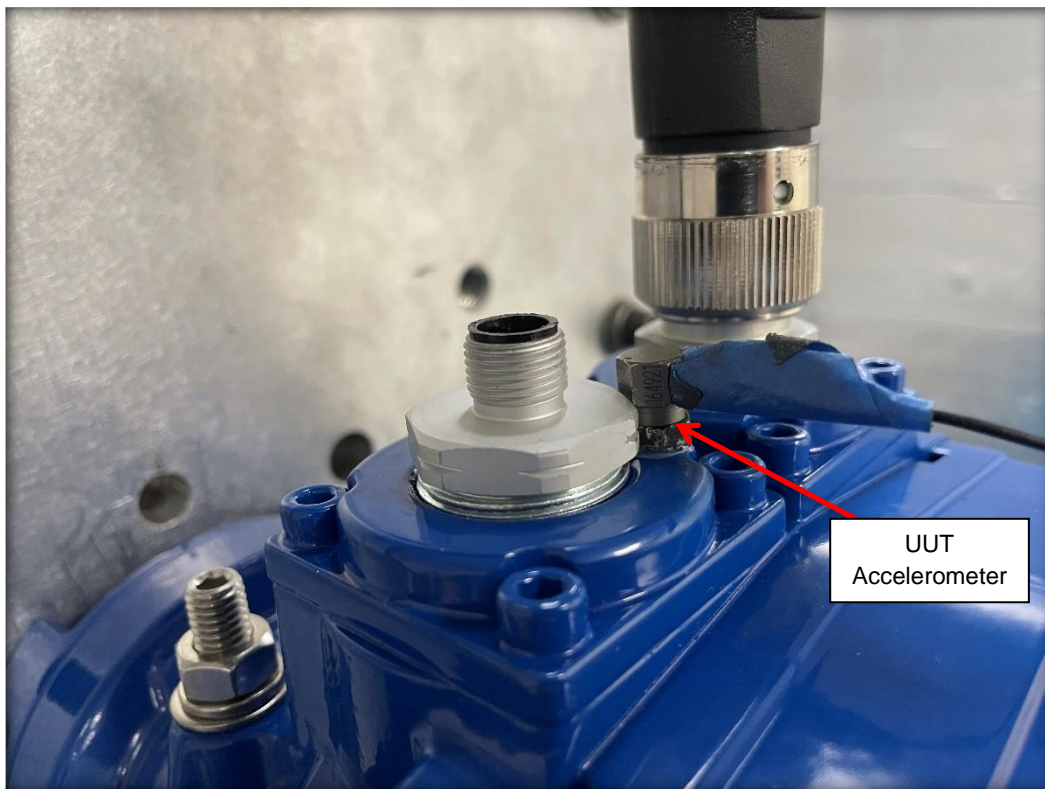
Figure 29: Detailed view of UUT accelerometer location for X +ve axis testing – Type “SER” units

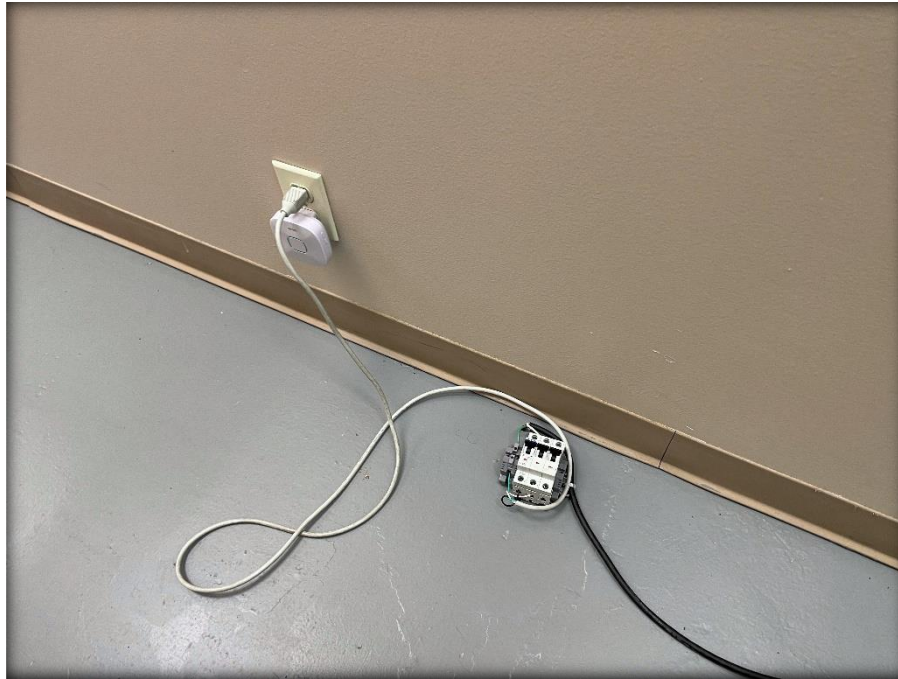
The UUT were powered and monitored for functionally during the pneumatic shock. They were checked to see that they were actuating after each drop or axis. The equipment used to power and monitor the UUT is shown below in Figures 44 and 45.

Figure 44: UUT power and monitoring equipment – 1 of 2

Figure 45: UUT power and monitoring equipment – 2 of 2
